# **PLX SDK**

## **General Notes & FAQ**

**August 2013**

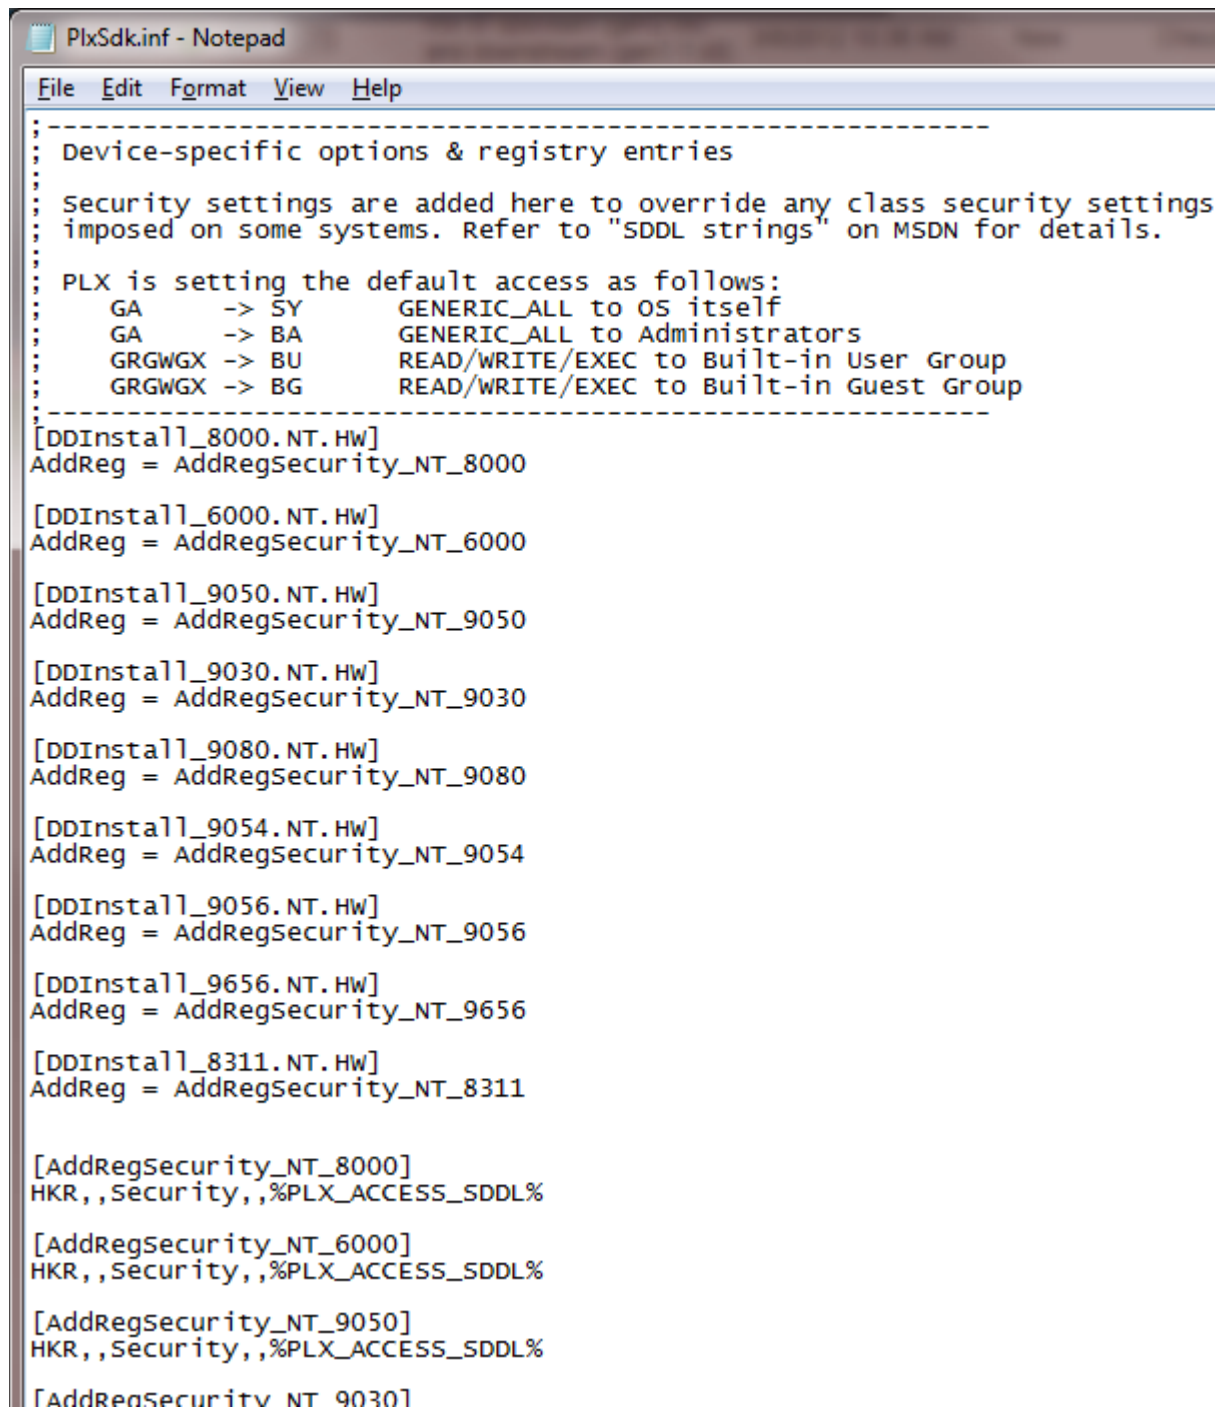
4. Starting with PLX SDK v6.50, PLX added a device security key in the INF so that it’s added for all device installations. Since PLX was never able to reproduce this issue in-house, there is no guarantee this setting will have any effect on the problem. The security descriptor of the parent class may override device-specific security. Below are snapshots from the PLX INF to demonstrate the changes:

PlxSdk.inf - Notepad
File Edit Format View Help
;-----
; Device-specific options & registry entries
;-----
; Security settings are added here to override any class security settings
; imposed on some systems. Refer to "SDDL strings" on MSDN for details.
;
; PLX is setting the default access as follows:
;   GA      -> SY      GENERIC_ALL to OS itself
;   GA      -> BA      GENERIC_ALL to Administrators
;   GRGWGX  -> BU      READ/WRITE/EXEC to Built-in User Group
;   GRGWGX  -> BG      READ/WRITE/EXEC to Built-in Guest Group
;-----
[DDInstall]_8000.NT.HW]
AddReg = AddRegSecurity_NT_8000
