Multimodal Construction Intelligence Platform
Safety audits, crack diagnostics, cost and valuation, and weather-aware site protocols.

Crack diagnostics and structural integrity

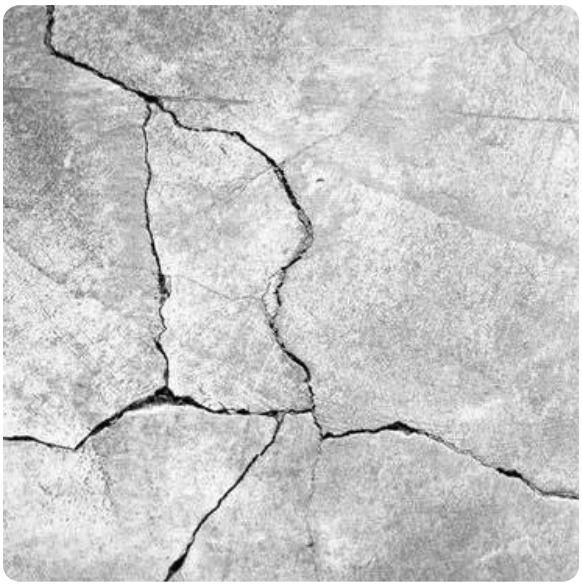
Structural Shear
Defect type

2.5 mm
Estimated width

85/100
Severity score

Urgency: Immediate - restrict access

- Differential foundation settlement
- Excessive structural shear stresses exceeding concrete tensile strength
- Inadequate reinforcement detailing or overloading per IS 456

Severe wide cracking network indicating significant structural movement and potential shear failure. Immediate safety assessment and restricted access are required.

- Conduct thorough structural load assessment and non-destructive testing
- Install crack monitors to track active movement
- Perform structural retrofitting, epoxy pressure injection, or underpinning per IS 13935 guidelines
