Annotated Chart Report: Data Wrangling and Analysis for Plant Manager.

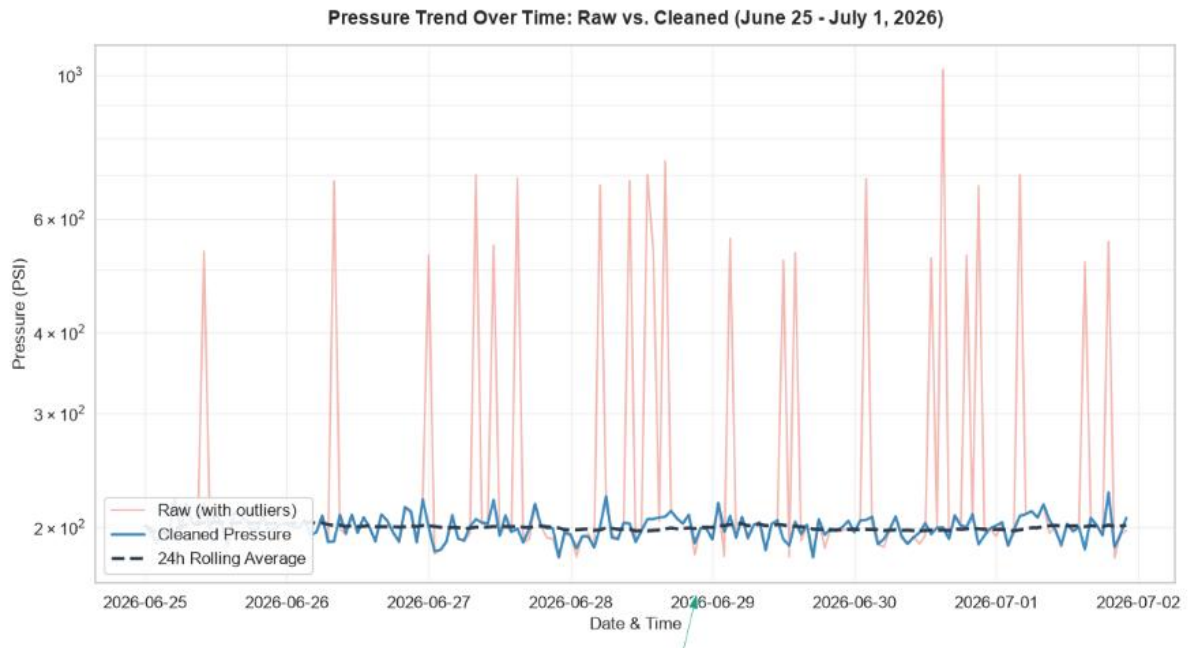
Data cleaning and linear interpolation revealed that the plant is operating within a stable baseline, but exposed a subtle, recurring night-shift pressure dip. Removing the invalid spikes and dropouts shows that the plant's actual pressure resides consistently within a safe operating window of 120 to 280 PSI (averaging 200.13 PSI), while temperature is

maintained between 45 °C and 85°C. However, with the extreme sensor noise eliminated, the cleaned data exposes a distinct operational anomaly: a nightly pressure drop centered in Zone West during the Night shift, where average pressure drops to 192.42 PSI (a 4% decrease compared to Day shifts). This nightly dip was completely hidden by the 15,000 PSI spikes in the raw log, but is now clearly visible as a systematic trend repeating across all seven days of the log.

To prevent process degradation and ensure pressure stability, immediate inspection and sensor upgrades are required in Zone West. First, dispatch maintenance teams to inspect Zone West during the Night shift (10 PM - 6 AM) to locate potential pneumatic leaks, valve failures, or utility supply drops that explain the 192.42 PSI dip. Second, replace the aging pressure and temperature sensors in Zone West and Zone South, as they exhibited the highest frequency of signal dropouts and extreme spikes. Finally, configure the plant's Supervisory Control and Data Acquisition (SCADA) system to flag any night-shift pressure drops below 180 PSI, ensuring real-time alerting before pressure dips trigger automatic safety shutdowns.
