Commissioning the Sussex remote control room

Martti Nirkko, Michal Rigan, Charlie Mills University of Sussex

July 5, 2019

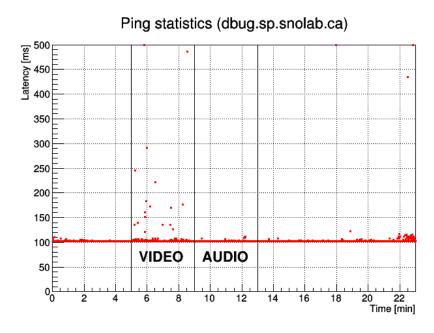
It was during shifts that most of the latency-related problems (time-outs etc.) occurred. This caused a lot of problems affecting detector operations, and was found to be caused by network-intensive "streaming" applications (e.g. xsnoed). Some tests were therefore run under load over the course of 30 minutes. Figures 2 and 3 show the latency for both machines during this test phase. It appears that the current threshold for a timeout at 150 ms is still too low, and the problems observed overseas would be resolved by increasing it to 250 ms. The increase in latency was less extreme on the Mac, which only runs ORCA and the TUBii audio.

Figure 3: Latency of the VPN connection on the Mac without any load, with the TUB camera stream (VIDEO) and with the video disabled (AUDIO).

To fix these problems, a second monitoring machine was installed, which runs any streaming-type applications (xsnoed, cameras, etc.). The latency on this machine is now higher than usual (200 ms) but this doesn't affect the latency on other machines. Therefore, the first monitoring

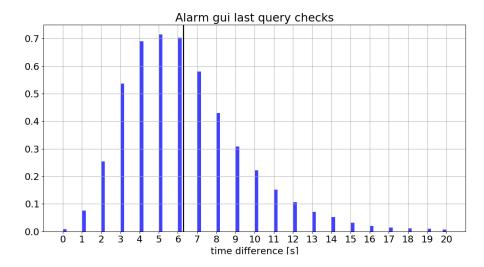
The alarm GUI intermittently showed db_lost alarms with a high frequency, which would clear up after a few seconds. A similar problem was reported by CROX [4]. This issue became very annoying as it made using the headset (e.g. for the software phone) unbearable. We noticed that the alarm GUI tries to query the database every second, and produces an alarm if the last successful query was more than 10 seconds ago. We edited the alarm_gui script to change the database hostname to its IP address (in case of DNS issues), and increased the alarm threshold to 20 seconds. This made the alarms a lot less frequent, as can be easily understood by studying Figure 4.

Figure 4: Time since last successful query as registered by the alarm GUI. The average time is indicated by the black line at 6.2 s, but a significant fraction of the distribution is above 10 s.

After realising that these issues were caused by an increased latency, we managed to resolve the problem by running xsnoed on a separate machine. The time since the last successful query then dropped to 2-5 seconds, and we were able to revert the above changes. After the installation of second monitoring machine there were no more reports of connection loss by the alarm GUI.

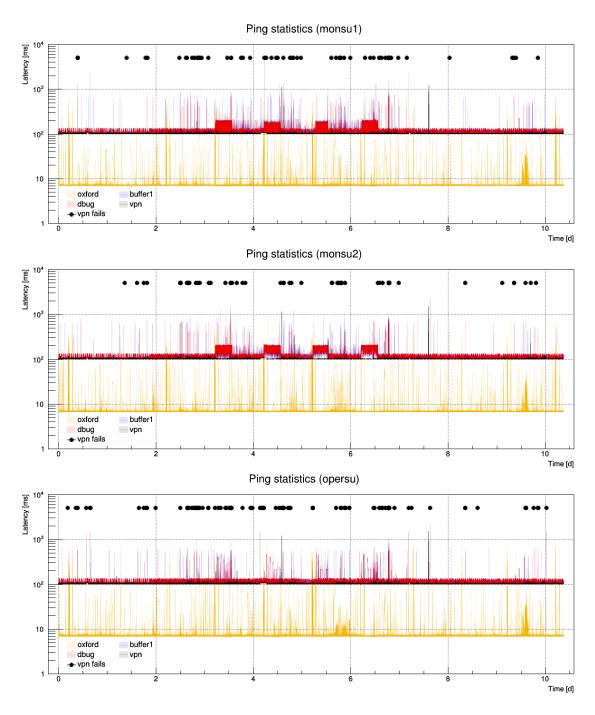
Figure 5: Various latencies at CRSU, monitored continuously over the course of 10 days. Note the logarithmic vertical scale. The latency to the UK host is of the order of 10 ms, while the latency to overseas machines tends to be of the order of 100 ms. VPN disconnects are represented by black dots, set to an arbitrary value of $5\,\mathrm{s}$.

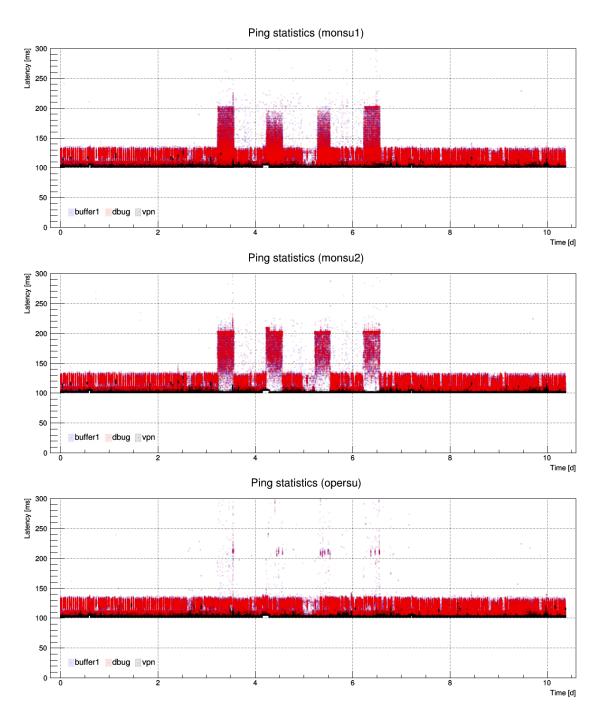
Figure 6: Same as Figure 5, but showing only the latencies for SNOLAB hosts, as a scatterplot on a linear scale. It can clearly be seen when CRSU was running under load, i.e. taking shifts (graveyard shifts 28/05/2018 - 31/05/2018). The VPN connection (black dots) however remains stable at a relatively low 102 ms.

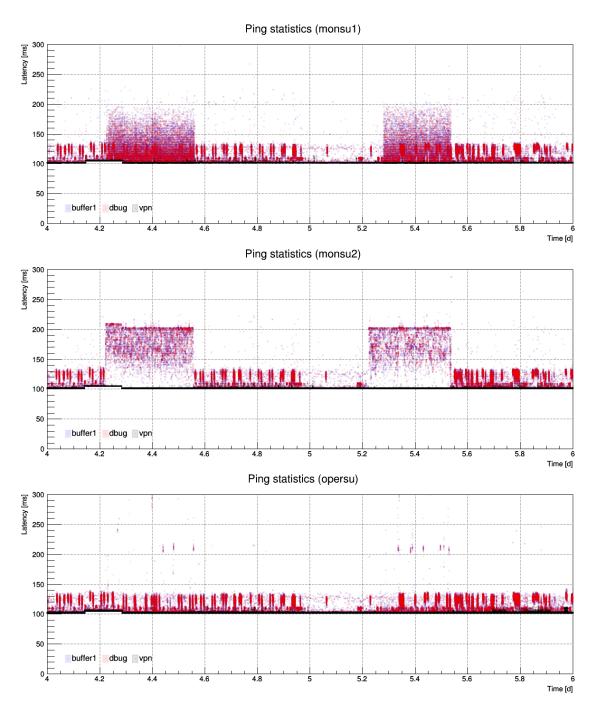
Figure 7: Same as Figure 6, but zoomed in on two of the days during which shifts were being taken at CRSU. On monsu1, which runs most monitoring tools as well as the software phone, the typical latency was just above 100 ms, with occasional fluctuations up to 200 ms. On monsu2 however, which monitored the cameras as well as 4 instances of xsnoed, the latency was most often at its highest values, i.e. 200 ms. The operating machine, which runs ORCA and the TUBii audio, was least affected by the latency fluctuations. The occasional peaks around 210 ms may be due to saving the ORCA file.
