Detroit Water and Sewerage Department

Wastewater Master Plan

Lateral Sewers and Connector Sewers

Technical Memorandum

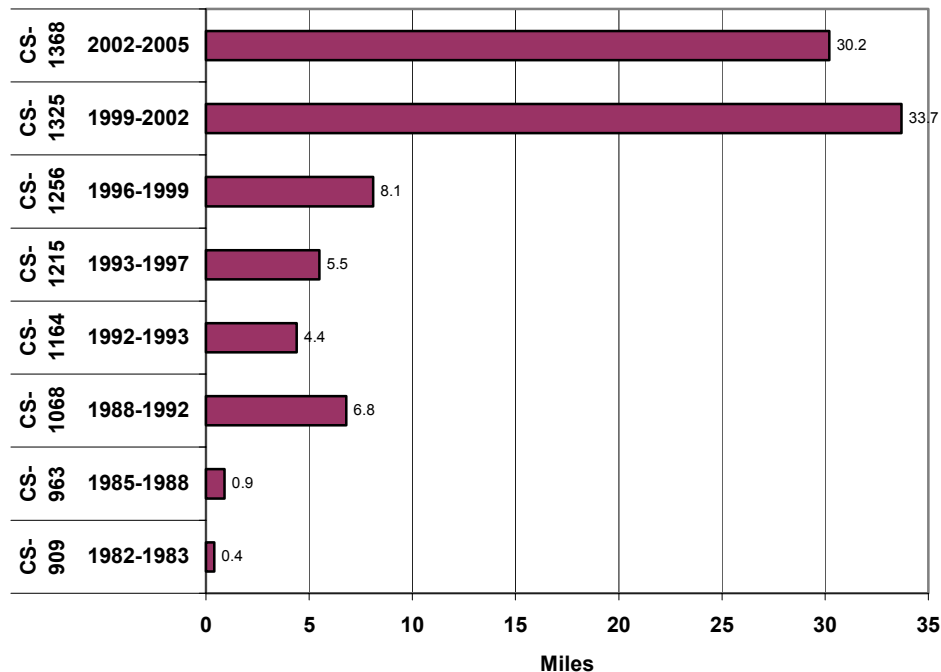
Figure 8. CIPP Installed Lengths by Contract

Figure 8 shows the approximate amount of active Cured In Place Pipe, which has been completed, on existing sewers over the past 20 years.
