Wi-Fi Site Survey & Coverage Audit Report

Project: Project 1 - Jain_Student **Scan ID:** Scan 1 **Facility:** DMGT EL Campus Block

Captured: 2026-10-13 10:36 UTC

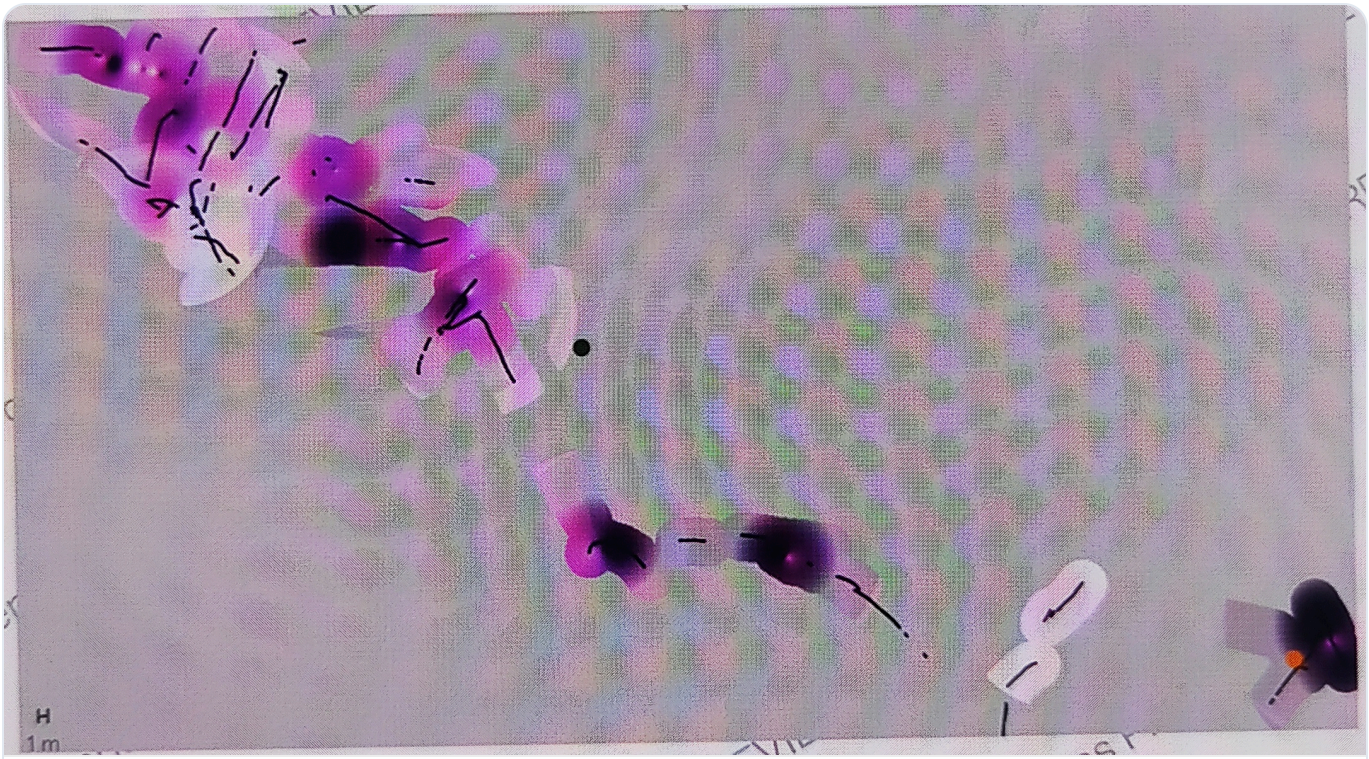
Radio Spectrum Rollup

2.4 GHZ BAND	5 GHZ BAND
91 APs	**184 APs**
33.1% of Radios	66.9% of Radios

Deployment Note: The campus infrastructure heavily leverages 5 GHz capacity (2:1 ratio over 2.4 GHz), offering superior throughput and low co-channel congestion.

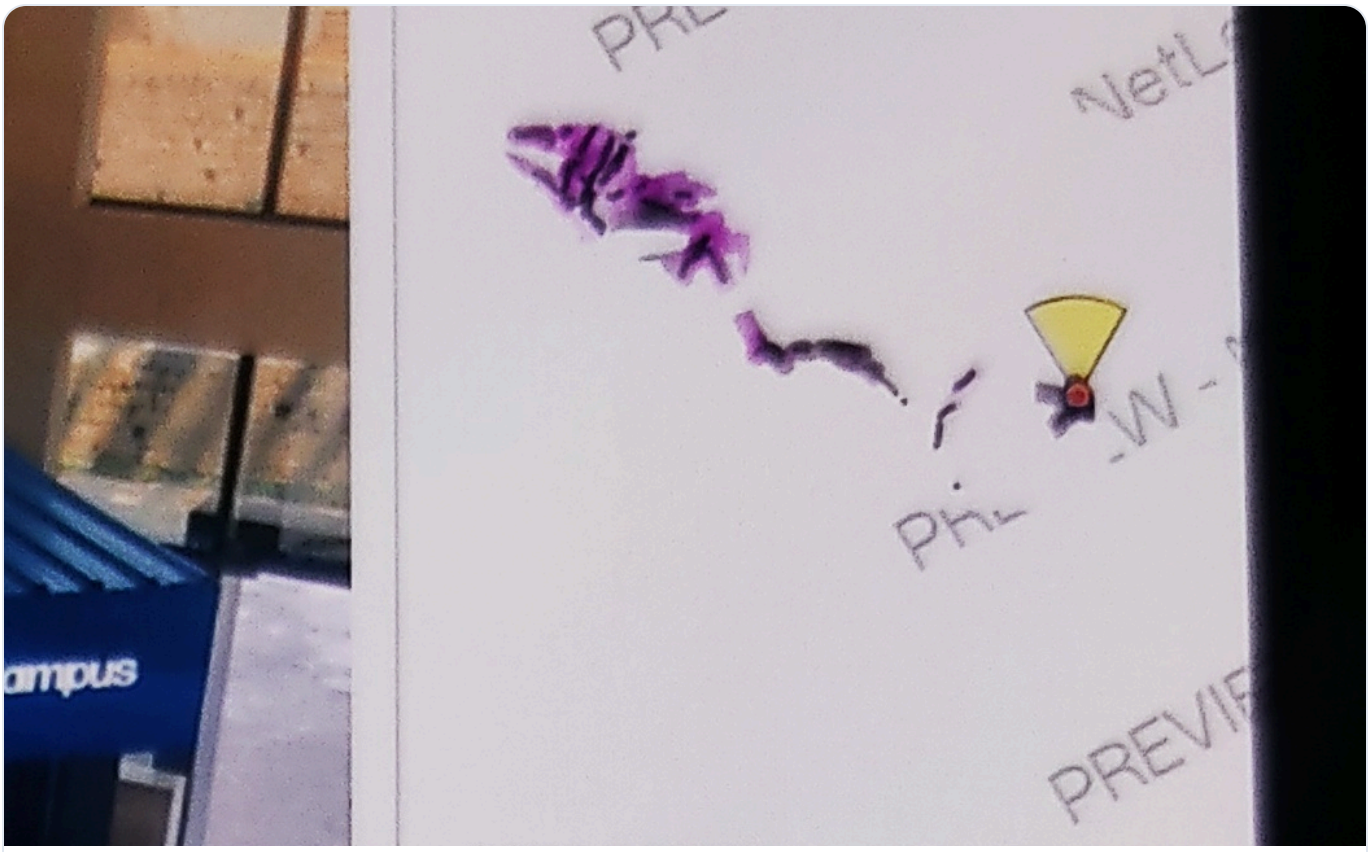
Overview Map: 404 Samples • 275 APs • Walk Path Trail Scale: 1m Bar

1. Peripheral Dead Zone Remediation (13% Footprint)

Signal metrics degrade past -85 dBm along the southern edge and outer access corridors. We recommend installing 1 additional Ruckus R550/R650 unit (or relocating existing AP `80:bc:37:0d:10:d8`) to achieve 100% floor plan coverage.
