FTTx GPON VoIP Service Troubleshooting

1. VoIP service fault analysis and locating
2. Categorized VoIP faults and troubleshooting
3. Case study

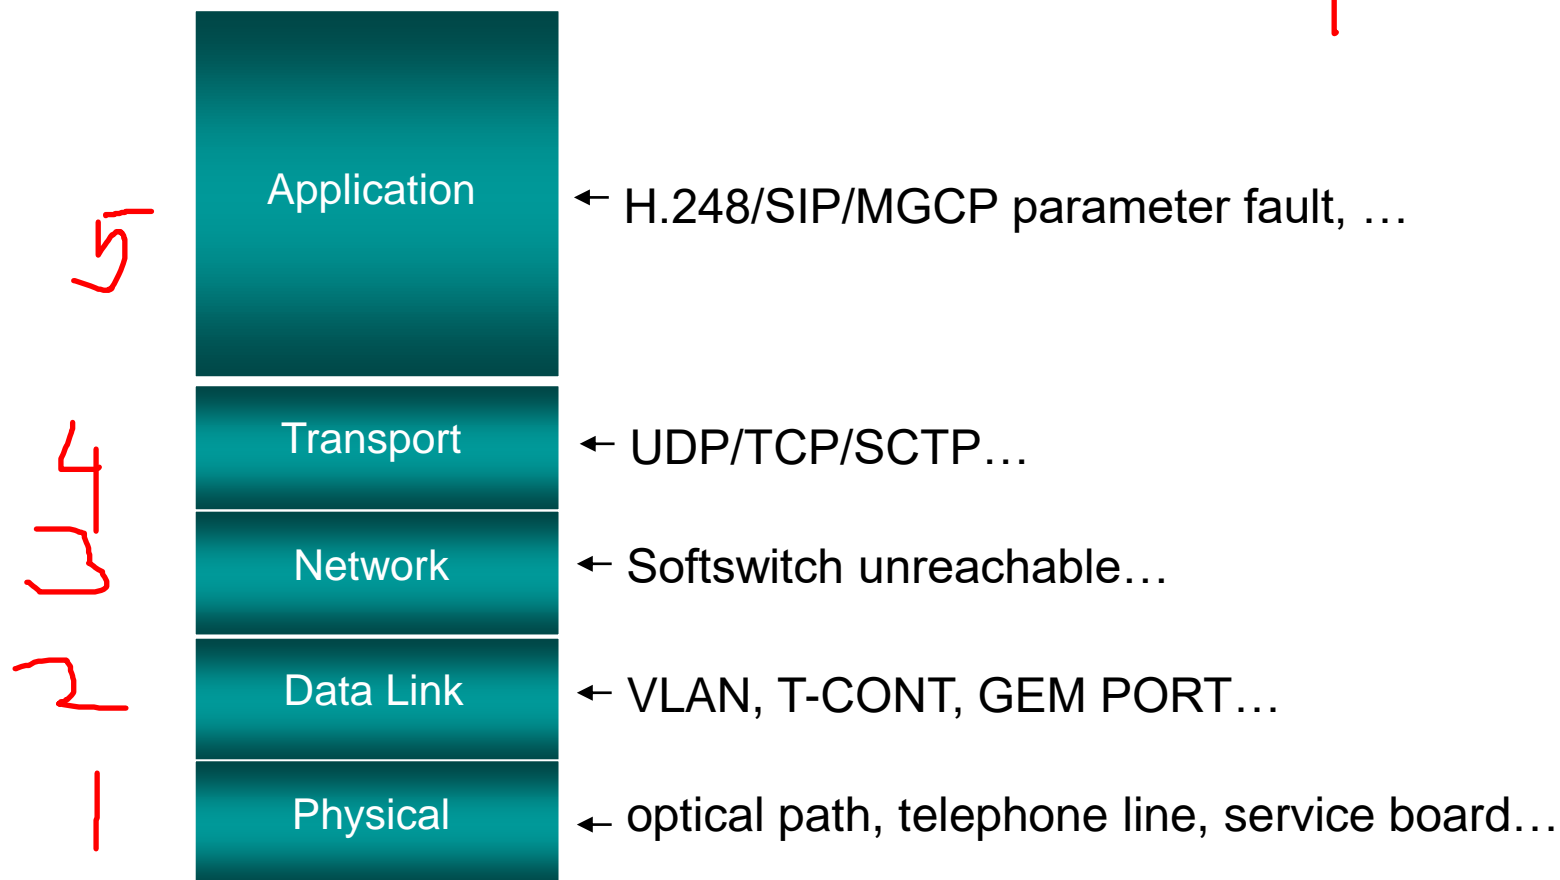
Layered Analysis

TCP/IP

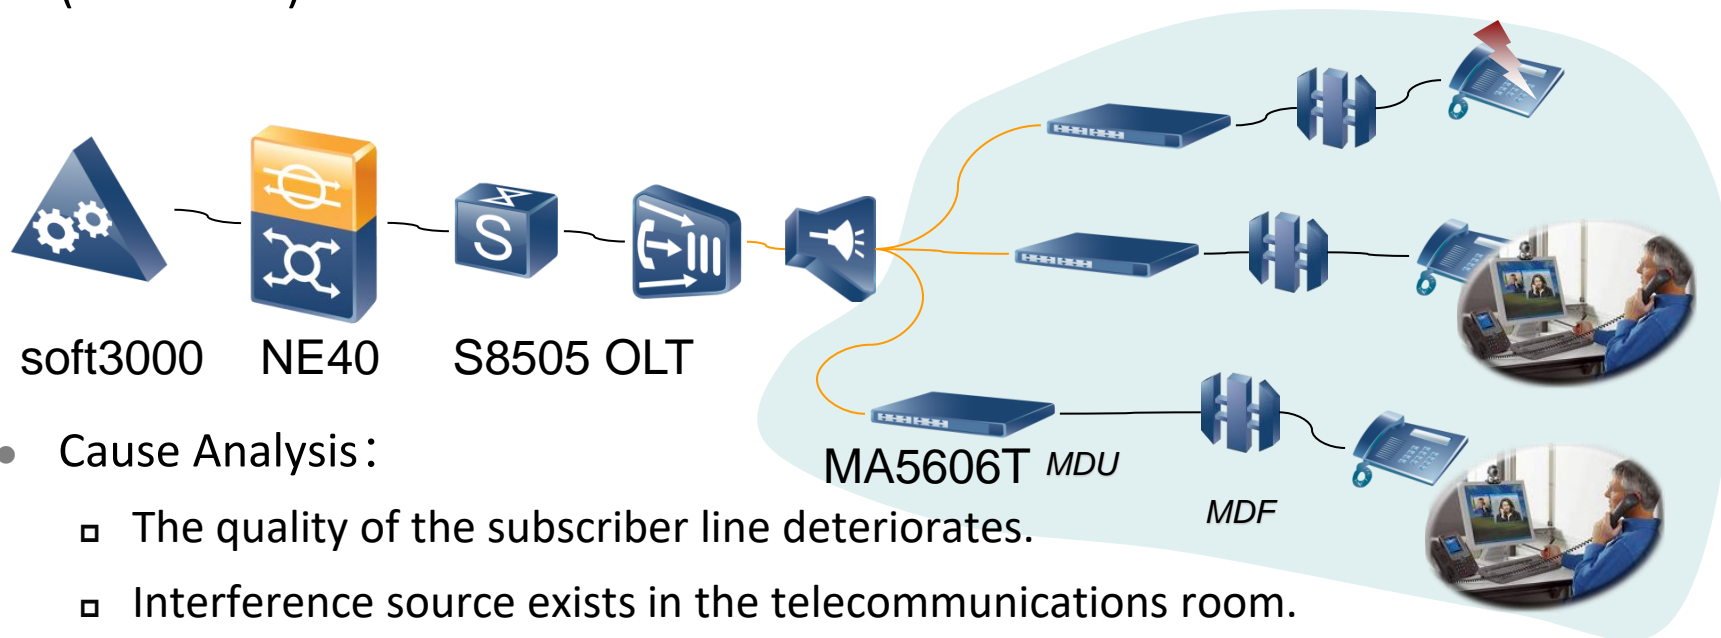
Case1 Noise Occurs in the VoIP Service of the ONU

- Description: Noise often occurs in the VoIP service of the ONU (MA5606T).

- Cause Analysis:
 - The quality of the subscriber line deteriorates.
 - Interference source exists in the telecommunications room.
 - The DDF grounding is improper.
 - The service boards are faulty.
 - The upstream transmission is faulty.

- Fault scope analysis:
 - Only one ONU has the problem, so we can locate the fault point between the ONU and the telephone set.
- Troubleshooting procedure
 1. Make calls for test on the DDF and the device separately. It is found that noise exists.
 2. Check the environment of the telecommunications room. It is found that both cabling and the power supply meet the specifications and there is no strong electromagnetic interference.
 3. Test the grounding resistance. It is found that the grounding resistance is 3.48 ohms, which is in the normal range.
 4. Test all the boards. It is found they are all faulty. This indicates that the noise is not caused by service boards.

After checking, it is found that the OLT suffers the ARP attack, which leads to high CPU usage. Configure the firewall for the OLT. It is found that the CPU usage recovers and the noise occurred in the VoIP service of the ONU disappears.

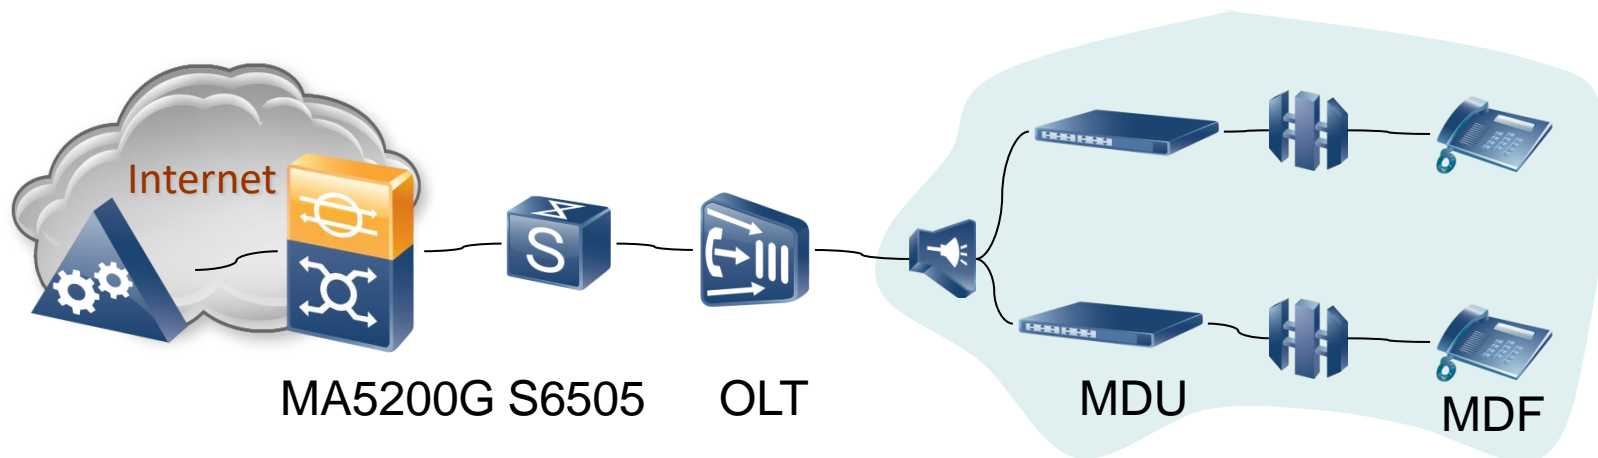
- Networking

- Configuration: AG_1 and AG_2 share the ip address of the same network, belong to the same sub interface on MA5200G. AG_1 and AG_2 use the same QINQ vlan.

- Fault scope analysis:
 1. AG register to the Softswitch fails global config or interface mode
 2. The configuration of OLT and SS has some problem
 3. Other problems
- Troubleshooting Procedure
 1. Two AGs can ping and register to remote SS successfully. Exclude the problem of registration.
 2. Because the communication of AGs that belong to the same network need not to through the gateway, but OLT isolate the data in layer 2, we must enable the “arp proxy” or “vlan bridge” function in OLT.
 3. Because that OLT be configured QINQ VLAN for VoIP service, prohibit ARP Proxy. Check the MA5200G find that the sub interface disable arp proxy, after enable it fault disapper.

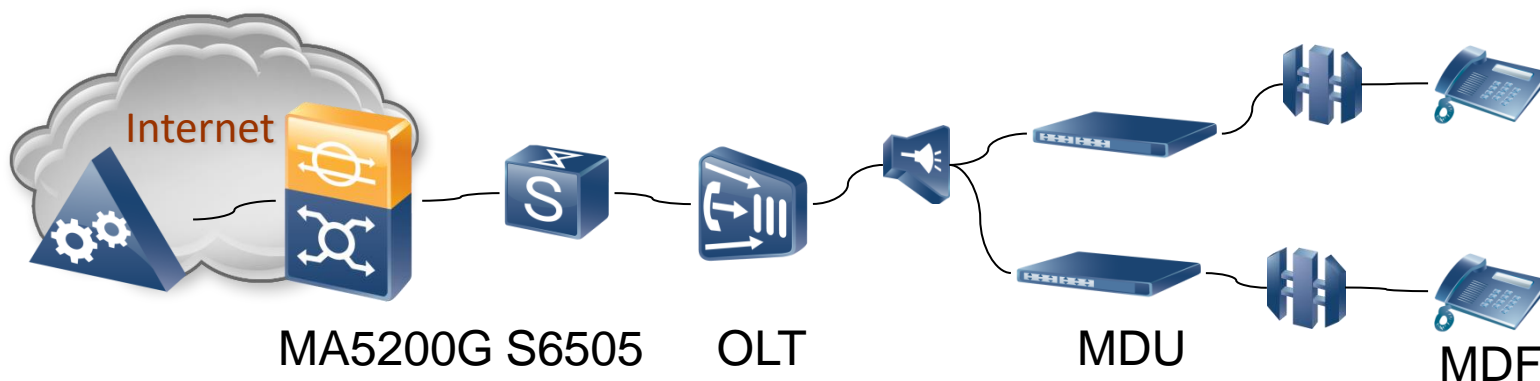
Case3 No Dialing Tone After Offhook

- Description
 - On one site, MA5606T (used as ONU) connect to OLT. The state of H248 interface in MA5606T is normal, but all the subscribers that belong to this interface can't hear the dialing tone after offhook.
- Alarm
 - No

- Fault scope analysis
 - The cause may be the interface configuration, MDU device fault, OLT fault, SS fault. But the fault occurs only for MDUs belong to the same OLT. So we can locate the fault point between the gateway and OLT.
- Troubleshooting procedure
 1. Check the state and parameter of H248 interface, all normal.
 2. Check subscriber's data configuration, it is normal.
 3. Ping the ip address of SS in MDU, find 50% of the packets get lost.
 4. Ping the ip address of SS in OLT, find 50% of the packets get lost either.
 5. Check the data configuration, find that the upper layer LAN switch was configured link aggregation, but not in OLT.

When the VoIP service is fault, after we confirm the H248 interface is normal, usually not care the link condition between AG and SS. This case tell us that the H248 interface is normal not indicate the link is normal.
