OLT(GPON) System Troubleshooting In-depth

GPON System Troubleshooting Overview

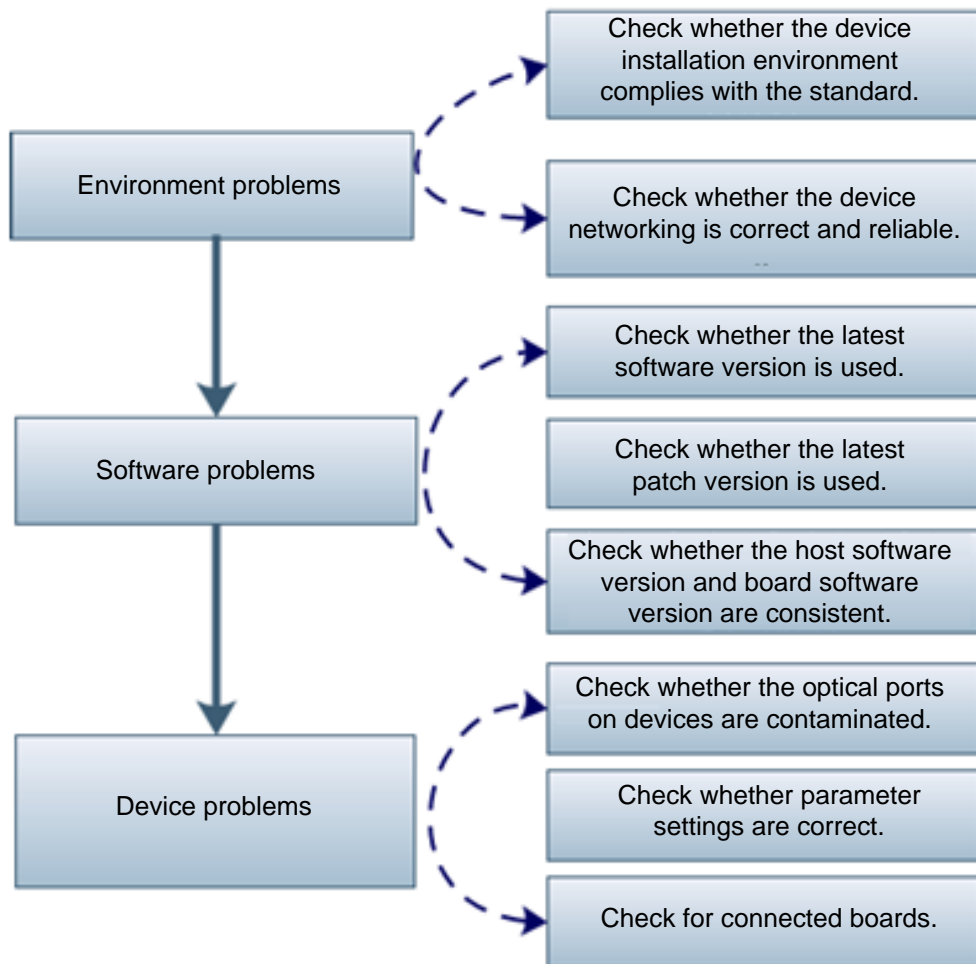
Verifying Causes for Fault Reproduction Failure During Device Repair

The check items listed in the figure on the left are used to verify only possible causes for fault reproduction failure during device repair, not all causes. For details about the cause verification standard, see related documents.
