# CLOSING PACKET

9614 DEER TRACK CT, BRENTWOOD, TN 37027

FRIDAY, AUGUST 28, 2026

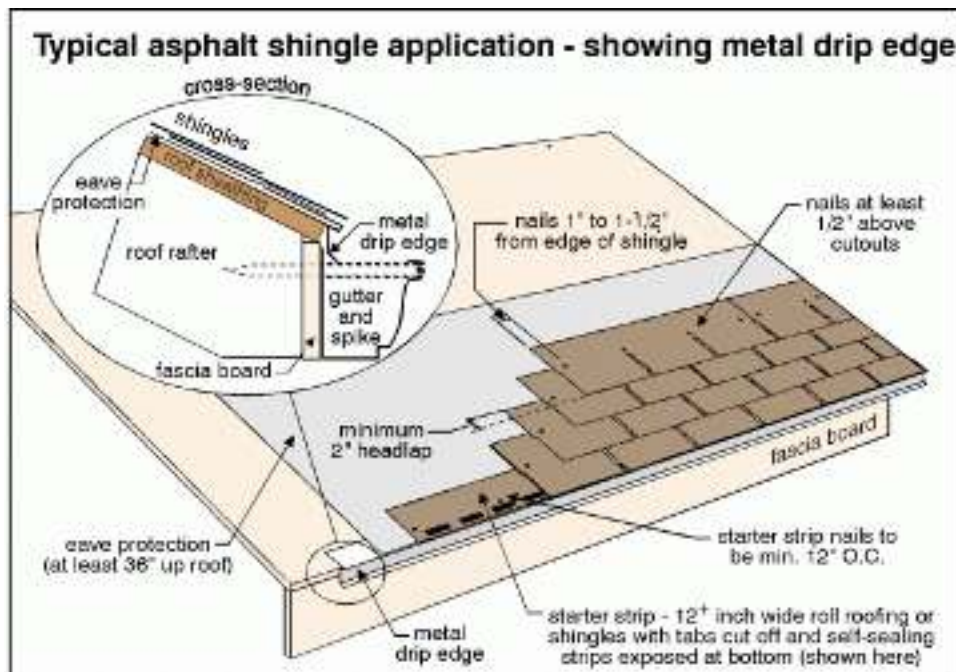
**1. Condition:** • Exposed fasteners

Exposed fasteners which penetrate roofing materials should be sealed with an appropriate, exterior-grade sealant to lessen the potential for leakage. Applied sealant should be periodically maintained when degradation occurs.

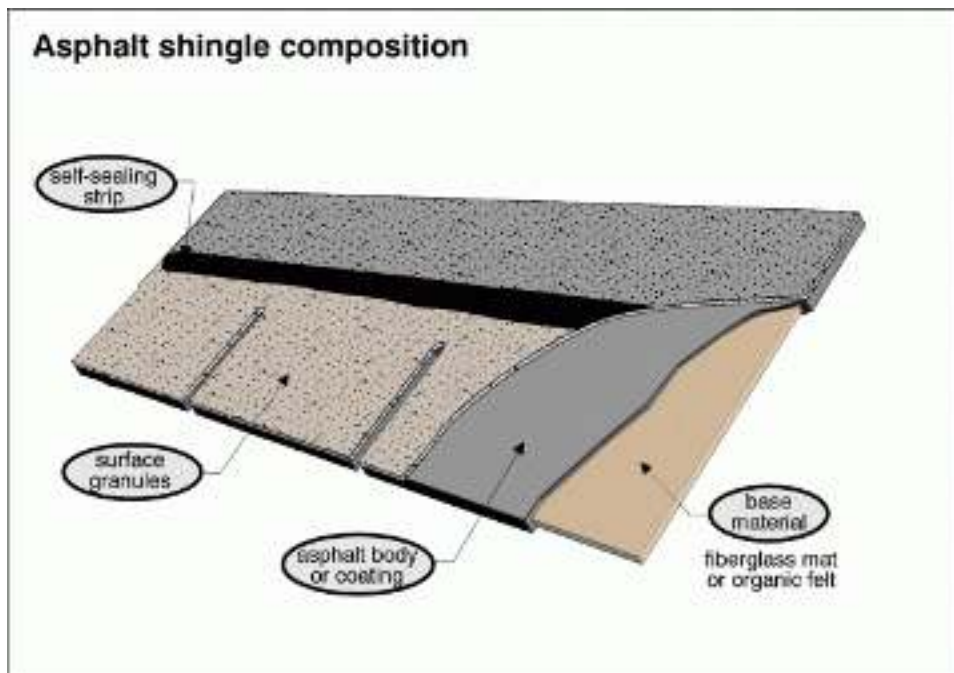
3. Minor abrasions

## 4. Condition: • Granule loss

Granule loss was found in areas of the roof. The amount of granule loss appeared to be consistent with the apparent age of the roof. Loss of granules is a normal part of the aging process of the roof.

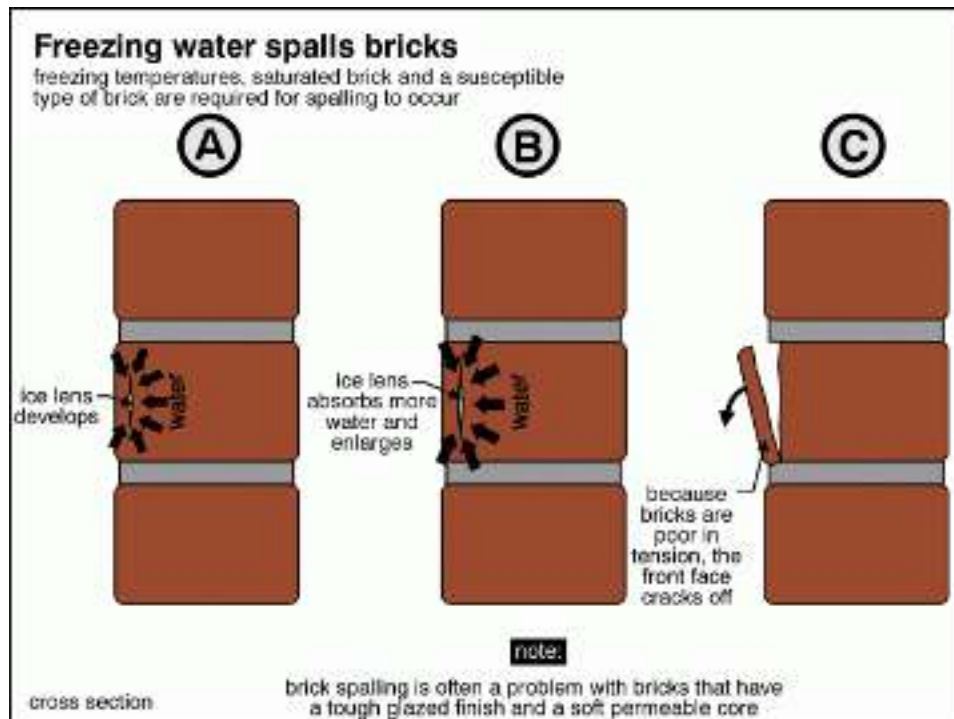
12. Cracked

### 9. Condition: • Cracked

Minor cracking in the brick veneer was noted at window and door openings. This type of cracking is often indicative of minor settlement which may have occurred at any point in the history of the home. It is recommended that the cracks be filled with an appropriate filler and monitored for further signs of movement.

Note: It is recommended that the cracks be filled with mortar, as it will alert the homeowner to any potential issues, and establishes a time line for movement in the brick veneer. Flexible sealant should not be used, as it obscures movement.

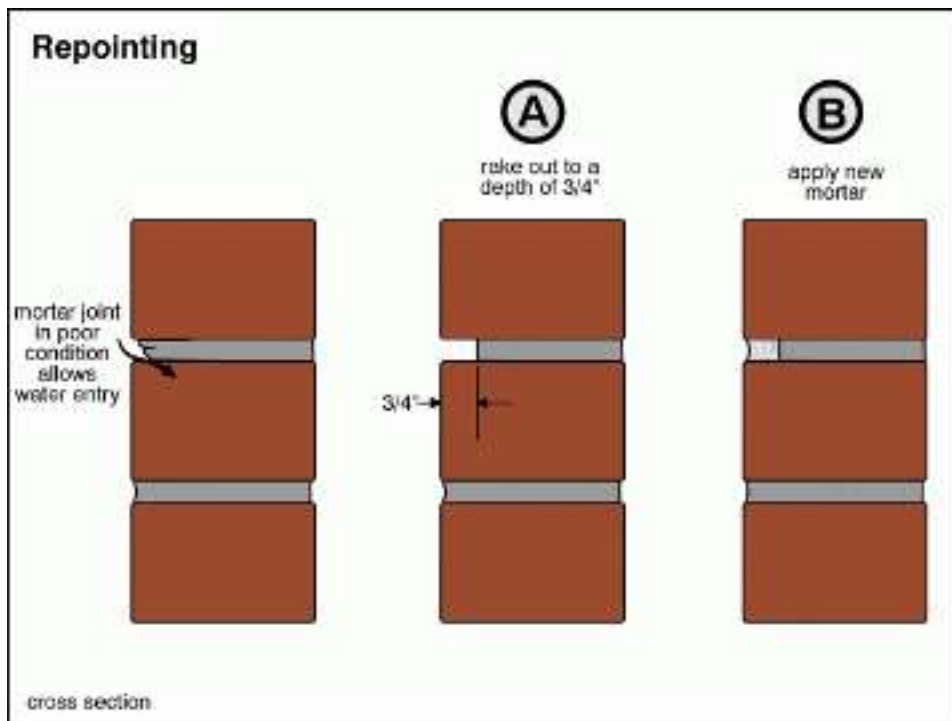
## 11. Condition: • Mortar deterioration / missing

Several areas of the mortar were missing or showed signs of deterioration. This issue can be common in older homes, but should be addressed to avoid further damage. It is recommended that the mortar joints be tuck-pointed by a qualified mason.

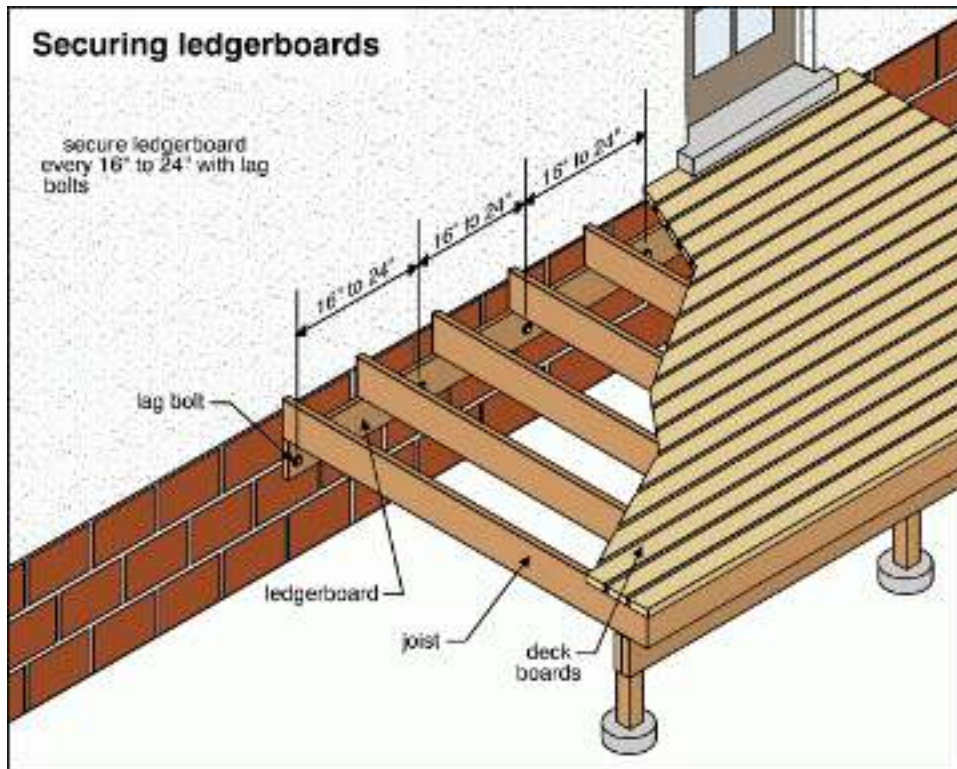
### **21. Condition:** • Ledgerboard problems

A wooden deck should be a free standing structure. Modern building practices indicate that a wooden deck directly connected to a brick (veneer) house via a through-bolted ledgerboard, may cause undue stresses on the brick veneer and may cause cracking or unwanted movement in the deck. It is better to have the deck be fully self supported with the appropriate beams and posts near to the house to avoid potential damage. In this case, there were no signs of associated cracking or movement. Additional support (columns) can be installed near the home to reduce the potential for deck movement.

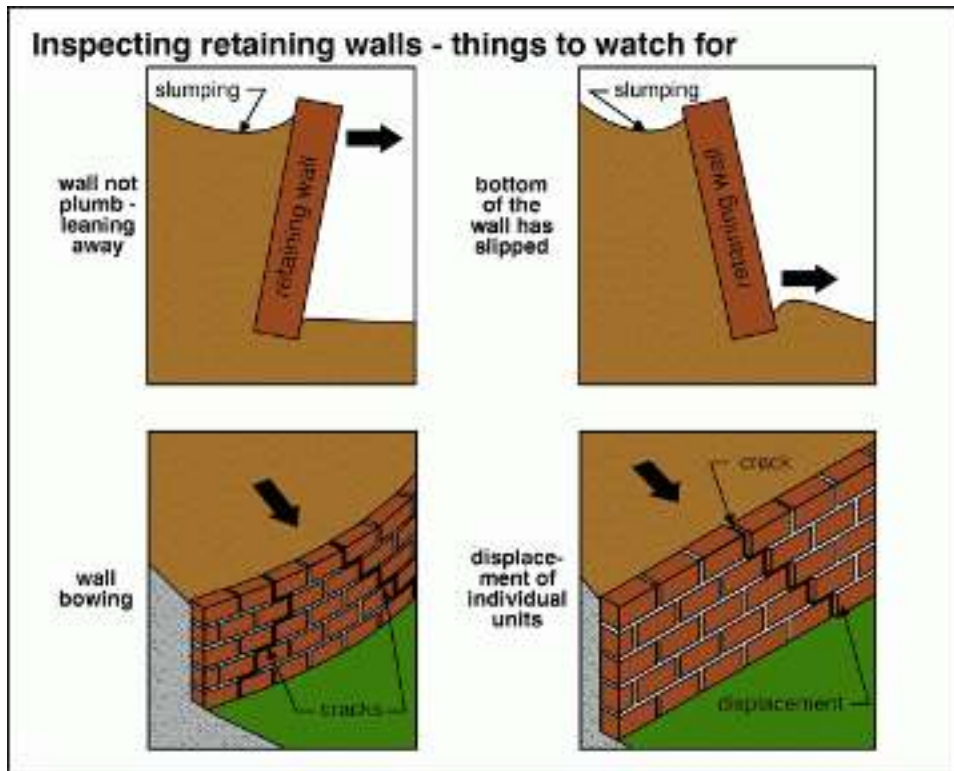
### 31. Condition: • Cracked

Minor to moderate cracking was noted in the retaining wall. To prevent further damage to the wall due to repeated freeze and thaw cycles, it is recommended that the cracks be sealed.

Note: The cracks should be filled with a non elastic filler, such as mortar. This type of material will re-crack if ongoing movement is present, alerting the homeowner to potential issues.

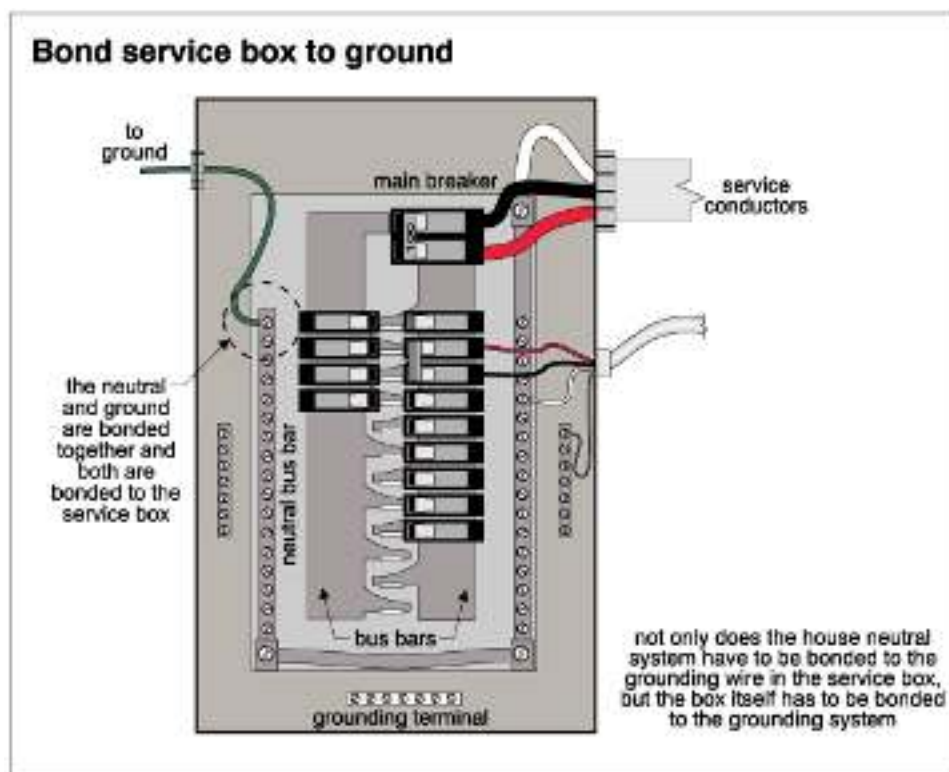
**39. Condition:** • Box not bonded to ground

The distribution panel box was not bonded to ground. When the bus bar is installed offset of the panel, bonding is commonly achieved with a bonding strap attached to the bus bar and panel enclosure, or the installation of a grounding screw when possible.

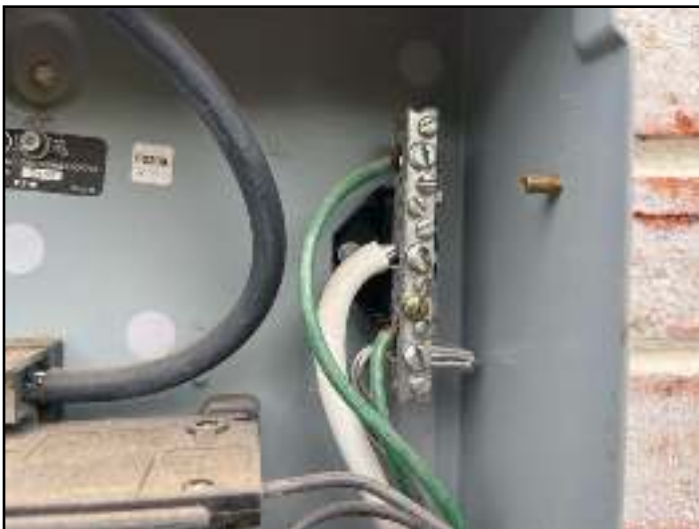
**42. Condition:** • Neutral and ground wires bonded at auxiliary panel

Neutral and grounding conductors were bonded together within the auxiliary panel. Bonding should only occur in the panel which houses the main disconnect. It is recommended that bonding be corrected by a licensed, and qualified electrician.

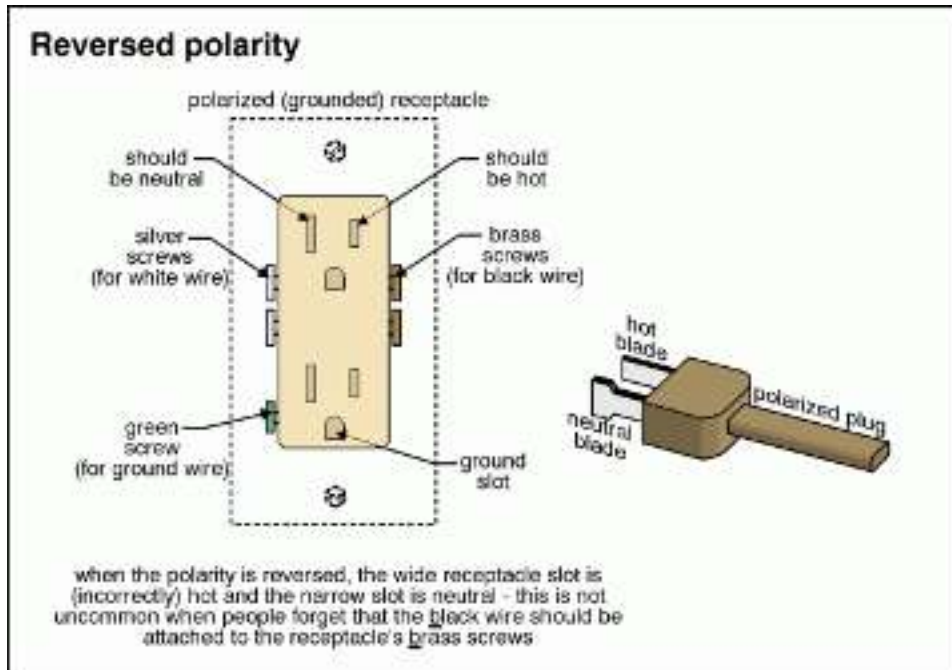
**DISTRIBUTION SYSTEM \ Outlets (receptacles)****43. Condition:** • Reversed polarity

The polarity was reversed (hot and neutral swapped) on the indicated outlets. This can pose shock hazards to occupants when using certain appliances. It is recommended that the polarity be corrected by a qualified, licensed electrician.

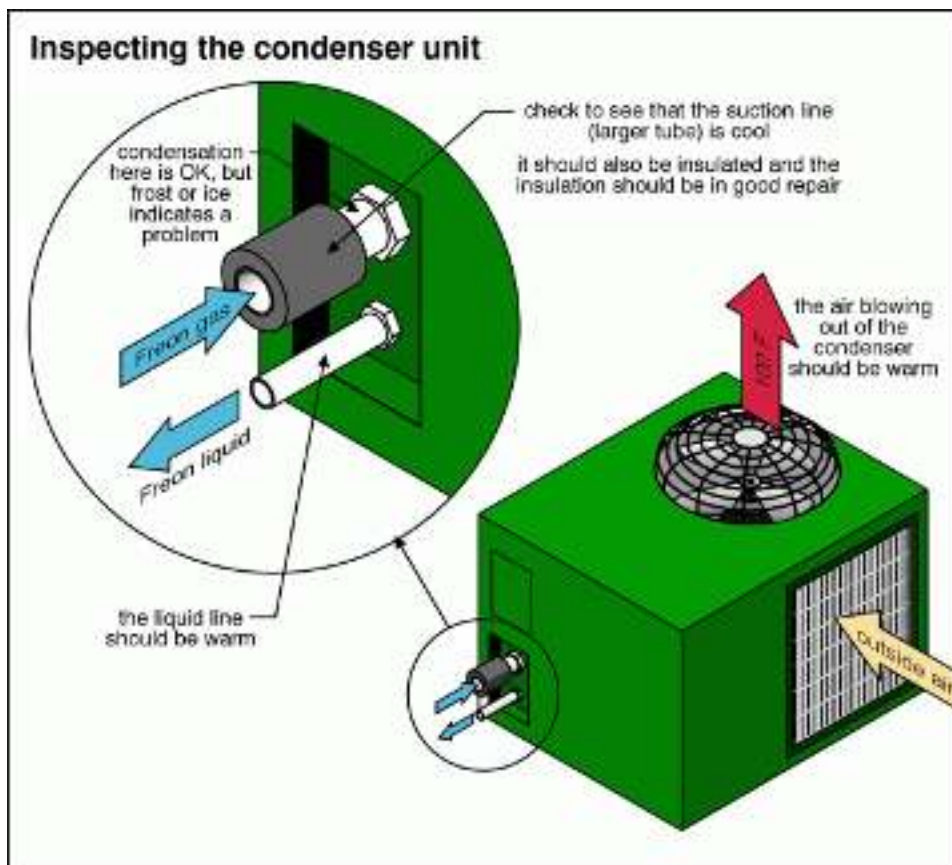
The coils on the condensing unit were dirty. Coils are typically cleaned as part of annual service. This may indicate that service of the unit is overdue. Cleaning/service by a qualified HVAC technician is recommended.

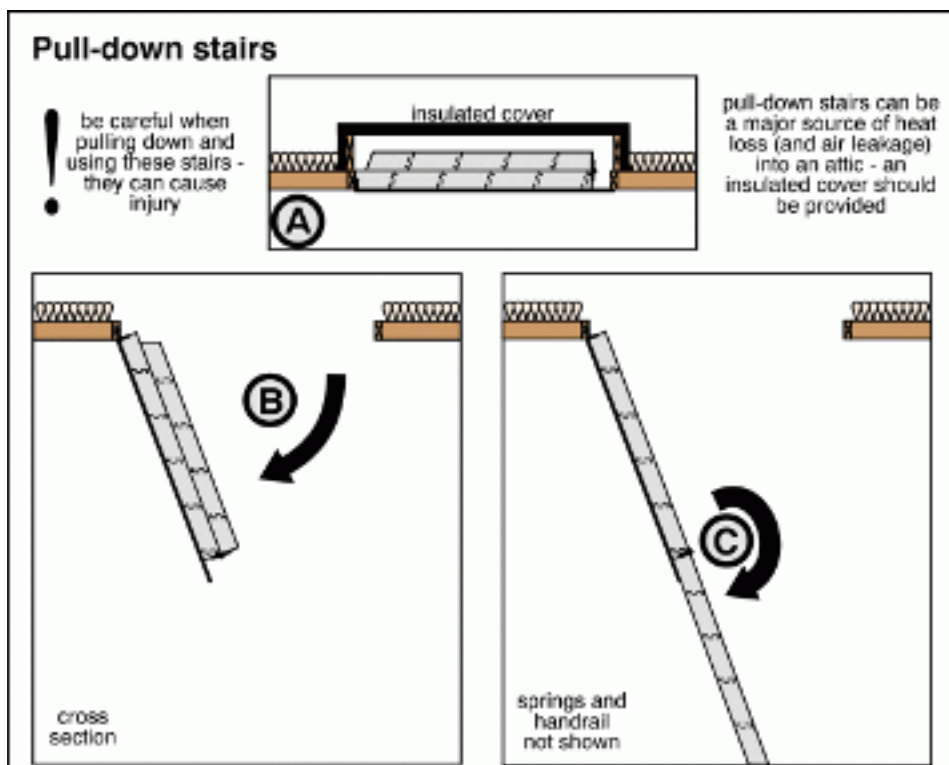
**54. Condition:** • Not insulated or weather-stripped.

The attic pull-down stairs were not insulated or weatherstripped. Improvements to this area would have a positive effect on energy efficiency.

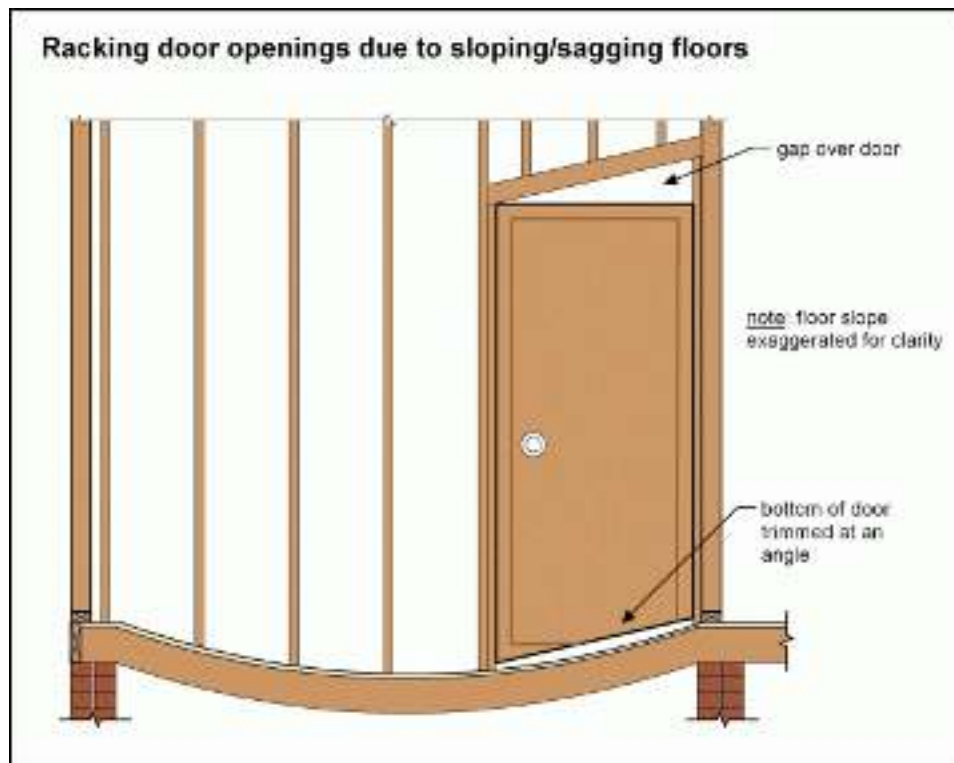
**63. Condition:** • Racked/out-of-square

The door was out of square inside the jamb. It is recommended that adjustments to the fit or hardware be made to restore normal function.

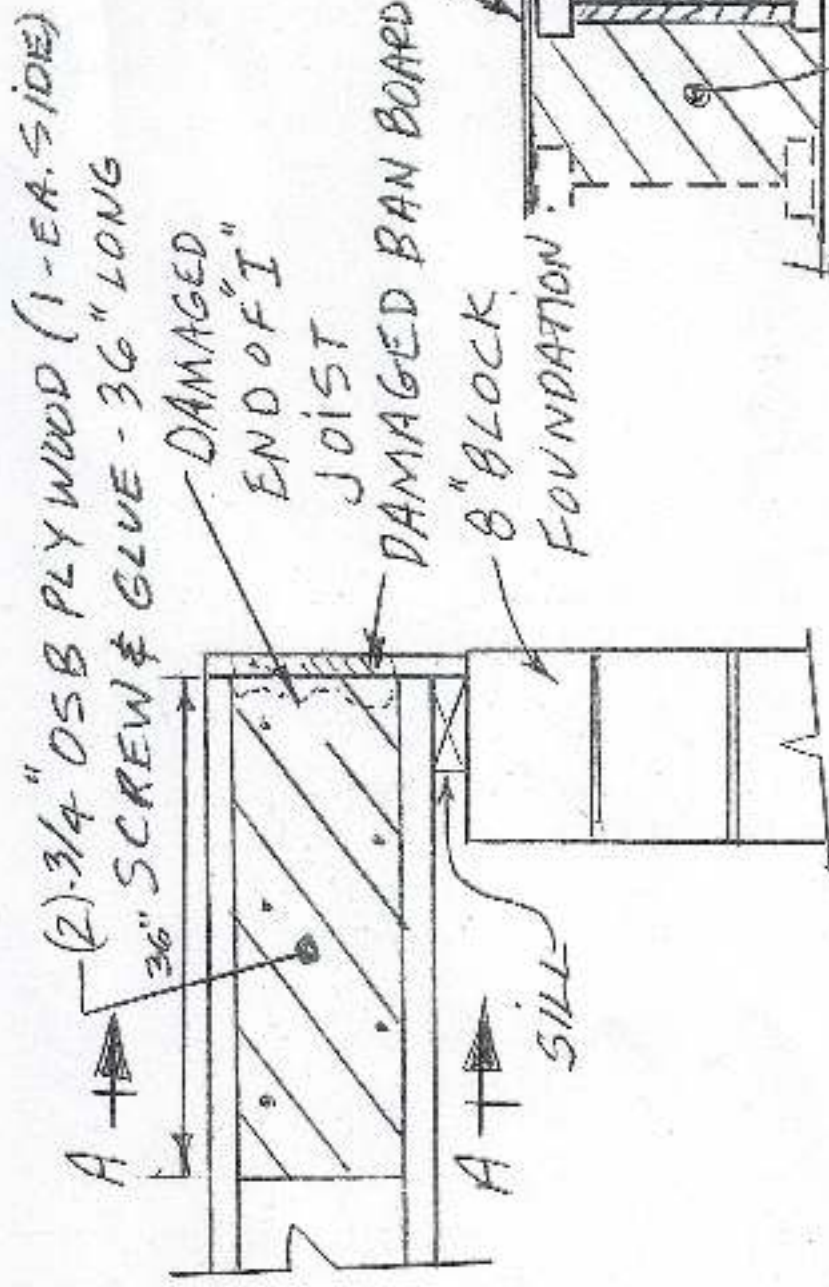
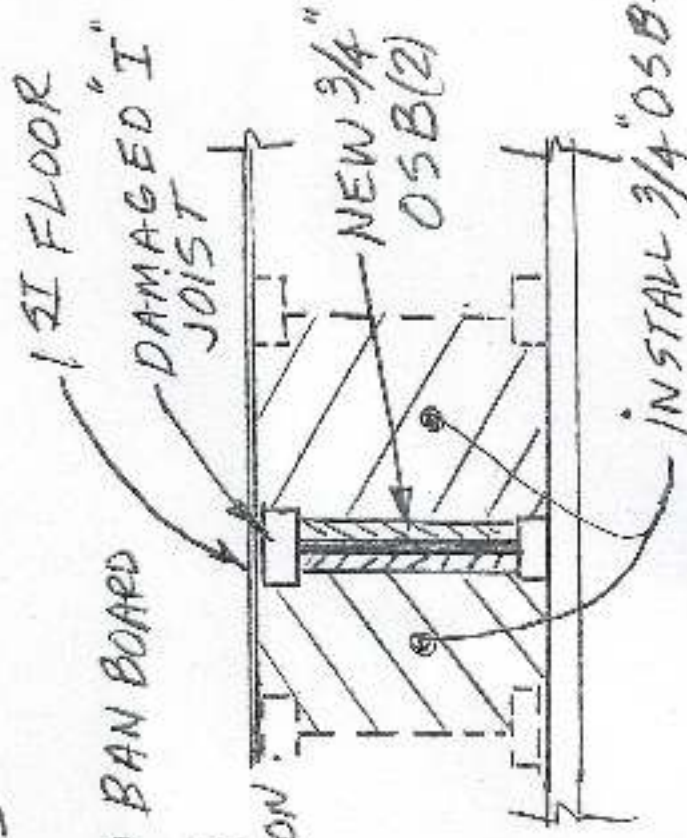
ELEVATION VIEW  
REPAIR TO JOIST

SECTION A-A (END VIEW)  
OVER-BAN BOARD (DAMAGED)  
INSTALL 3/4\" OSB-
