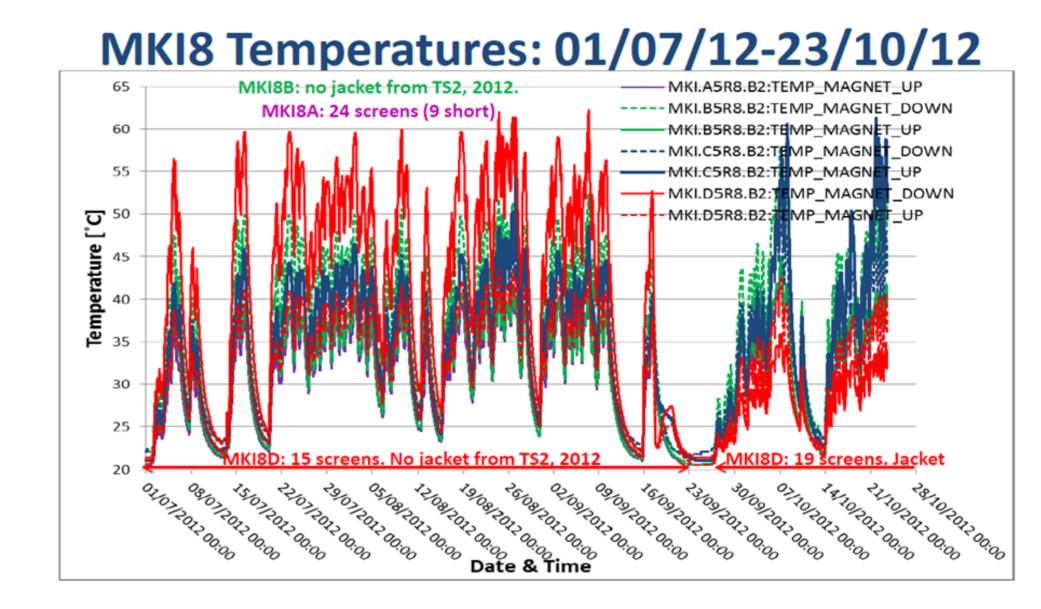
Cross-section of beam screen and ferrite yoke, showing the screen conductors on the internal face of the ceramic tube. Due to poor high voltage performance 9 conductors (in the black box) were originally removed to prevent electrical breakdown during pulsing.

One MKI in particular showed higher temperatures than the others – MKI8D (the solid red line above). This was replaced in September 2012 during, technical stop 3 (TS3), with a beam screen with 19 conductors (in the red box above-left), which was predicted to have a much lower power loss due to improved screening of the ferrite yoke from the beam. This magnet had the lowest temperature after TS3.

MKI8D was found to have a 90° twist in its ceramic screen. This cause a significant portion of it's ferrite yoke to be directly exposed to the beam, causing a very high beam coupling impedance
