10G GPON OLT System Troubleshooting

10G GPON System Troubleshooting Overview

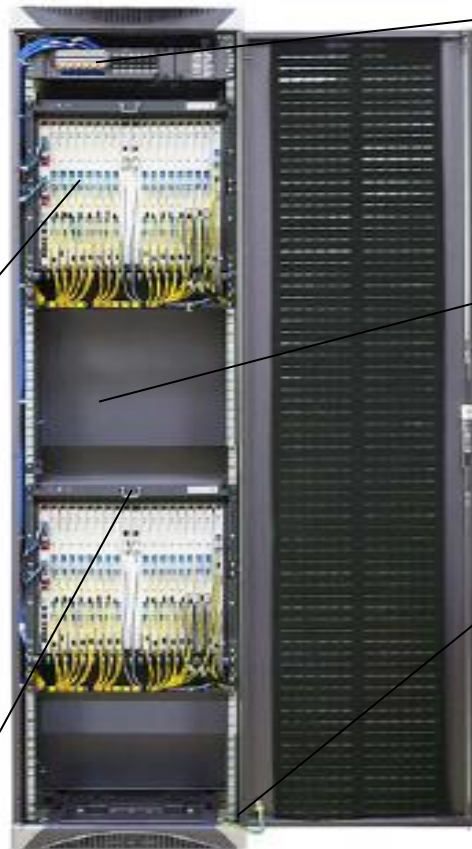
In FAN mode, run the **display fan alarm** command to check whether the fan is normal.

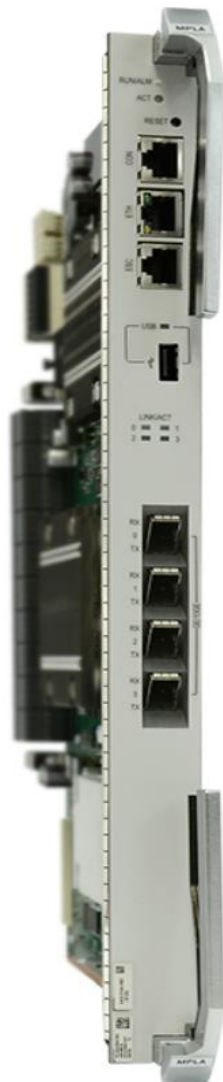
Checking the LED Status

RUN/Alarm
-

Act

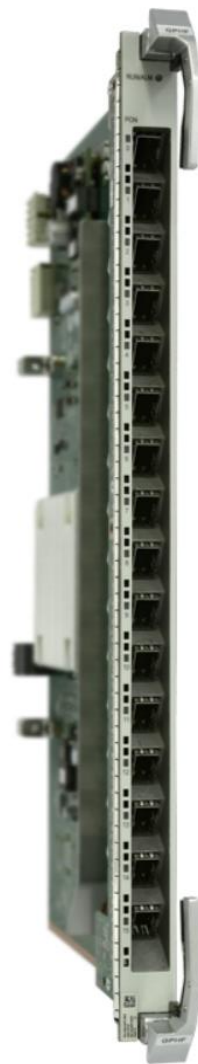
- RUN/Alarm

- PON

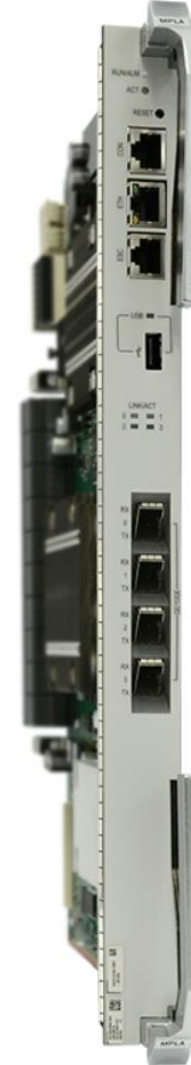
Repeated Reboot of the Control Board

- The possible causes are as follows:

The components of the control board are damaged

The backplane pins are damaged

The control board is not inserted tightly

The loaded version is incorrect

S/N	Fault Category	Possible Cause
3	Repeated reboot of the control board	<ul style="list-style-type: none">◆The components of the control board are damaged.◆The backplane pins are damaged.◆The environment and the fan are faulty.◆The subscriber ring network is faulty.◆The control board is not inserted tightly.◆The CPLD, BIOS and the programs are loaded incorrectly.
4	Switchover failure	<ul style="list-style-type: none">◆The active/standby software versions do not match.◆The active/standby hardware versions do not match.◆The standby board or the upstream port is faulty.◆The data between the active/standby control boards is not synchronized sufficiently.◆The system is saving configuration.
