# **Raspberry Pi based Wireless Access Point**

# RTL8188

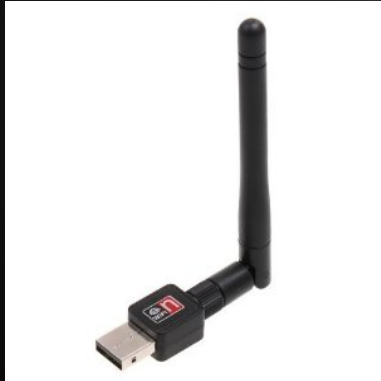
The wireless network adapter pictured at left uses a RealTek RTL8188 microprocessor. In order to operate this with the Raspberry Pi, the proper linux specific drivers had to be installed.
