# **Raspberry Pi based Wireless Access Point**

Module & Makefile editing

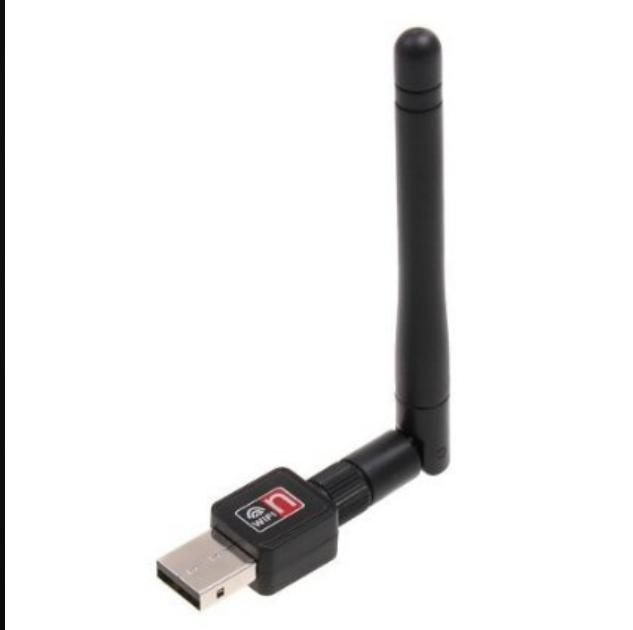
# RTL8188

The wireless network adapter pictured at left uses a RealTek RTL8188 microprocessor. In order to operate this with the Raspberry Pi, the proper linux specific drivers had to be installed.
