HP 9133/9134 D/H/L Service Manual

Manual part number: 5957-6560

Edition 2
E0488

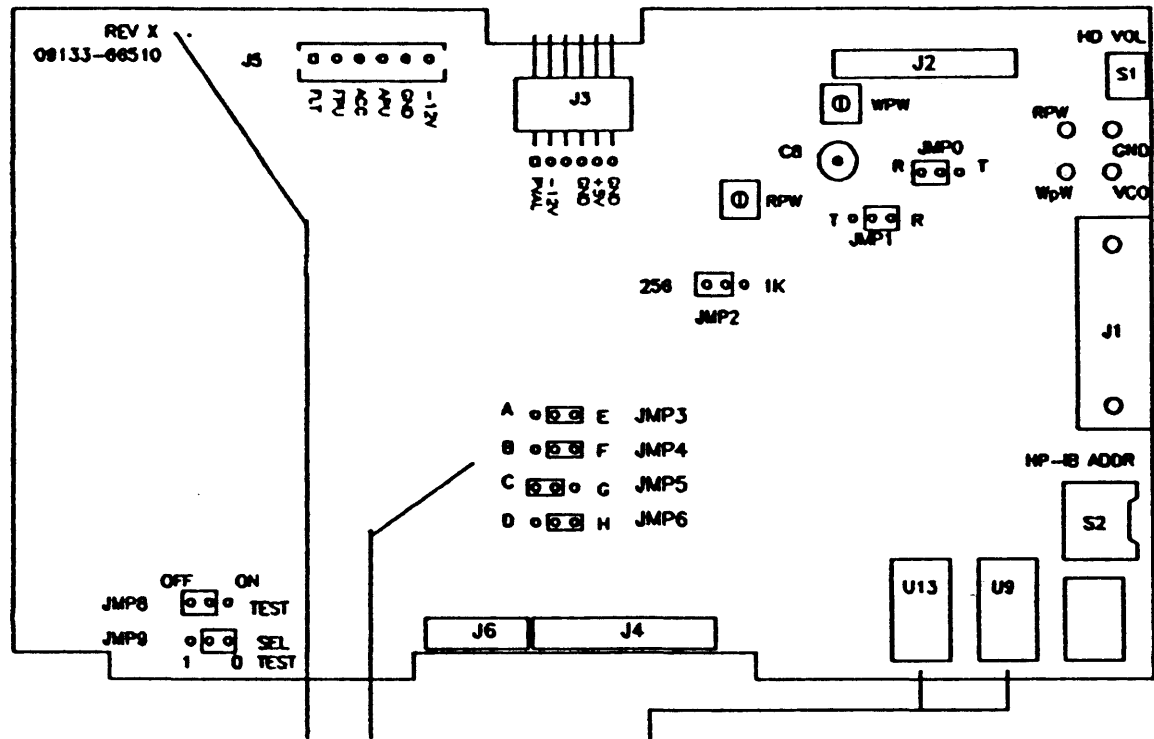
Product	S/N Prefix	Rev	JMP3-JMP6	Required Firmware
9133D	2419A/2511A	B	EFCH	Any 09133-8910X/-8920X
9133D	2419A/2511A	C	EFCD	09133-89105/-89205 and above
9133D	2513A and above	B	ABCH	09133-89105/-89205 and above
9133D	2513A and above	C	ABCD	09133-89105/-89205 and above
9134D	2425A	B	EFGH	Any 09133-8910X/-8920X
9134D	2425A	C	EFGD	09133-89105/-89205 and above
9134D	2514A and above	B	ABGH	09133-89105/-89205 and above
9134D	2514A and above	C	ABGD	09133-89105/-89205 and above
9133H	ALL	B	AFCH	09133-89105/-89205 and above
9133H	ALL	C	AFCD	09133-89105/-89205 and above
9134H	ALL	B	AFGH	09133-89105/-89205 and above
9134H	ALL	C	AFGD	09133-89105/-89205 and above

NOTE: JMP2 is shown in the position for standard product.
Option001 will have JMP2 in 1K position.

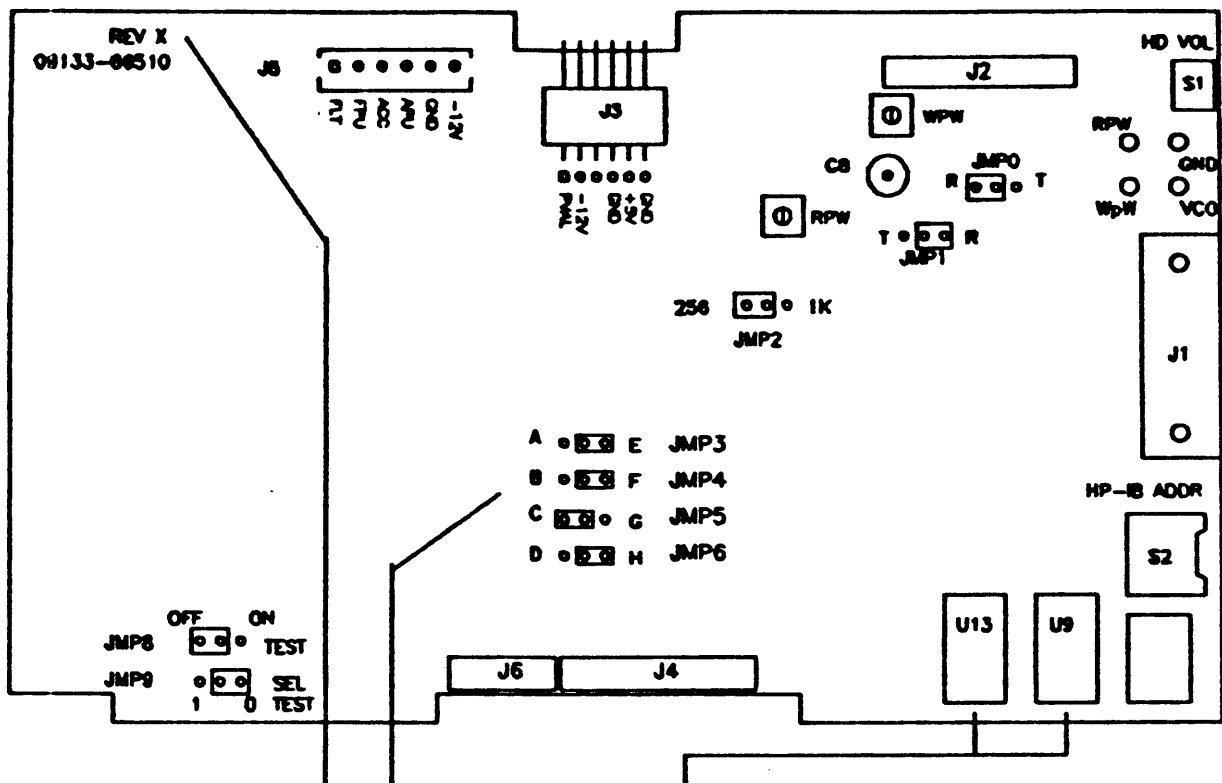
Product	S/N Prefix	Rev	JMP3-JMP6	Required Firmware
9133D	2419A/2511A	B	EFCH	Any 09133-8910X/-8920X
9133D	2419A/2511A	C	EFCD	09133-89105/-89205 and above
9133D	2513A and above	B	ABCH	09133-89105/-89205 and above
9133D	2513A and above	C	ABCD	09133-89105/-89205 and above
9134D	2425A	B	EFCH	Any 09133-8910X/-8920X
9134D	2425A	C	EFCD	09133-89105/-89205 and above
9134D	2514A and above	B	ABGH	09133-89105/-89205 and above
9134D	2514A and above	C	ABGD	09133-89105/-89205 and above
9133H	ALL	B	AFCH	09133-89105/-89205 and above
9133H	ALL	C	AFCD	09133-89105/-89205 and above
9134H	ALL	B	AFGH	09133-89105/-89205 and above
9134H	ALL	C	AFGD	09133-89105/-89205 and above

NOTE: JMP2 is shown in the position for standard product.
Option001 will have JMP2 in 1K position.

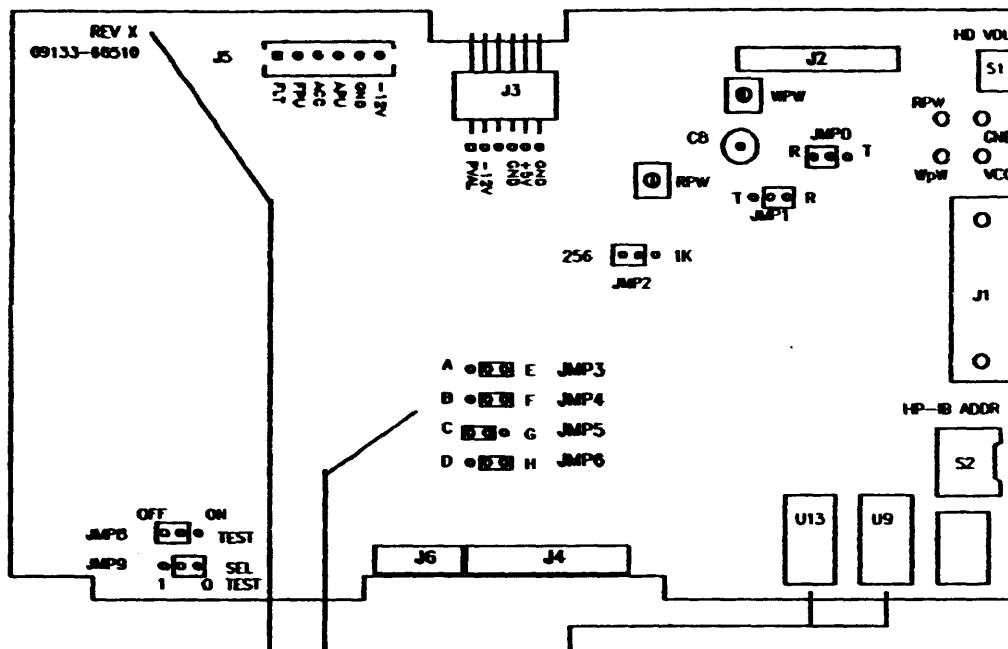
Product	S/N Prefix	Rev*	JMP3-JMP6	Required Firmware
9133D	2419A/2511A	B	EFCH	Any 09133-8910X/-8920X
9133D	2419A/2511A	C	EFCD	09133-89105/-89205 and above
9133D	2513A and above	B	ABCH	09133-89105/-89205 and above
9133D	2513A and above	C	ABCD	09133-89105/-89205 and above
9134D	2425A	B	EFGH	Any 09133-8910X/-8920X
9134D	2425A	C	EFGD	09133-89105/-89205 and above
9134D	2514A and above	B	ABGH	09133-89105/-89205 and above
9134D	2514A and above	C	ABGD	09133-89105/-89205 and above
9133H	ALL	B	AFCH	09133-89105/-89205 and above
9133H	ALL	C	AFCD	09133-89105/-89205 and above
9134H	ALL	B	AFGH	09133-89105/-89205 and above
9134H	ALL	C	AFGD	09133-89105/-89205 and above
9133L	ALL	B	EBCH	09133-89108/-89208 and above
9133L	ALL	C	EBCD	09133-89108/-89208 and above
9134L	ALL	B	EBGH	09133-89108/-89208 and above
9134L	ALL	C	EBGD	09133-89108/-89208 and above

NOTE: JMP2 is shown in the position for a standard product.
Option 001 will have JMP2 in the 1K position.
