ACE Board Rev 1.0: Build Notes

The work an ACE Board Rev 1.0 needs beyond its bill of materials, for a new build or for upgrading a built board. Rev 1.1 makes these fixes on the PCB. On Rev 1.0 you make them by hand.

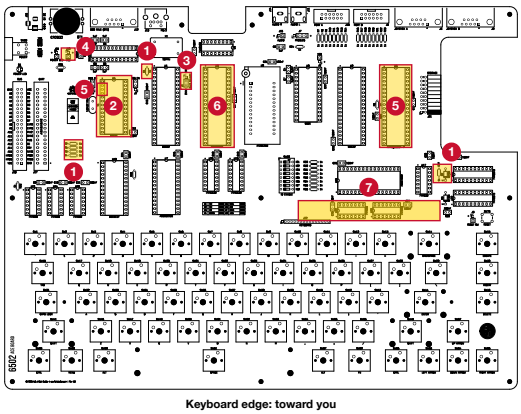
Figure 1. Top of the ACE. Where each change is. Change 5 is in two places: the ATmega, U6, and its pull-up under U4.

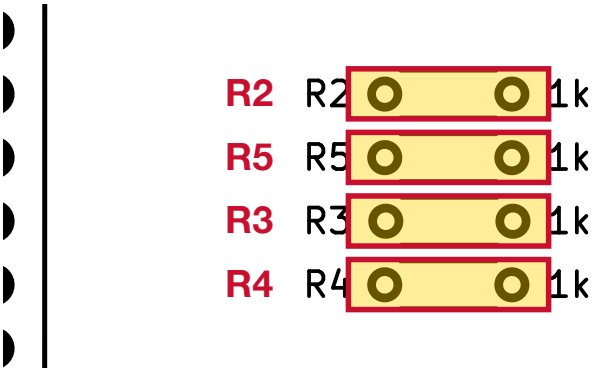
Rev 1.0's BOM lists 1 kΩ at these six places. Rev 1.1 makes five of them 10 kΩ and removes R1. R2, R5, R3 and R4 pull up shared lines: BE, RDY, NMIB and IRQB. A 1 kΩ pull-up draws 5 mA, more than the 3.2 mA the 65C22's IRQ output is rated to sink. R27 pulls up the banked RAM's chip enable (U15 pin 22). R1, beside U1's top left corner, holds SOB (U1 pin 38) high. Nothing else holds that pin, so don't leave R1 out. Every other 1 kΩ on the board stays 1 kΩ, including R6, which is the ATmega's reset pull-up.

Figure 2. R2–R5, beside the CART connector. Note the order: R2, R5, R3, R4.

- [ ] R1, R2, R3, R4, R5: 10 kΩ.
- [ ] R27: 10 kΩ.

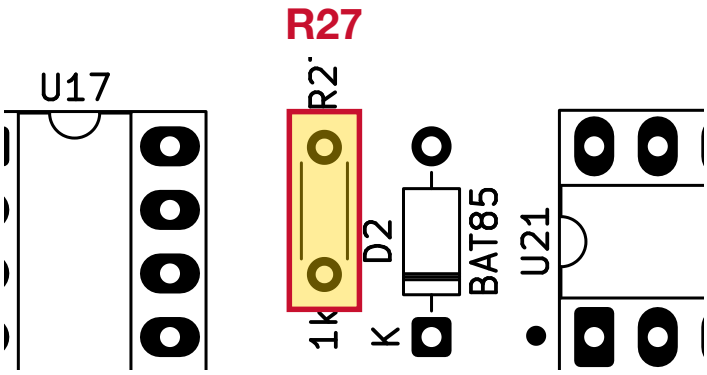
Figure 3. R27, between U17 and U21.

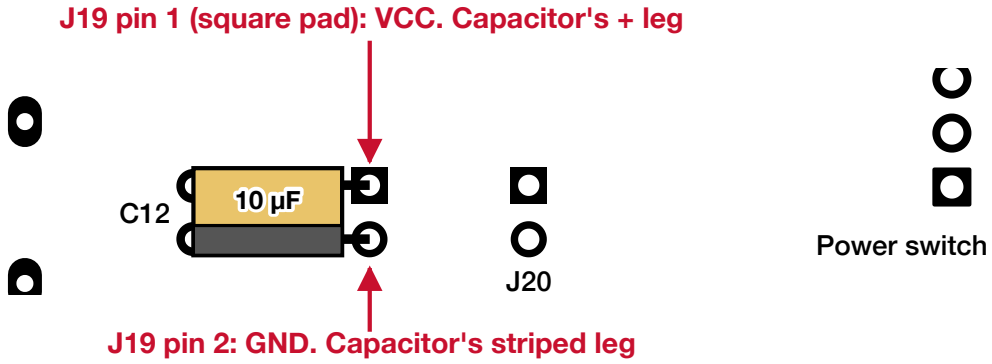
Rev 1.1 adds a 10 µF electrolytic across VCC and GND beside the power input, as bulk capacitance for the whole board. Rev 1.0 has no holes for it, so it goes on the underside, across the pads of J19, the VCC header. J19's pads are close to the power switch and 2.54 mm apart, and J19 can still be fitted. Rev 1.0's own C20 is a 100 nF capacitor elsewhere on the board: leave it alone.

Figure 5. The capacitor across J19's pads, lying flat. Underside of the ACE, keyboard edge toward you.

- [ ] Bend the legs to 2.54 mm. Positive leg to J19 pin 1 (VCC), striped leg to J19 pin 2 (GND).
- [ ] Lay the body flat on the board, so it stays clear of the plate. Its insulated sleeve can rest on C12's joints. Solder the legs to the pads, or to J19's tails if J19 is fitted, and clip them.

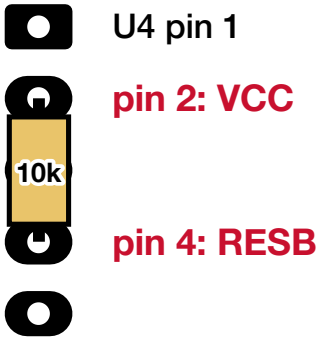
The ATmega's internal pull-up raises RESB on its own, but a 10 kΩ is stiffer on a line that runs out to CART and BUS. Rev 1.1 has one. On Rev 1.0, U4's pins 2 and 4 are VCC and RESB, 5.08 mm apart, the same pitch as a resistor footprint.

Figure 6. The RESB pull-up on the underside, keyboard edge toward you. U4's pin 1 is nearest the connectors.

- [ ] 10 kΩ across U4 pin 2 and U4 pin 4, on the underside. Pin 3 is between them: keep the legs off its joint.

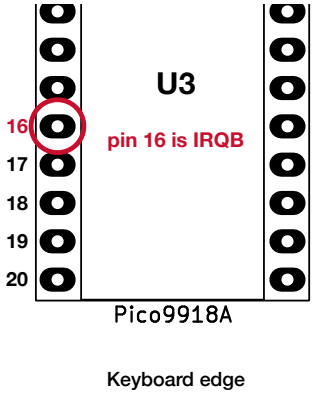
U3 pin 16 is the video chip's /INT, and Rev 1.0 wires it straight to IRQB. A TMS9918A's /INT is open-drain, but every pico9918 drives it high as well as low, and holds IRQB at about 3.8 V while the VIA tries to pull it low. Keyboard and serial input are then dead. This affects the PRO and the v1.3 alike: a v1.3 can appear to work, but only by luck. Rev 1.1 has a diode on the PCB. Rev 1.0's PCB has no place for one, so it goes in a socket stack: a second socket between U3's socket and the card, with pin 16 routed through the diode.

Figure 7. Find pin 16: the fifth pin up from the keyboard end of U3's left row.

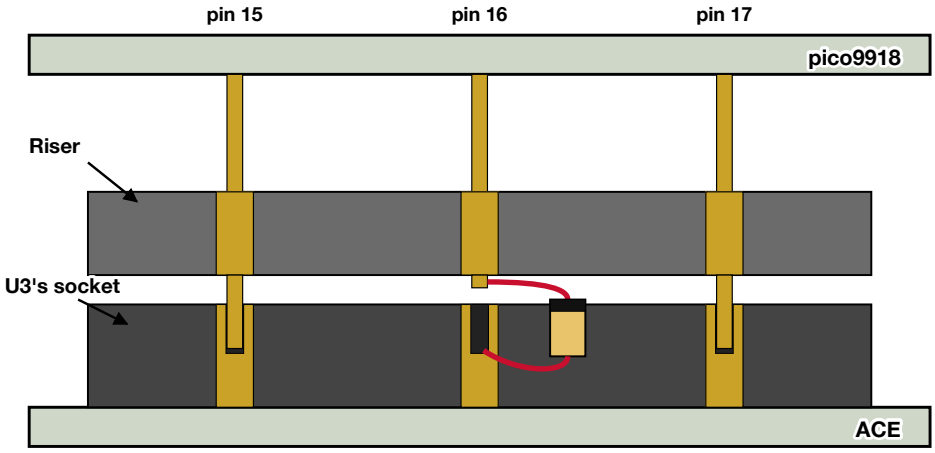
Figure 8. The stack, seen from inside the left row. Not to scale. The riser's pin 16 stops short of the socket below, so the only path from the card's pin 16 to IRQB is through the diode.

- [ ] Take a machined-pin DIP-40 socket: this is the riser. The pico9918's pins are solid and can't be bent or cut, so the change is made here.
- [ ] Count to pin 16 on the riser, with its notch the same way as U3's. Cut off pin 16's tail below the plastic, so it can't reach U3's socket.
- [ ] Solder the BAT85's band end (cathode) to what is left of the riser's pin 16.
- [ ] Put the other leg (anode) into U3's socket at pin 16, and press the riser into U3's socket. Keep the diode under the card or on the board beside U3's left row, with its legs clear of the other pins.
- [ ] Check with the meter's diode test, with the card out: red on IRQB (R4's left leg, Figure 2), black in the riser's pin 16. About 0.3 V this way, and open the other way.
- [ ] Fit the card into the riser, with its pin 1 at the connector end. It now sits one socket higher: check that it clears any top panel.

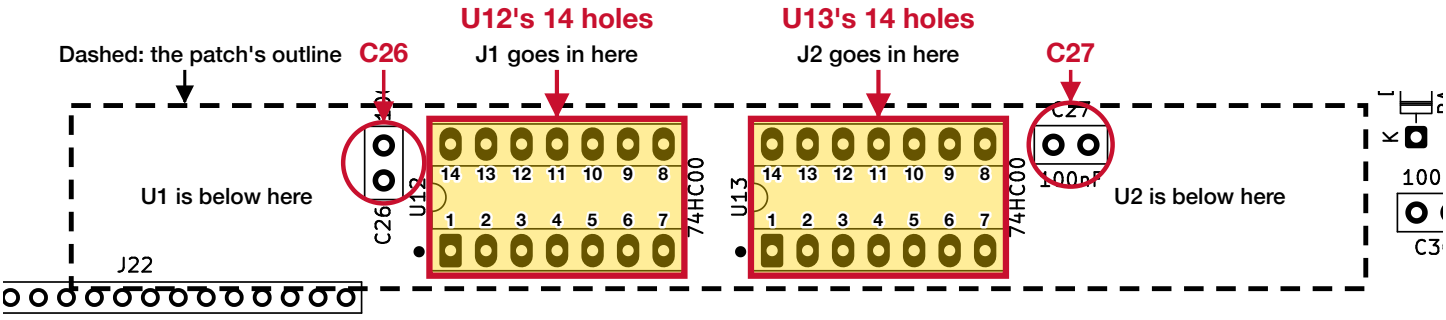
Figure 9. Top of the ACE, keyboard toward you. The patch's four parts run in one row: U1, J1, J2, U2. J1 goes in U12's holes and J2 goes in U13's. Pin numbers are marked on both sockets.

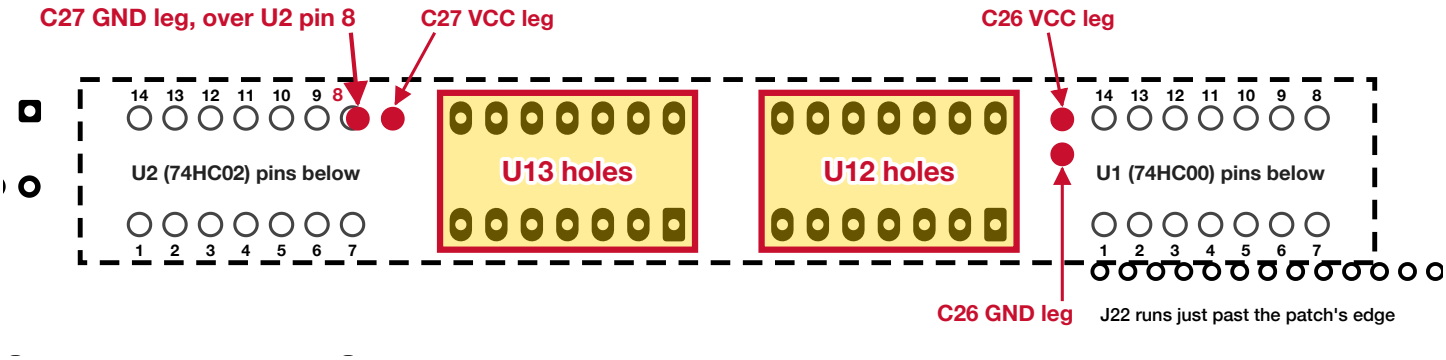
Figure 10. Underside of the ACE, keyboard toward you. Left and right swap, so U13 is left of U12. Red dots are the legs of C26 and C27. Numbered white circles show where the patch's U1 and U2 pins land, 2.54 mm below the ACE.

> **Watch C27:** its GND leg sits 0.38 mm off the center of U2 pin 8, with only the 2.54 mm header gap between them. U2 pin 8 carries the signal from U1 pin 8. If the leg touches the joint, that signal is shorted to ground. Step 2 deals with this.

- [ ] **C27 and C26:** clip all four legs to no more than 1 mm below the ACE. C27's GND leg matters most.
- [ ] The whole strip inside the dashed outline in Figure 10 is free of wires and parts.
- [ ] **J22:** its tails stand just past the patch's long edge, about 0.3 mm clear. Keep them straight.

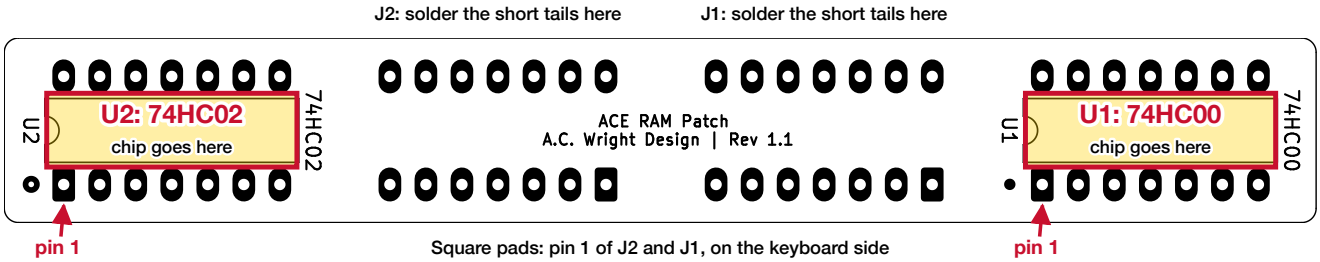
Figure 11a. The patch's back: text upright. U2 (74HC02) is on the left and U1 (74HC00) on the right. Both have pin 1 at lower left, so both notches point left.

- [ ] U2, the **74HC02**, on the left. U1, the **74HC00**, on the right. Check the markings: the two chips look alike.
- [ ] Notches to the left. Chips seated flat on the board. **No sockets:** a socket adds about 3 mm and the chip would hit the plate.
- [ ] Solder all 28 legs on the front. Clip them flush now: this side faces the ACE and you can't reach it later.

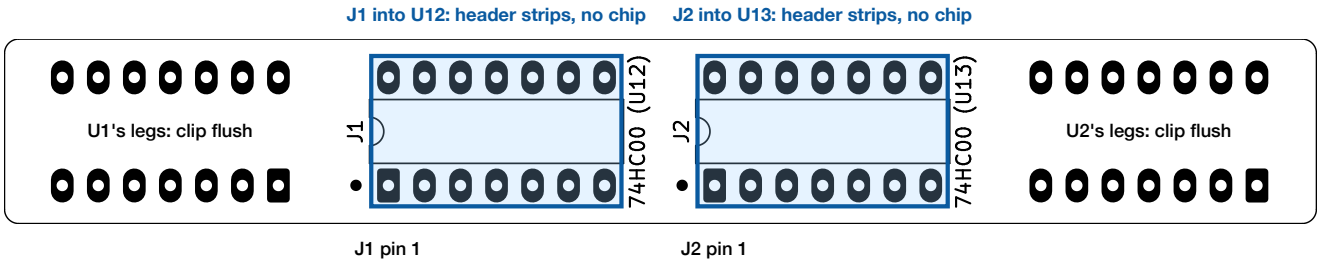
Figure 11b. The patch's front. The silkscreen on J1 and J2 looks like two chip outlines. Those are headers. No chip goes on this side.

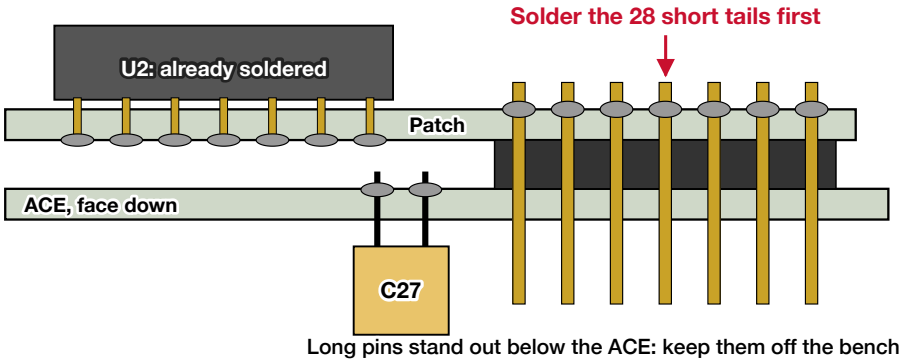
> **The patch also fits turned 180°, and that is wrong.** Every pin finds a hole, but VCC lands on GND (J1 pin 14 goes in U13 pin 7). Check all of these before any solder:

Figure 12. Steps 4 to 6: the ACE face down, seen from the keyboard edge (one row of pins, to scale). U2 is on the left in this view.

- [ ] Keyboard edge toward you, and the text on the patch reads **upright**.
- [ ] U2 (74HC02) on your left and U1 (74HC00) on your right.
- [ ] The patch's square J1 and J2 pads are on the keyboard side, under the ACE's square U12 and U13 pads.
- [ ] C27's and C26's legs don't touch the patch. Look through the gap with a light.

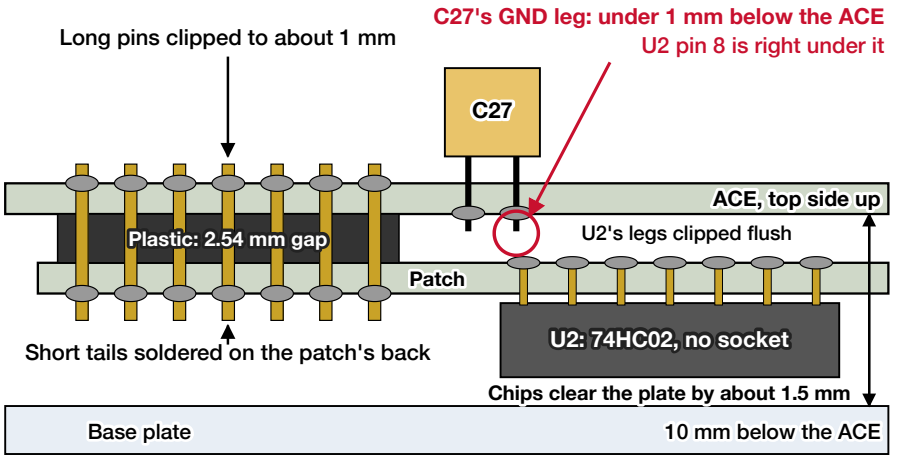
Figure 13. The finished stack, ACE on top, seen from the keyboard edge (one row of pins, to scale).

- [ ] Turn the ACE face up. Hold it on blocks or its standoffs, so the patch hangs free. It hangs about 8.5 mm.
- [ ] Push the patch up, so the plastic is against the ACE's underside. Tack the end pins of each strip and check again.
- [ ] Solder the rest: 28 joints in U12's and U13's pads. Clip the pins to about 1 mm above the joint.
