WO-500-04 — Replace VALVE, BALL, FLOATING 1" P150 (1"-P150-HS-5011/A3)

Area	A500 Pipe rack	**Task**	VR Valve replacement in kind
Priority	3 (reliability)	**Issued by**	Facility owner (demonstration)
Primary asset	rack-bent:720 — Pipe rack bent at E 60'-0" — E 60'-0" N 0.000" EL 122'-0"		
Equipment	—	**Lines**	1"-P150-HS-5011
Isometrics	ISO-HS-5011 (owner's drawings, attached)		
Permits	General work permit

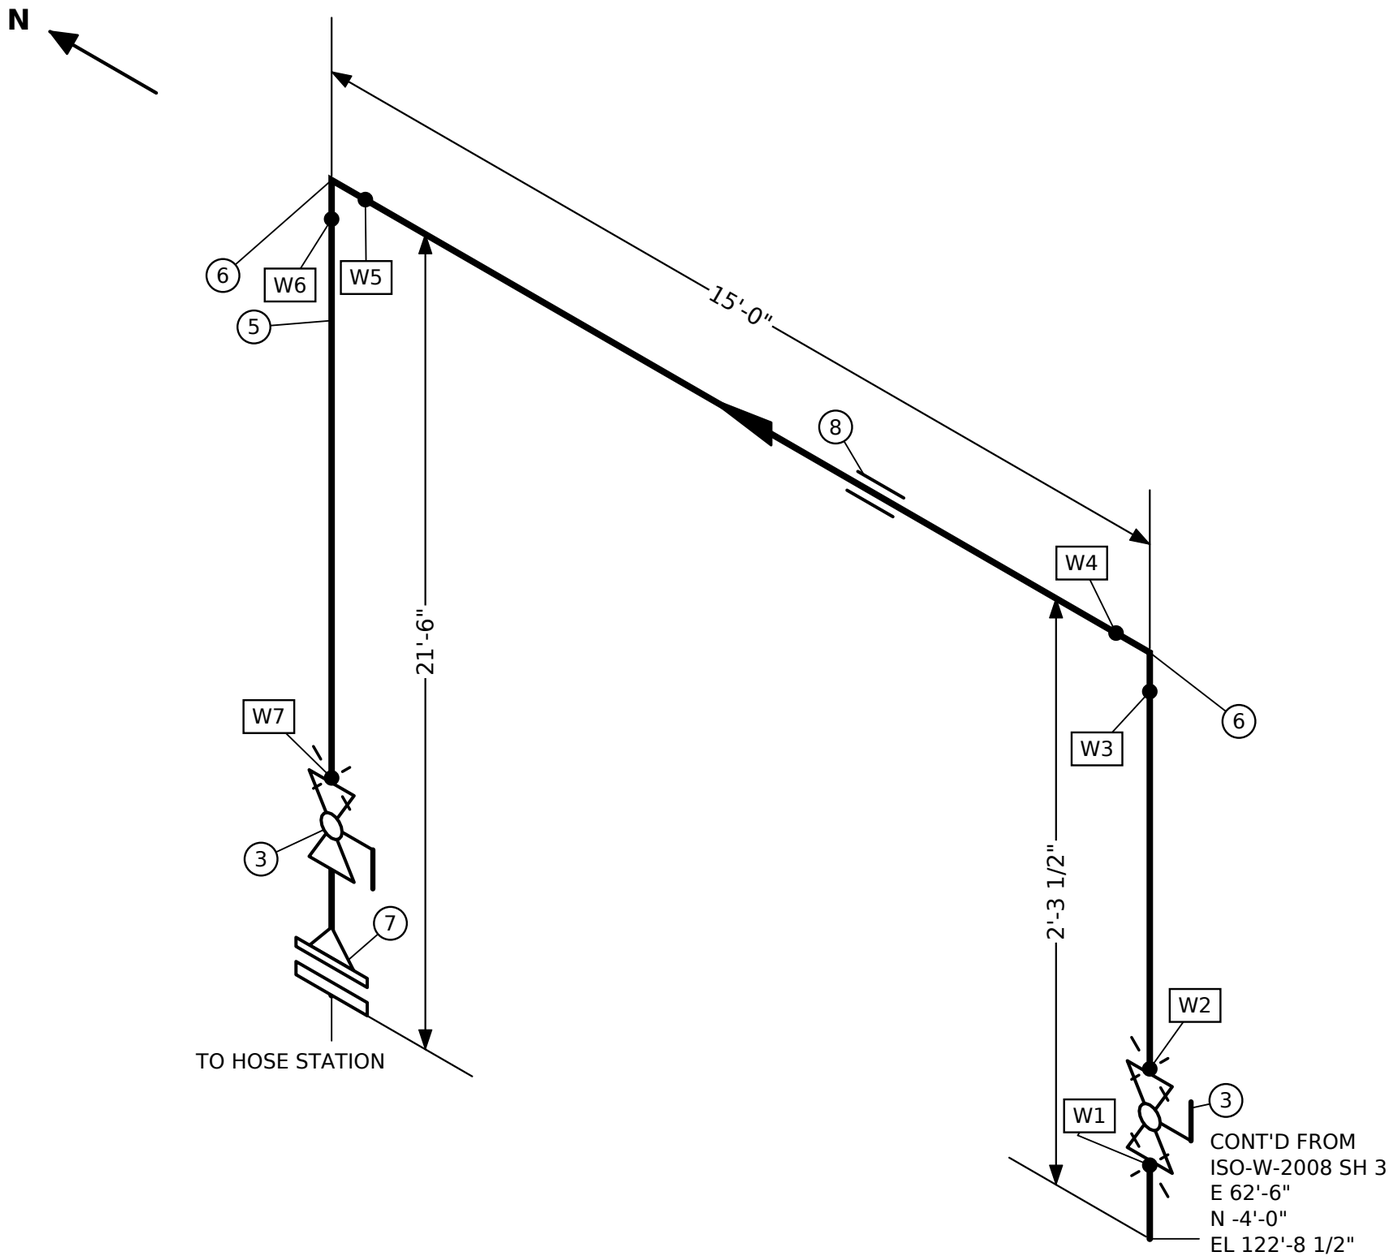
DRAWING NO.	SHEET	REV
ISO-HS-5011	1 OF 1	1

Hose-station take-off valve at the water header seized.

1. Isolate per the isolation list, drain and vent 1"-P150-HS-5011 between the isolations.
2. Unbolt and remove VALVE, BALL, FLOATING 1" P150 (1"-P150-HS-5011/A3) at E 62'-6" N -4'-0" EL 123'-7-1/2".
3. Inspect both flange faces (SW-NDE-5); dress or report damage.
4. Install a new VALVE, BALL, FLOATING 1" P150 of the same size, class and face-to-face (BALL1-P150), with new gaskets and studs, stem orientation as removed.
5. Tighten the studs to the stated preload in three passes, cross pattern (SW-WO-5).
6. Remove blinds, restore the line-up, leak test the two joints on start-up (SW-TEST-2).
