12th Generation Intel® Core™ Processor

Specification Update

Supporting 12th Generation Intel® Core™ Processor for S, H, U, P, and HX Processor Line Platforms, formerly known as Alder Lake

Revision 009

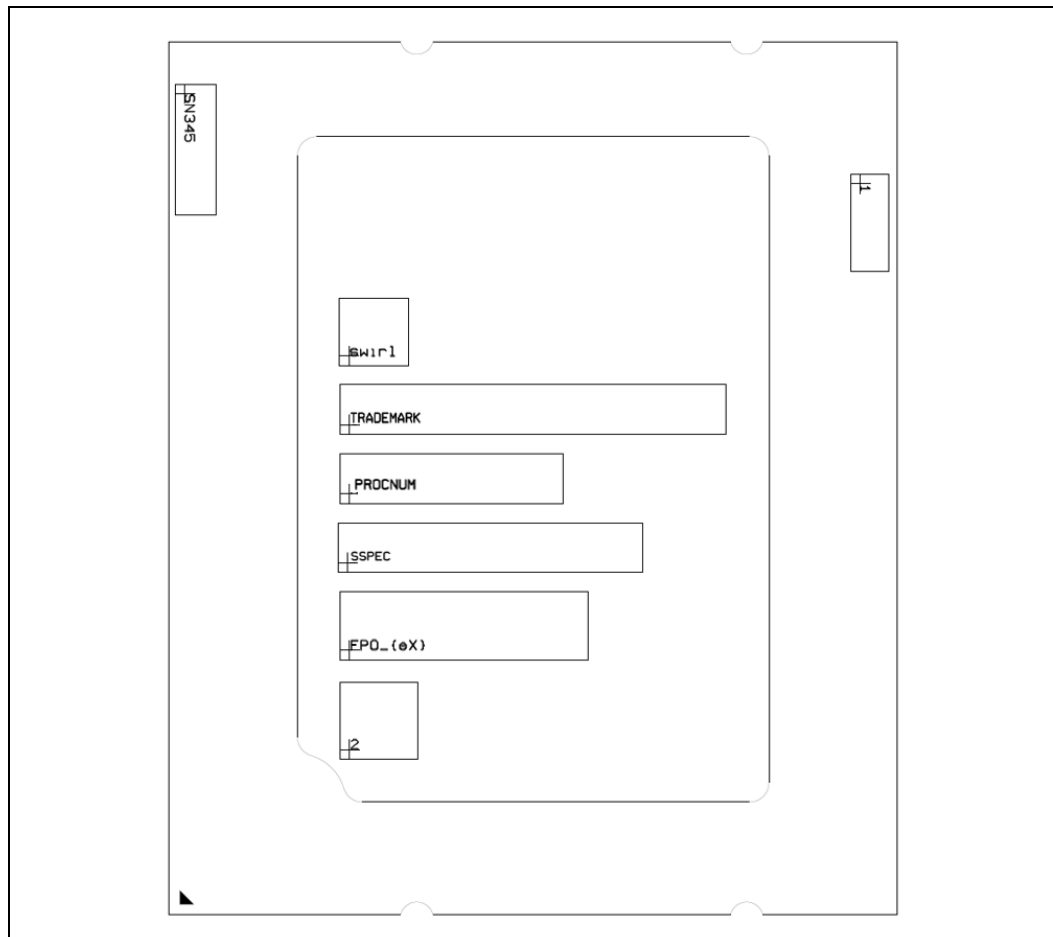
Figure 1. Processor Based on S Processor Line Chip Package LGA Top-Side Markings

Pin Count: 1700

Package Size: 45mm x 37.5mm

Production (SSPEC):

SWIRL (Intel logo)
TRADEMARK BRAND
PROCESSOR NUMBER
SSPEC
FPO {eX}

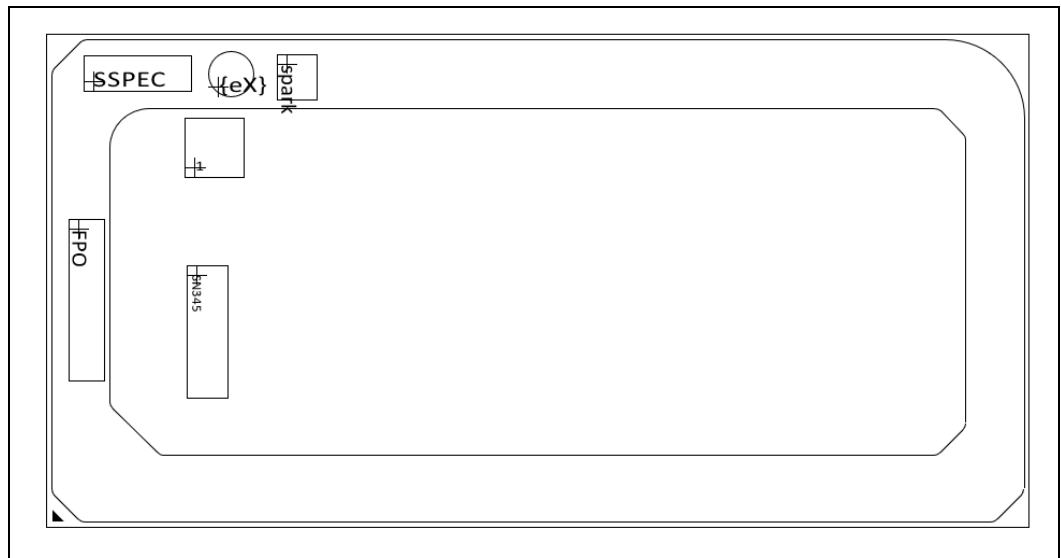
Figure 2. Processor Based on H/P Processor Line Chip Package BGA Top-Side Markings

Pin Count: 1744

Package Size: 50mm x 25mm

Note: "1" is unit visual ID (2D ID).
"2" is Pin 1 indicator on IHS.

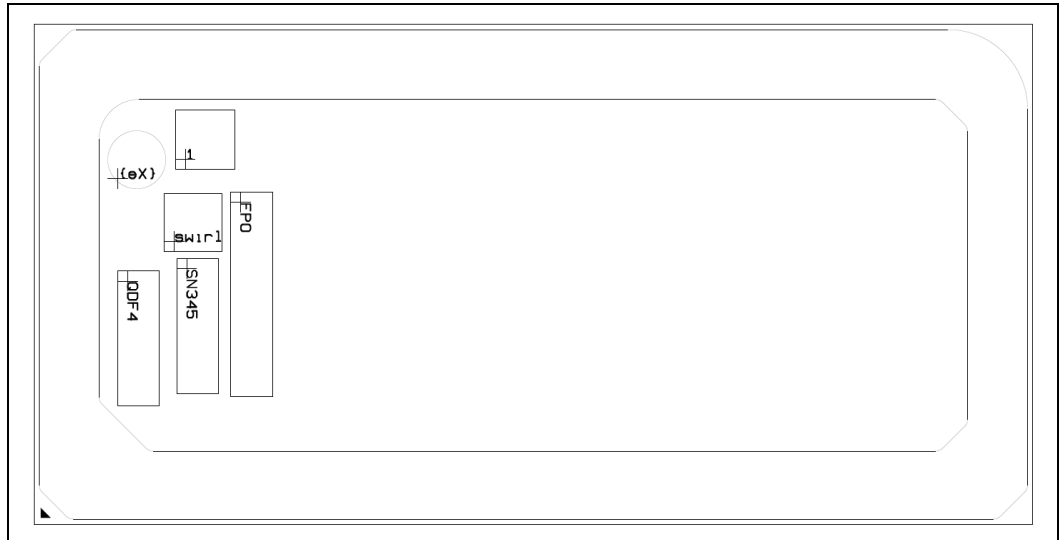
Figure 3. Processor Based on U15 Processor Line Chip Package BGA Top-Side Markings

Pin Count: 1744

Package Size: 50mm x 25mm

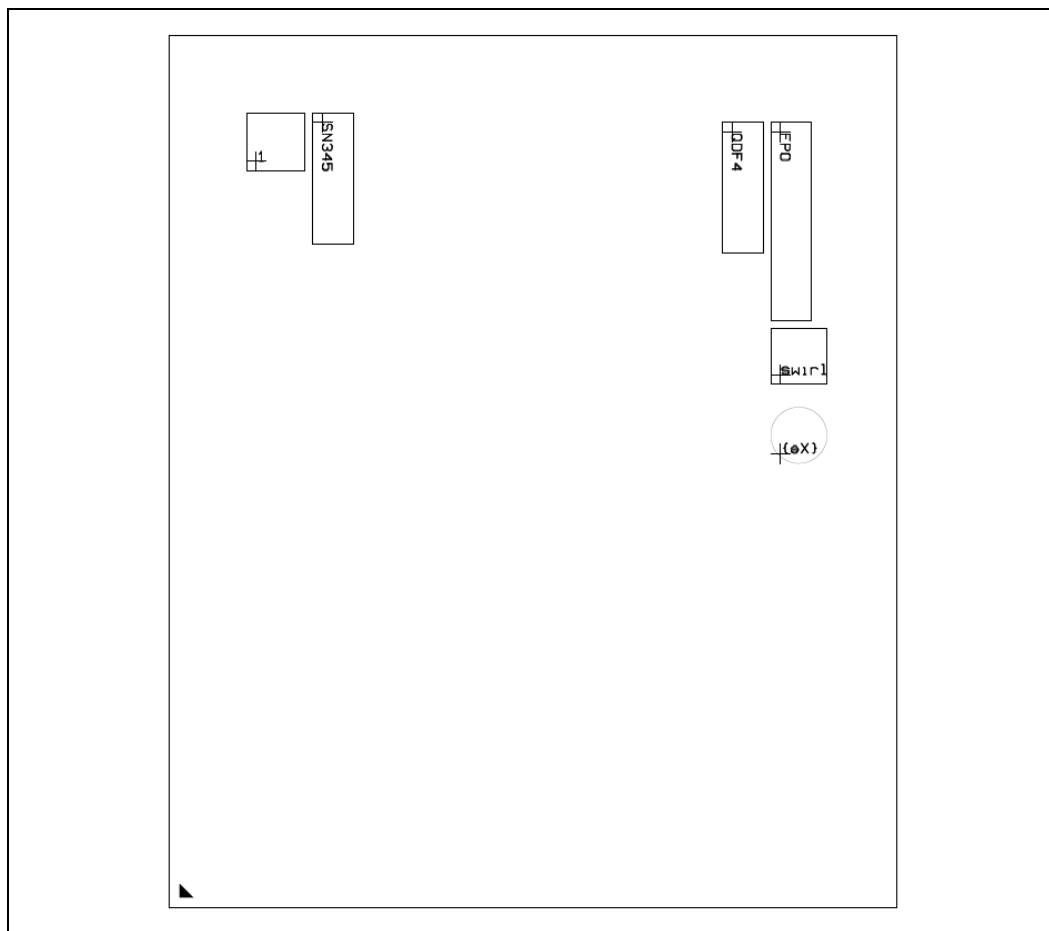
Figure 5. Processor Based on HX Processor Line Chip Package BGA Top-Side Markings

Pin Count: 1964

Package Size: 37.5mm x 45mm
