Firmware update procedure for Ubuntu LINUX

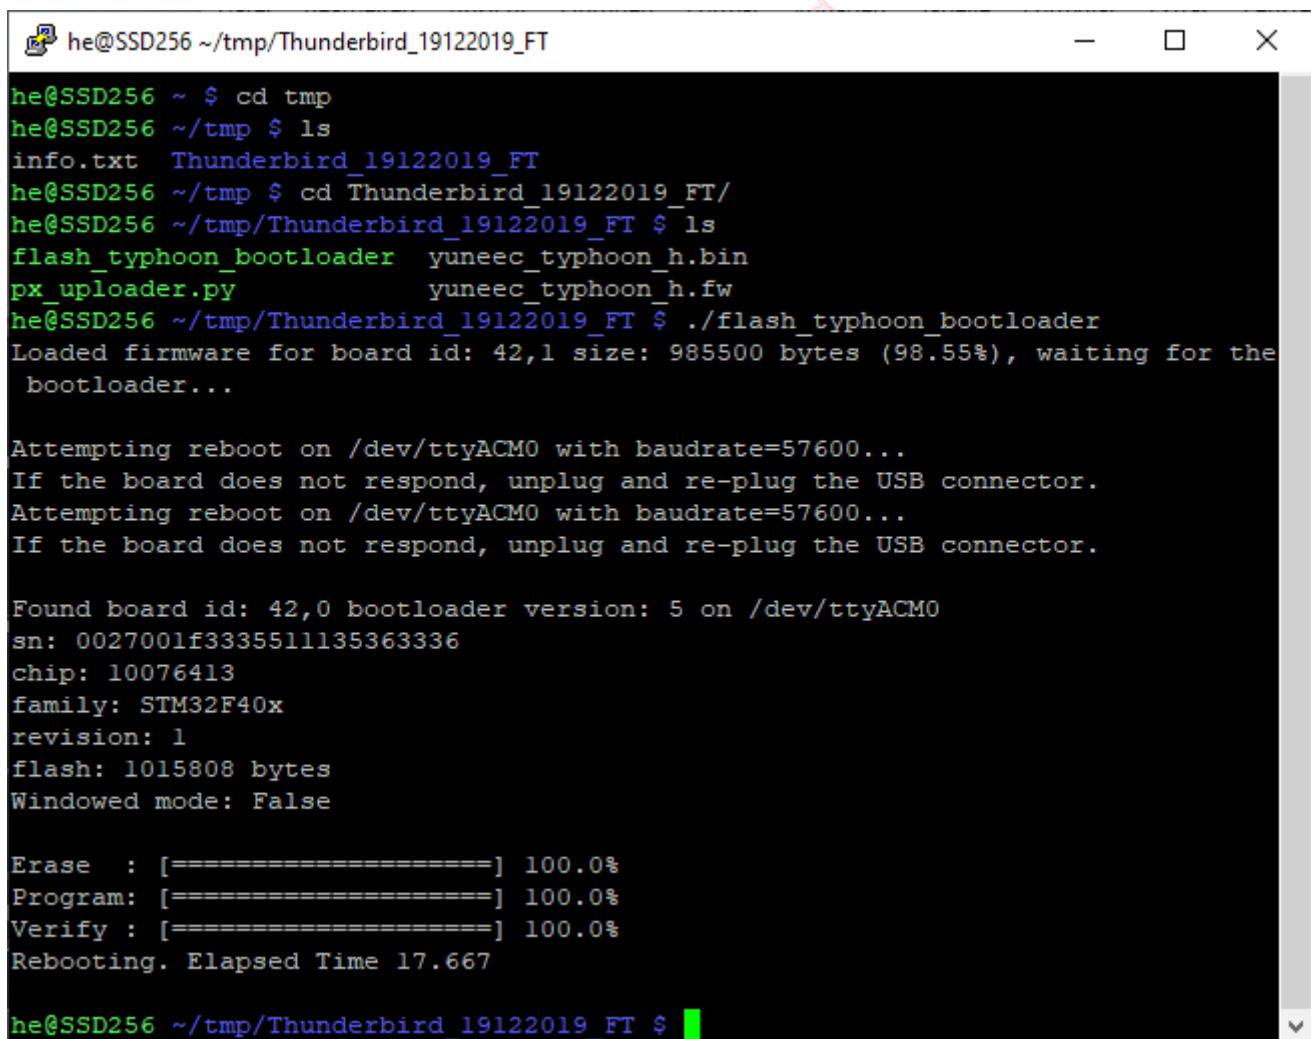
Plug in the USB cable immediately. Wait and observe terminal output. Update process will start soon...

```
he@SSD256 ~/tmp/Thunderbird_19122019_FT  
he@SSD256 ~ $ cd tmp  
he@SSD256 ~/tmp $ ls  
info.txt  Thunderbird_19122019_FT  
he@SSD256 ~/tmp $ cd Thunderbird_19122019_FT/  
he@SSD256 ~/tmp/Thunderbird_19122019_FT $ ls  
flash_typhoon_bootloader  yuneec_typhoon_h.bin  
px_uploader.py            yuneec_typhoon_h.fw  
he@SSD256 ~/tmp/Thunderbird_19122019_FT $ ./flash_typhoon_bootloader  
Loaded firmware for board id: 42,1 size: 985500 bytes (98.55%), waiting for the  
bootloader...

Attempting reboot on /dev/tttyACM0 with baudrate=57600...  
If the board does not respond, unplug and re-plug the USB connector.  
Attempting reboot on /dev/tttyACM0 with baudrate=57600...  
If the board does not respond, unplug and re-plug the USB connector.

Found board id: 42,0 bootloader version: 5 on /dev/tttyACM0  
sn: 0027001f3335511135363336  
chip: 10076413  
family: STM32F40x  
revision: 1  
flash: 1015808 bytes  
Windowed mode: False
