WO-400-03 — Replace VALVE, SWING CHECK 3" P300 (4"-P300-P-1008/A2)

Area	A400 Pumps	**Task**	VR Valve replacement in kind
Priority	2 (integrity)	**Issued by**	Facility owner (demonstration)
Primary asset	P-102A — P-102A centrifugal pump — E 164'-0" N -18'-6" EL 100'-9"		
Equipment	P-102A	**Lines**	4"-P300-P-1008
Isometrics	ISO-P-1008 (owner's drawings, attached)		
Permits	General work permit

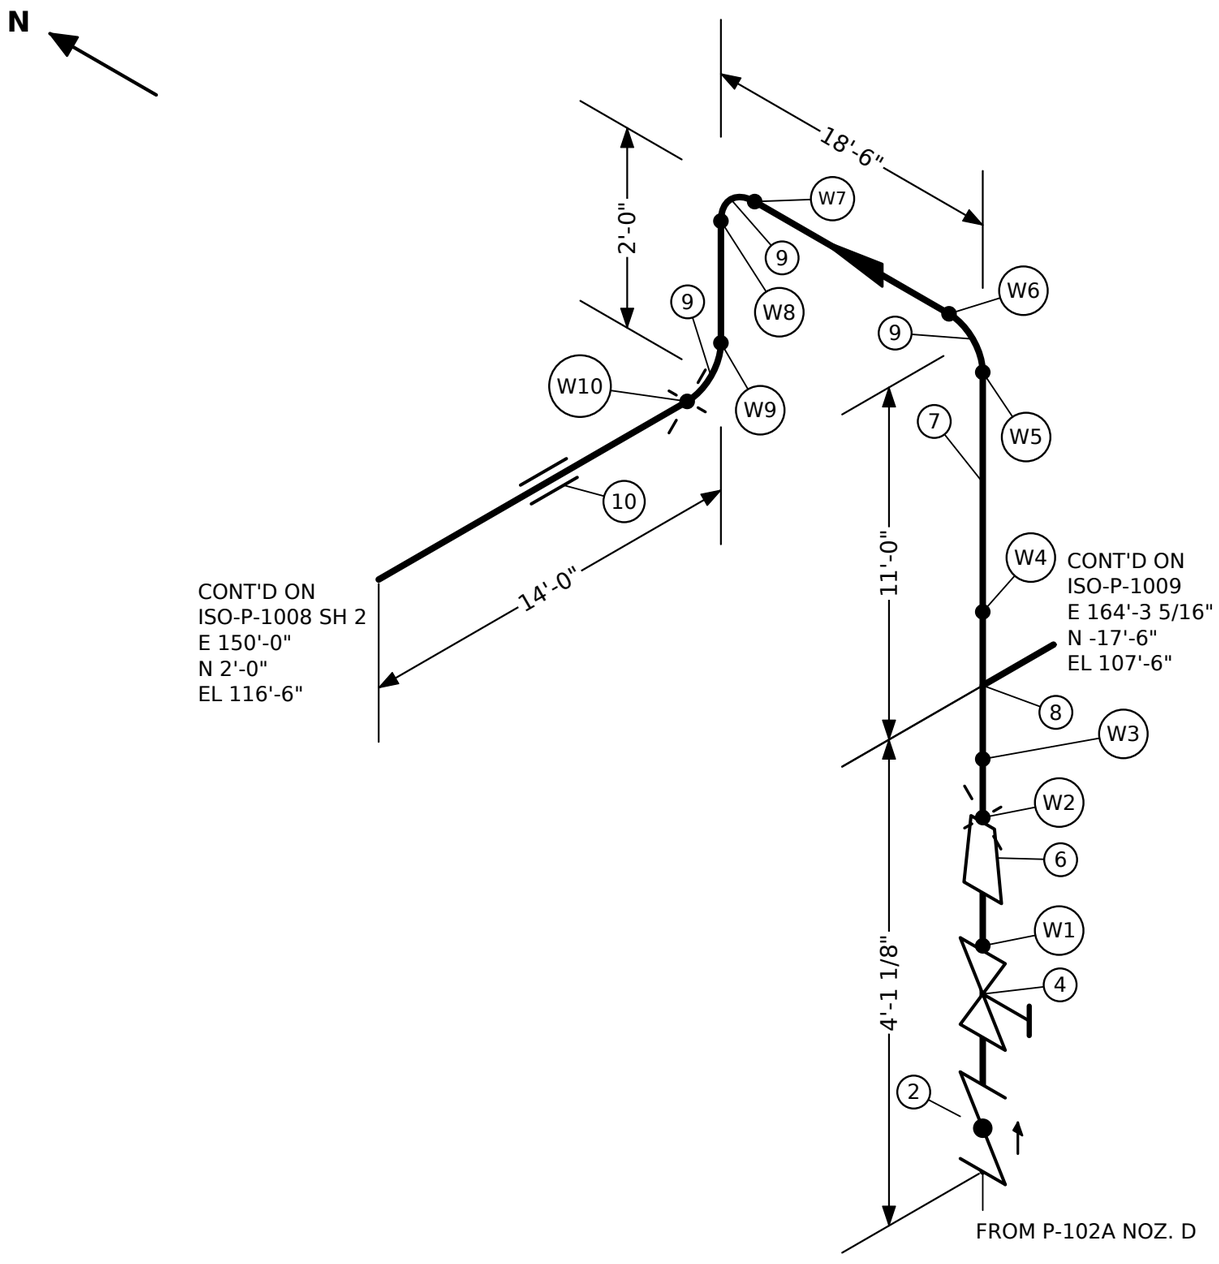
DRAWING NO.	SHEET	REV
ISO-P-1008	1 OF 3	0

Discharge check valve slamming; replace in kind.

Drawing	Sheet	Level	Finding
ISO-P-1008	1	error	sheet 1: CONT'D ON ISO-P-1009 prints E 164'-3 5/16" N -17'-6" EL 107'-6" for E 164'-3 5/16" N -16'-6" EL 107'-6": the minus sign applies to the feet only; read as written the point is 12.00 in away and 12.00 in off where 4"-P300-P-1008 meets 4"-P300-P-1009 (E 164'-3 5/16" N -16'-6" EL 107'-6")
ISO-P-1008	2	warning	weld 4"-P300-P-1008/W14 (E 134'-8 11/16" N 2'-0" EL 116'-6", sheet 2) has no label
ISO-P-1008	3	warning	W15 (4"-P300-P-1008/W15, sheet 3) is labelled again on sheet 2; it is 4.0 in from the nearest break
ISO-P-1008	2	warning	branch weld 3/4"-P300-SP-7024/W1 (E 136'-0" N 2'-0" EL 116'-9 5/16", sheet 2) has no label
ISO-P-1008	2	warning	branch weld 3/4"-P300-I-7008/W1 (E 135'-0" N 2'-0" EL 116'-9 5/16", sheet 2) has no label

Tag	Role	Drawing	Sheet	Weld label
4"-P300-P-1008/A2	affected	ISO-P-1008	1	
4"-P300-P-1008/A1	affected	ISO-P-1008	1	
4"-P300-P-1008/A4	affected	ISO-P-1008	1	
4"-P300-P-1008/A5	isolation: valve	ISO-P-1008	1	
4"-P300-P-1008/A2	isolation: blind	ISO-P-1008	1

1. Isolate per the isolation list, drain and vent 4"-P300-P-1008 between the isolations.
2. Unbolt and remove VALVE, SWING CHECK 3" P300 (4"-P300-P-1008/A2) at E 164'-0" N -16'-6" EL 104'-1/8".
3. Inspect both flange faces (SW-NDE-5); dress or report damage.
4. Install a new VALVE, SWING CHECK 3" P300 of the same size, class and face-to-face (CHECK3-P300), with new gaskets and studs, stem orientation as removed.
5. Tighten the studs to the stated preload in three passes, cross pattern (SW-WO-5).
6. Remove blinds, restore the line-up, leak test the two joints on start-up (SW-TEST-2).
