Firmware update procedure for Ubuntu LINUX

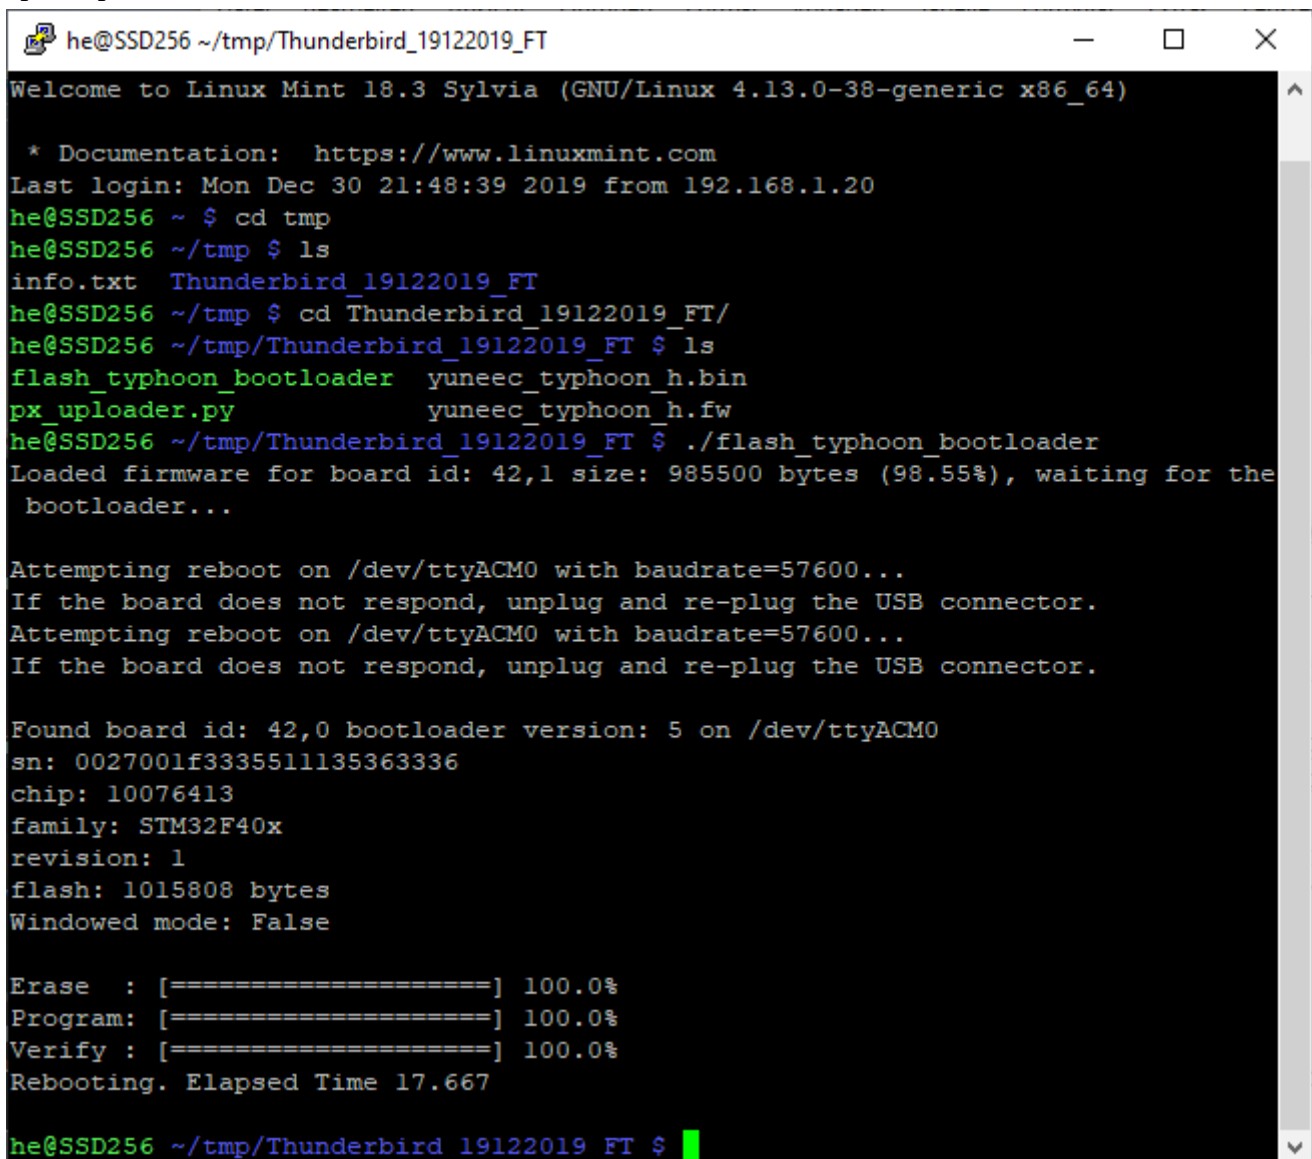
Plug in the USB cable immediately. Wait and observe terminal output.

Update process will start soon ...
