WO-100-03 — Replace spool SP02 of 6"-P150-P-1001

Area	A100 Tank farm	**Task**	SR Spool replacement
Priority	2 (integrity)	**Issued by**	Facility owner (demonstration)
Equipment	—	**Lines**	6"-P150-P-1001
Isometrics	ISO-6"-P150-P-1001		
Permits	General work permit, Hot work permit

Isometric ISO-6"-P150-P-1001

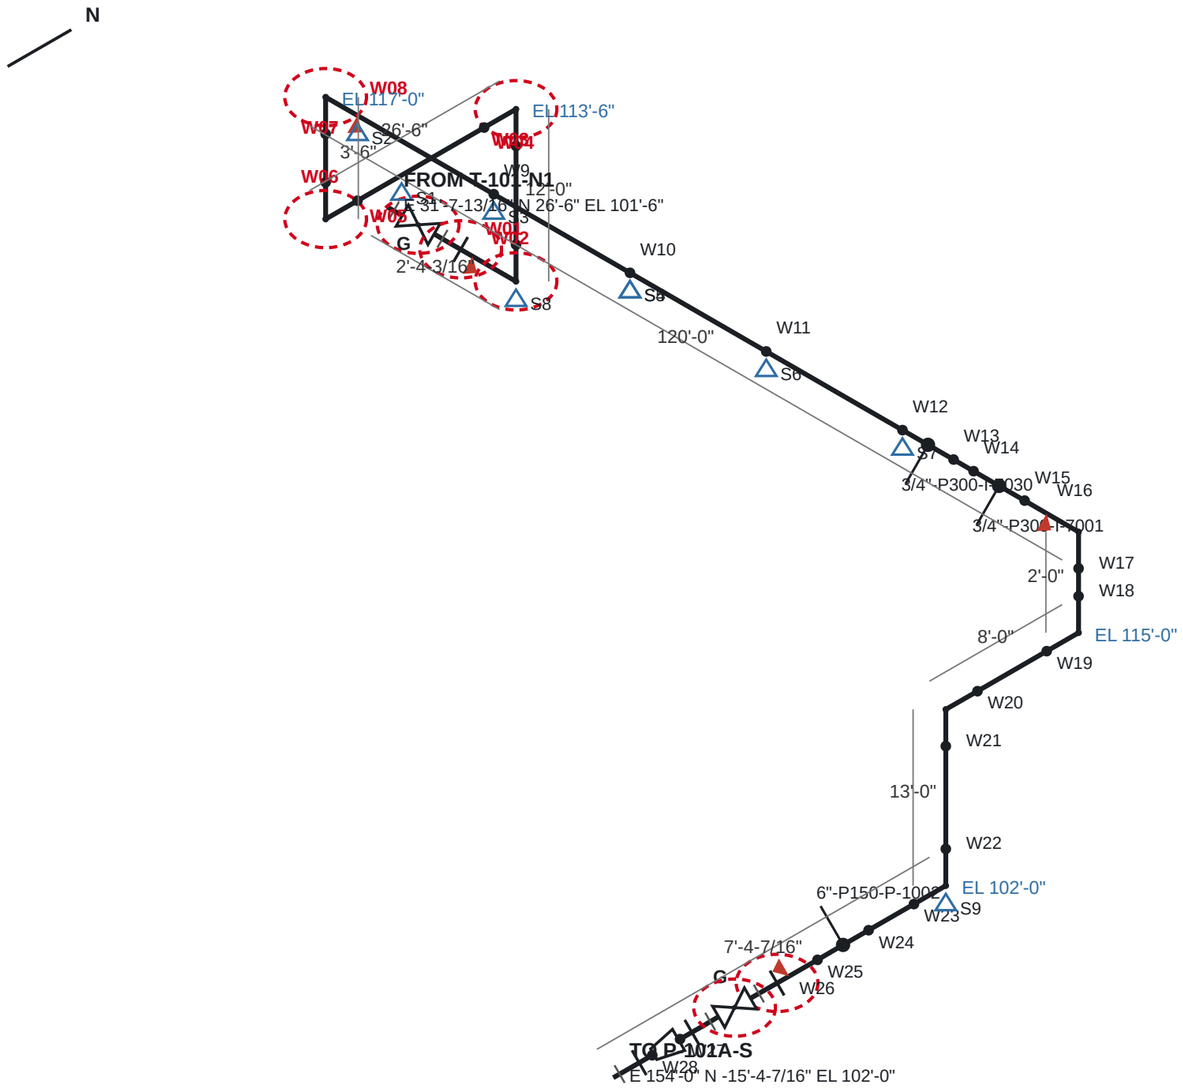
External corrosion found on the tank outlet line at the first bend.

1. Isolate per the isolation list; drain, vent and purge 6"-P150-P-1001 between the isolations; confirm gas-free for hot work.
2. Remove spool 6"-P150-P-1001-SP02 (7 items, 37'-0" of pipe) — cut at the field welds and break the flanged joints at its ends as listed.
3. Fabricate the replacement spool to ISO-6"-P150-P-1001 with the same items (parts list), welding to WS-01; 6 shop welds.
4. Install the spool; make 2 field welds; new gaskets and studs at flanged ends, tightened per SW-WO-5.
5. NDE per the NDE table; hydrostatic test at 210 psi for 30 minutes with the relief valves blinded (SW-TEST-1).
6. Remove blinds, restore the line-up, hand back.
