Fatigue Fracture Appearances

Ronald J. Parrington, Engineering Systems Inc. (ESi)

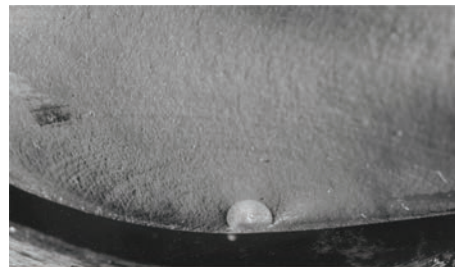
Fig. 5 Subsurface fatigue origin in-service failure of 6.4 cm (2.5 in.) nitrided medium-carbon alloy steel crank pin. In contrast with the fracture surface shown in Fig. 4, produced in the laboratory under continuous uniform loading, this surface exhibits beach marks. Courtesy of G.J. Fowler, Fowler Inc.

In some situations, fatigue crack initiation does not occur at a free surface. For example, components that have been case hardened, surface hardened, or shot peened can exhibit subsurface initiation. Such surface treatments introduce compressive surface residual stresses (favorable for improving fatigue resistance by reducing the driving force for initiation) and/or increase surface fatigue strength. Under some conditions, these gradients in driving force and resistance result in subsurface fatigue crack initiation (Fig. 3). Figures 4 and 5 illustrate subsurface fatigue initiation in surface-hardened and case-hardened steel components.

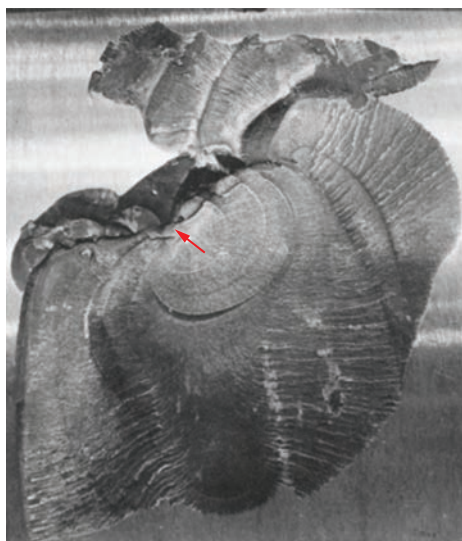
Fig. 10 Large circular spall on forged, hardened alloy steel mill roll. Faint red arrow marks location of subsurface fatigue origin. Beach marks are evident within the fatigue propagation zone, which is surrounded by fast brittle fracture. Source: Ref 4

Fatigue caused by contact stress, such as rolling-contact loading, also frequently initiates subsurface. As illustrated in Fig. 6, stresses generated by contact between two surfaces characteristically display a maximum shear stress component located beneath the surface. For sufficiently high varying contact stress levels, this can result in subsurface initiation and initial growth of fatigue in shear (Fig. 7). Under contact loading, as sliding increases, fatigue crack initiation sites shift to the surface (Fig. 8). Rolling and sliding contact can cause fatigue damage, such as pitting of gears and spalling of rolls (Fig. 9, 10).

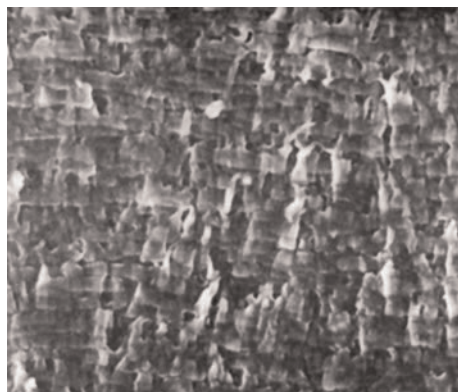
Fig. 49 Scanning electron microscope view of fatigue striations in medium-density polyethylene, laboratory tested at 0.5 Hz with maximum stress 30% of the yield strength. Crack growth is upward in this view. Original magnification: 200×. Source: Ref 4
