25455/25460/25465/25470/25480/25485/25490

Toyota Adjustable Upper Control Arms

SPC - FAQ

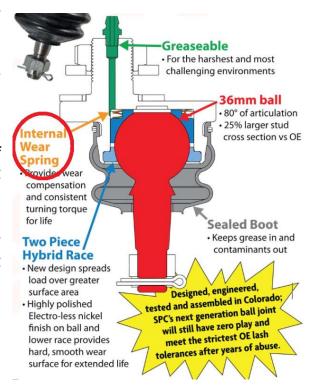
Fig. 3

A12: Our grease-able ball joints incorporate an internal spring which keeps a constant pressure on the ball stud. Proper inspection should look for radial play only. Any vertical wear is compensated for with a wear spring.

Pull knuckle extension straight out and zero dial indicator. Push knuckle extension straight in and record movement. See **green** arrow of Fig. 3. There should be no perceptible radial motion.

NOTE: Checking for axial / vertical play (up/down) is not necessary, because the spring can be compressed if excessive force is used. Compression of the spring is NOT wear! If a shop insists on checking it this way, they should use a indicator to measure dial axial If more than 0.050" of movement. movement is present, then the ball joint should be replaced. This is represented by the **red** arrow of Fig. 3.
