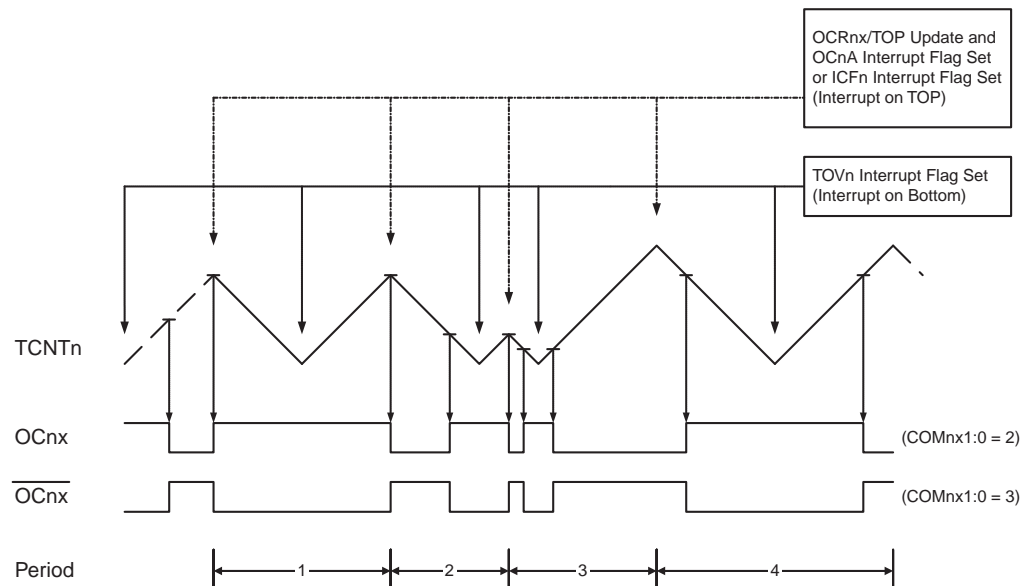
Figure 13-8. Phase Correct PWM Mode, Timing Diagram

In phase correct PWM mode the counter is incremented until the counter value matches either one of the fixed values 0x00FF, 0x01FF, or 0x03FF (WGM13:0 = 1, 2, or 3), the value in ICR1 (WGM13:0 = 10), or the value in OCR1A (WGM13:0 = 11). The counter has then reached the TOP and changes the count direction. The TCNT1 value will be equal to TOP for one timer clock cycle. The timing diagram for the phase correct PWM mode is shown on [Figure 13-8](#). The figure shows phase correct PWM mode when OCR1A or ICR1 is used to define TOP. The TCNT1 value is in the timing diagram shown as a histogram for illustrating the dual-slope operation. The diagram includes non-inverted and inverted PWM outputs. The small horizontal line marks on the TCNT1 slopes represent compare matches between OCR1x and TCNT1. The OC1x Interrupt Flag will be set when a compare match occurs.

The Timer/Counter Overflow Flag (TOV1) is set each time the counter reaches BOTTOM. When either OCR1A or ICR1 is used for defining the TOP value, the OC1A or ICF1 Flag is set accordingly at the same timer clock cycle as the OCR1x Registers are updated with the double buffer value (at TOP). The Interrupt Flags can be used to generate an interrupt each time the counter reaches the TOP or BOTTOM value.

When changing the TOP value the program must ensure that the new TOP value is higher or equal to the value of all of the Compare Registers. If the TOP value is lower than any of the Compare Registers, a compare match will never occur between the TCNT1 and the OCR1x. Note that when using fixed TOP values, the unused bits are masked to zero when any of the OCR1x Registers are written. As the third period shown in [Figure 13-8](#) illustrates, changing the TOP actively while the Timer/Counter is running in the phase correct mode can result in an unsymmetrical output. The reason for this can be found in the time of update of the OCR1x Register. Since the OCR1x update occurs at TOP, the PWM period starts and ends at TOP. This
