# MBE 900 / 4000 Eparts Catalog Quick Reference Guide

SUBJECT: MBE 4000 Cylinder Head And Head Gasket Information

SUBJECT: MBE 4000 Coolant Leaks

SUBJECT: MBE 4000 Turbo Brake Assembly Service Parts

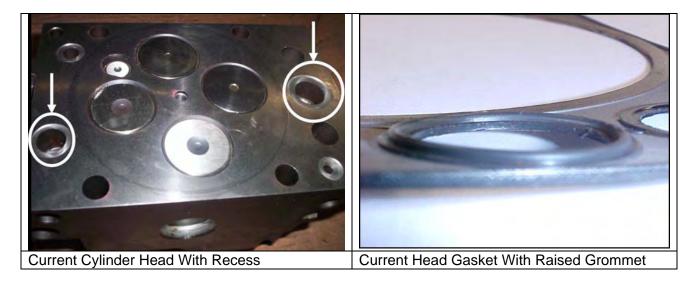
Figure 1 – MBE 4000 Cylinder Head Recess and Head Gasket Grommet

A recessed grommet sealing area was machined around each coolant inlet and outlet port in the cylinder head to give a better mating surface for the thicker rubber seal in the head gasket. See Figure 1. The new cylinder head and gasket became effective with engine S/N: 0460866443 built on August 1, 2006.

- Grommet style cylinder heads and gaskets MUST be used together on the same cylinder. Do NOT mix grommet and non-grommet style cylinder heads and gaskets on the same cylinder.
- Grommet and non-grommet style cylinder heads and gaskets can be used in the same engine provided they are matched as noted above. Do NOT replace all six cylinder heads and gaskets simply to have all the same new parts on the engine.
- Reference Technical Service letter 09 TS-9 for more information.

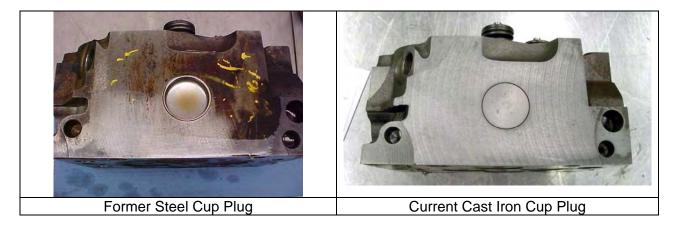
Figure 2 - MBE 4000 Cylinder Head Cup Plug

Further improvements to the cylinder head is a change to a cast iron cup plug instead of a steel cup plug to prevent head cracking. See Figure 2. The new cylinder head became effective with engine S/N: 0460884866 built on April 25<sup>th</sup>, 2007.

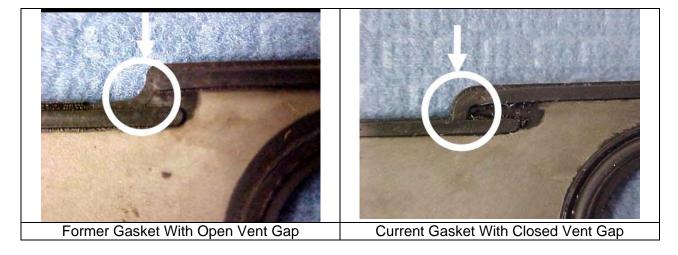
Figure 3 – MBE 4000 Cylinder Head Gasket Vent Gap

Another improvement to the head gasket includes the removal of the vent gap around the perimeter of the gasket. This will prevent water intrusion under the gasket which can cause rusting and pitting of the fire deck surfaces of the cylinder block and head, but ultimately does not affect the sealing surfaces. See Figure 3. The new cylinder head gasket became effective with engine S/N: 0460896913 built on September 3<sup>rd</sup>, 2007.

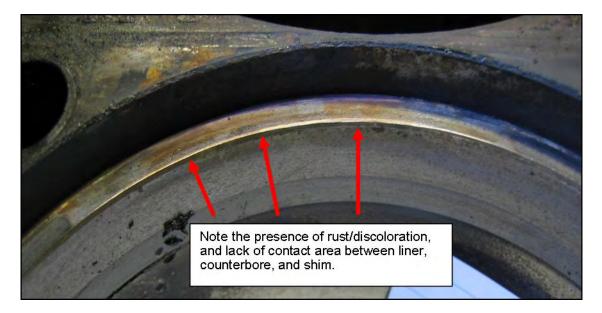
Figure 1 - Leakage in the Counterbore Area

The current stainless steel shim installed between the cylinder liner and cylinder block counterbore area cannot adequately seal out coolant in this area. The coolant acts as a lubricant, causing movement between the cylinder liner and cylinder block and subsequent wear in the counterbore area. Coolant will then leak past the counterbore area. See below for pictures showing the affected areas.

- Only the <u>FAILED</u> cylinders should have their counterbores cut. This decision is based on the condition of the cylinder block counterbore sealing area. See Figures 1-3 on pages 1 and 2 for examples of failed counterbores.

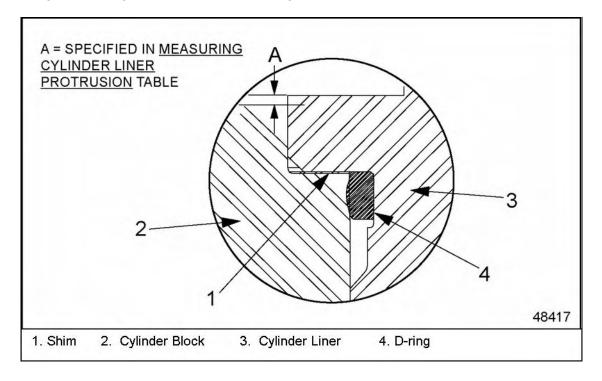
Figure 4 – New Design Cylinder Liner and D-ring Seal

To seal the counterbore area from coolant and prevent liner movement, Detroit Diesel has released a new cylinder liner design which uses an additional rubber D-ring just below the liner flange to seal against the coolant. See Figure 4.

- Install the new D-ring to the cylinder liner. Make sure the D-ring is installed dry with the
  flat surface against the vertical face of the liner. See Figure 4 above, and
  SIB <u>08 MBE 4000-1Rev (EPA07)</u> and SIB <u>08 MBE 4000-1Rev (EPA04)</u>. Be careful not
  to over-stretch the D-ring when it is installed over the liner flange.

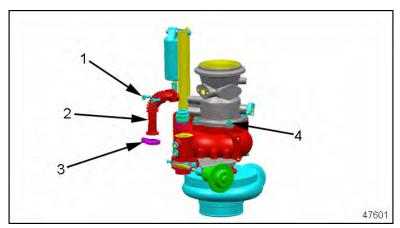
Prior to disassembly of the turbo brake assembly, a routine inspection of the turbocharger should be completed. Areas of concern could include:

- Evidence of foreign objects entering and exiting the turbocharger
- Evidence of restricted air flow
- Evidence of lack of lubrication
- Evidence of turbine or compressor wheel damage

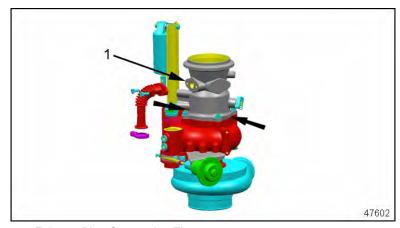
Figure 2 Exhaust Bypass Pipe and Brake Assembly Nuts

5. Remove the four (4) nuts holding the brake assembly to the housing and discard. See Figure 2.

- 1. Bolt (2 qty.)
- 2. Exhaust Bypass Pipe
- 3. V-Band Clamp
- 4. Nut (4 qty.)
