Applied Foundation Testing

Report of Cross-Hole Sonic Logging Test Shaft 1

Drilled Shaft Load Test Program I-80 Bridge Project Council Bluffs, Pottawattamie County, Iowa NHS-080-1(318)0-11-78 AFT Project No.: 108026

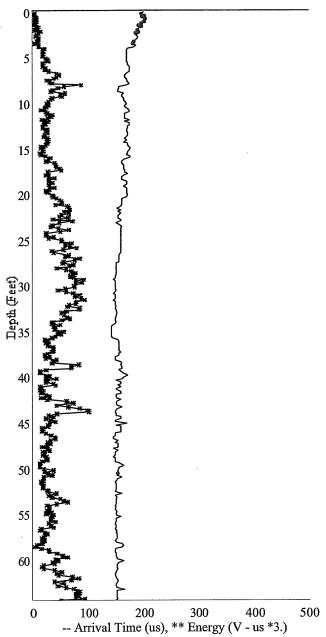
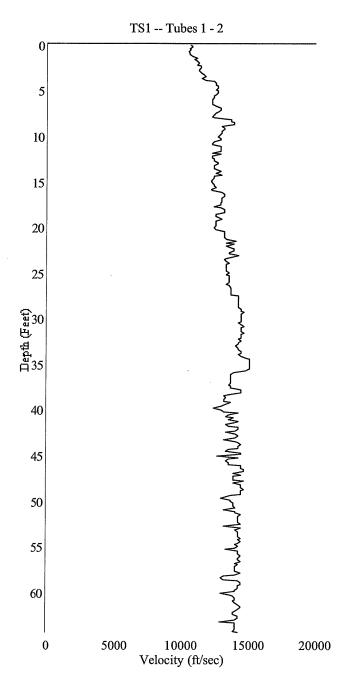
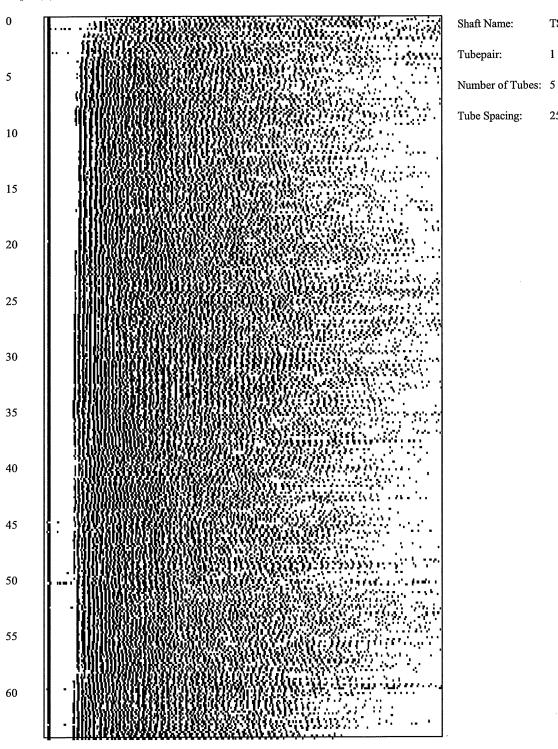
1 - 2

All tested tube pairs exhibited velocity reductions of less than 10 percent for the tested length of the shaft except the upper 2 to 4 feet in tube pairs 1-2 and 2-3. These zones had velocity reductions of 14 to 15 percent. Signals in these areas had good energy, amplitude and slightly delayed but well defined arrival times. Moreover, the wave velocities in these areas were above 10,000 feet per second which is indicative of good concrete. Furthermore, these areas are located within the permanent casing. Based on our evaluation of this data we recommend the shaft concrete between the tubes be considered acceptable for the purposes of post grouting and load testing.
