FAILURE MODES IN HEAT RECOVERY STEAM GENERATORS (HRSGS)

LIYANAGE A.L.D.N.
SAMARATHUNGE S.M.T.N.

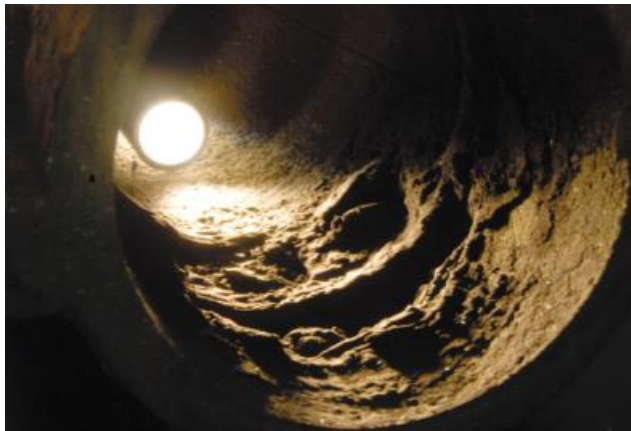
Heavy deposits and caustic gouging

Features of failure	<ul style="list-style-type: none">• Gouged areas; thick, adherent deposits.• Ductile, thin-edged or pinhole failure.• Longitudinal cracks are the typical appearance in HP evaporators of HRSGs since any bulging is restricted by the fins.
Key microstructural features	<ul style="list-style-type: none">• Material removal only, no microstructural changes in the tube material.• No protective magnetite layer.
Attack rate	<ul style="list-style-type: none">• Rapid (up to 2 mm per year).

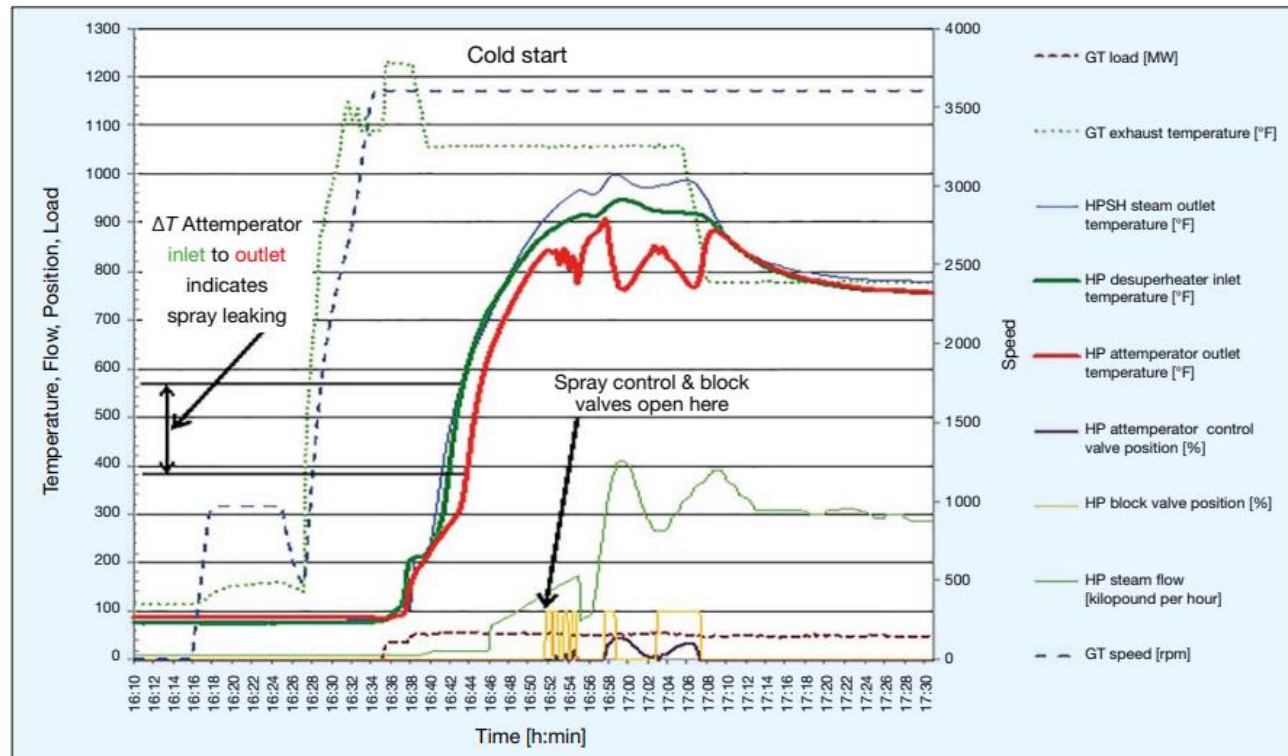
- When the HP SH outlet has zero or low steam flow and attemperator water leakage is present in the system. Spray water will accumulate at the bottom of the pipes.
- Small leakages cause no problem. But better to be aware of this.
- Possible failures:
 - Cracks in girth welds
 - Hogging of the pipe due to top and bottom temperature difference of the pipe.
