Design review report

Code:	AE-33285	
Rev:	6	
Date:	2021-02-11	
Page:	1/ 8

Aim of this document is to describe suggestions and corrections that Telit advises to improve Ovoo Electronics B100AA application that integrates Telit GE910-QUAD V3 and BlueMod S50 modules.

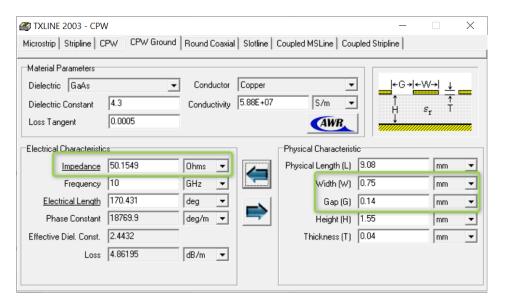
▲ On B151BA PCB, RF line for the BlueMOD S50 module is a waveguide with characteristic impedance of about 50 Ohms. According to our calculations done assuming a Er=4.3 of the pre-preg, the resulting impedance of your CPWGs is about 51,05 Ohm: too high. The RF trace impedance must be 50 Ohms.

For achieving 50 Ohm impedance, we recommend modifying RF copper trace Width(W) and Gap(G) to 0.75mm and 0.14mm, as shown below.
