Practical Detailing for Mid-Rise Wood Frame Buildings

Jon Hall AIA, Quality Management Director
February 23 & 24, 2016

GGLO DESIGN

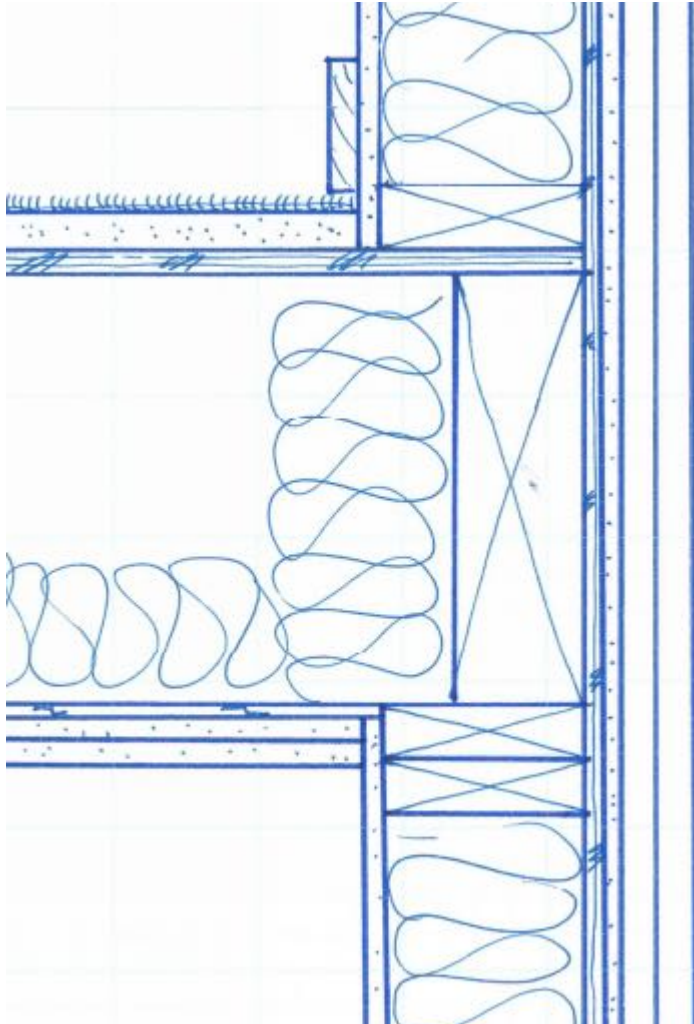
Type VA Detailing

- 1 Hour Rated Floor
- 1 Hour Rated Wall
- Rated from Both Sides

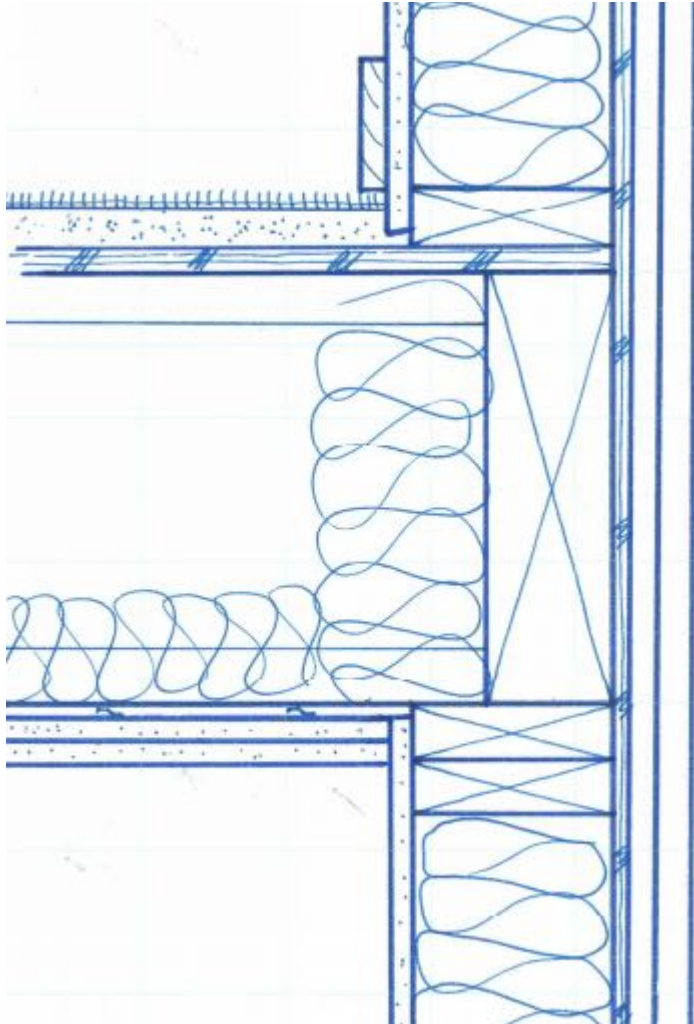
Type VA Detailing

- 1 Hour Rated Floor
- 1 Hour Rated Wall
- Rated from Inside Only

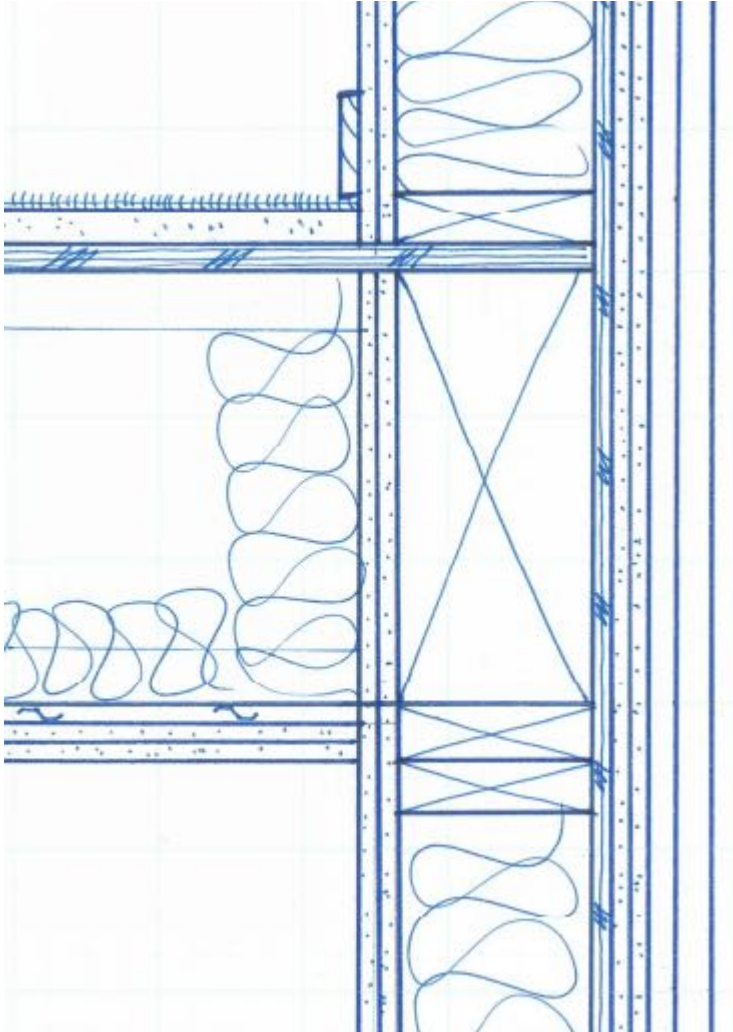
Type IIIA Detailing

- 1 Hour Rated Floor
- 2 Hour Rated Wall
- Fire Retardant Treated
- Rated from Both Sides

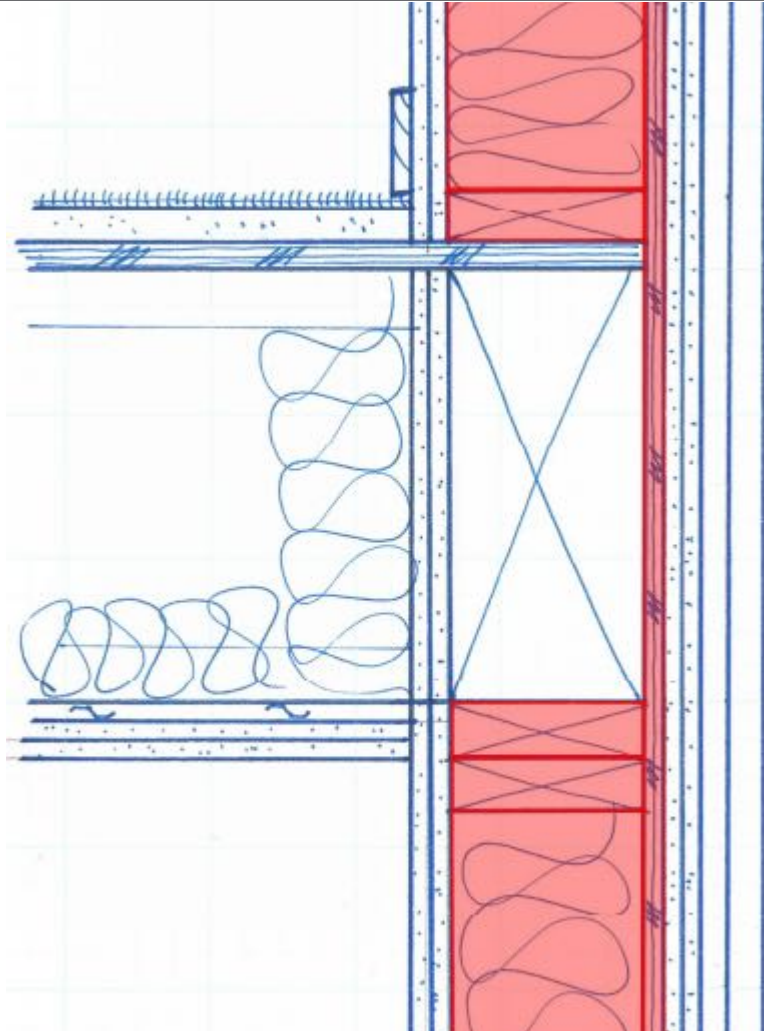
Type IIIA Detailing

- 1 Hour Rated Floor
- 2 Hour Rated Wall
- Fire Retardant Treated
 - Wall Framing
 - Wall Sheathing
- Rated from Both Sides

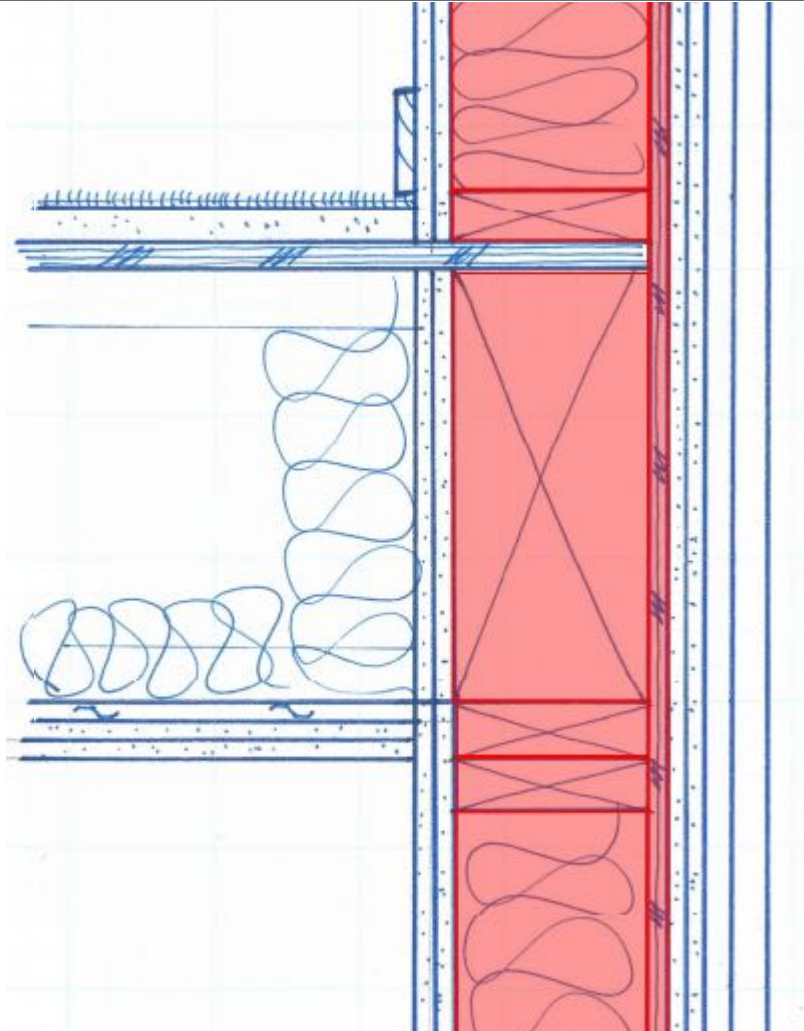
Type IIIA Detailing

- 1 Hour Rated Floor
- 2 Hour Rated Wall
- Fire Retardant Treated
 - Wall Framing
 - Wall Sheathing
 - Rim Beam
- Rated from Both Sides

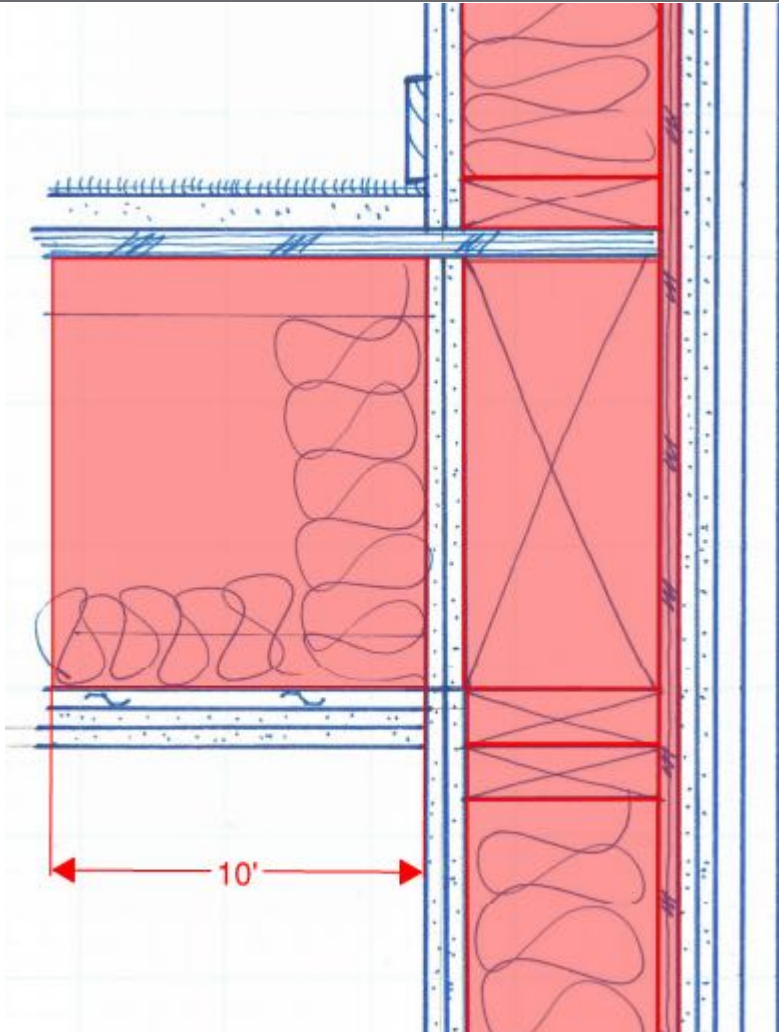
Type IIIA Detailing

- 1 Hour Rated Floor
- 2 Hour Rated Wall
- Fire Retardant Treated
 - Wall Framing
 - Wall Sheathing
 - Rim Beam
 - Floor Joists for at least 10' & individually wrapped with GWB
- Rated from Both Sides

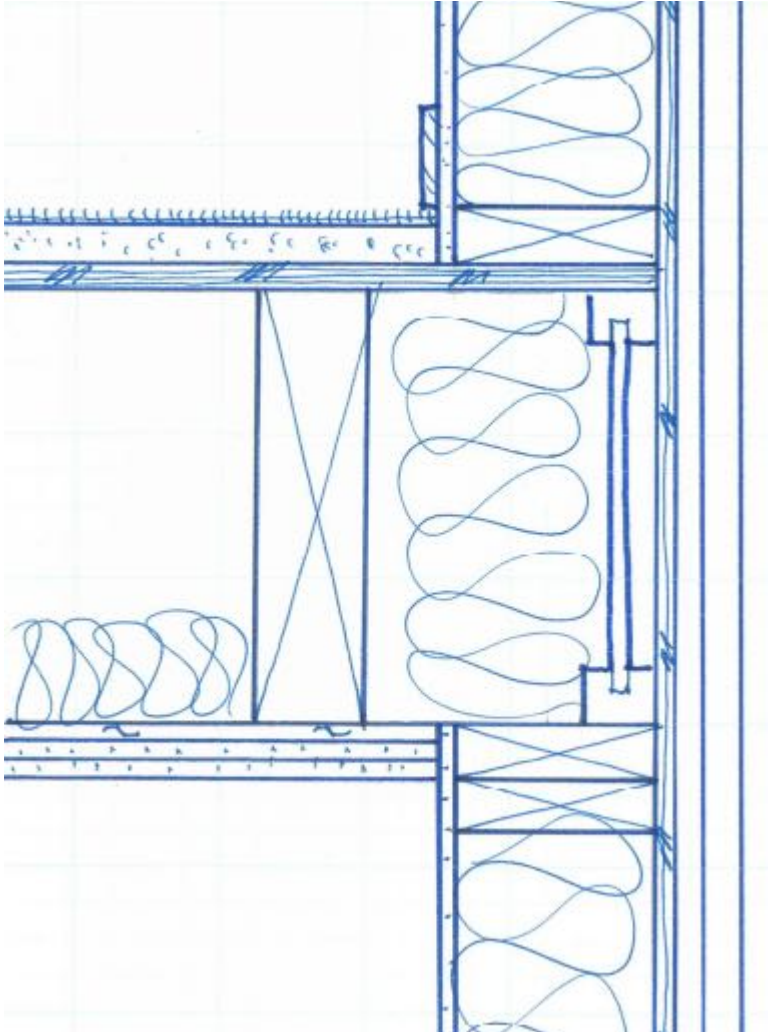
Type IIIA Detailing

- 1 Hour Rated Floor
- 1 Hour Rated Non-Bearing Wall
- Fire Retardant Treated

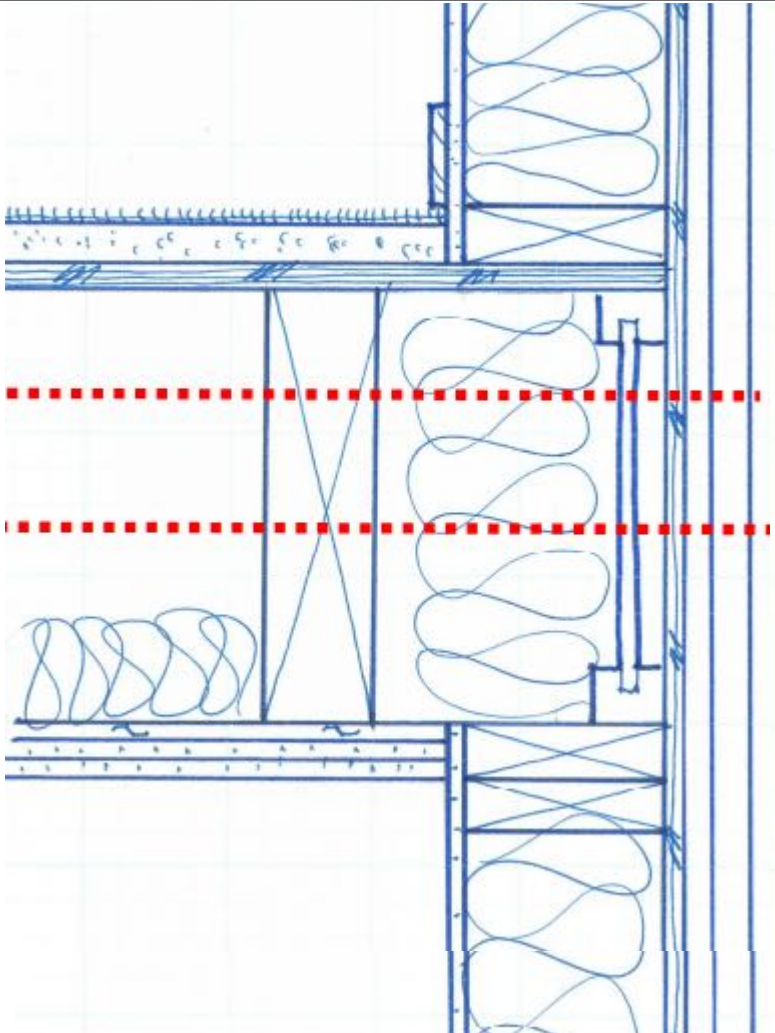
Type IIIA Detailing

- 1 Hour Rated Floor
- 1 Hour Rated Non-Bearing Wall
- Fire Retardant Treated

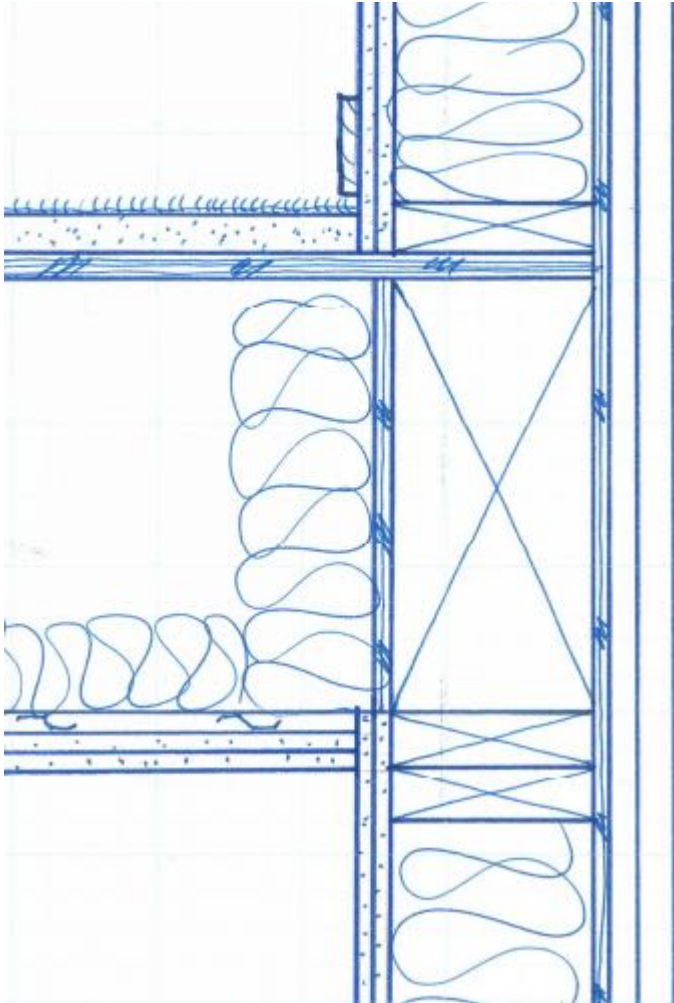
Type IIIA Detailing

- 1 Hour Rated Floor
- 2 Hour Rated Non-Bearing Wall
- Fire Retardant Treated
- Fire Coated Plywood

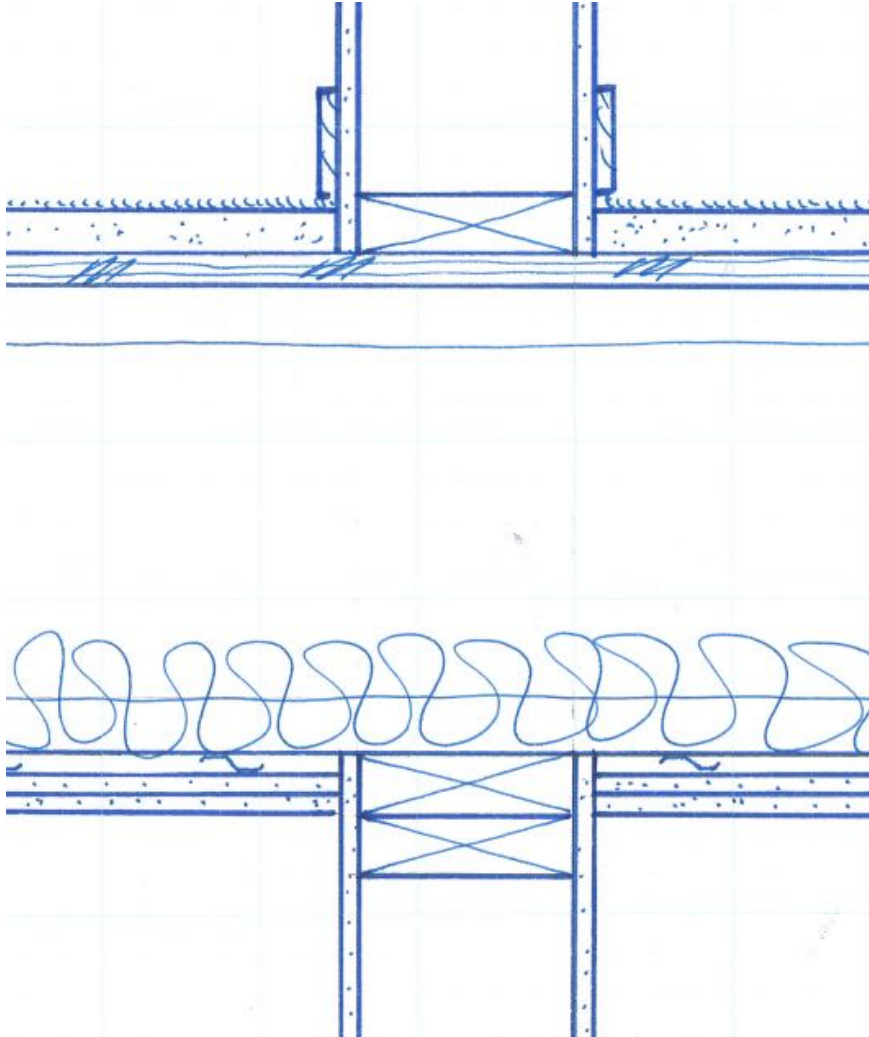
Interior Wall Detailing

- 1 Hour Rated Floor
- Non-Rated Wall

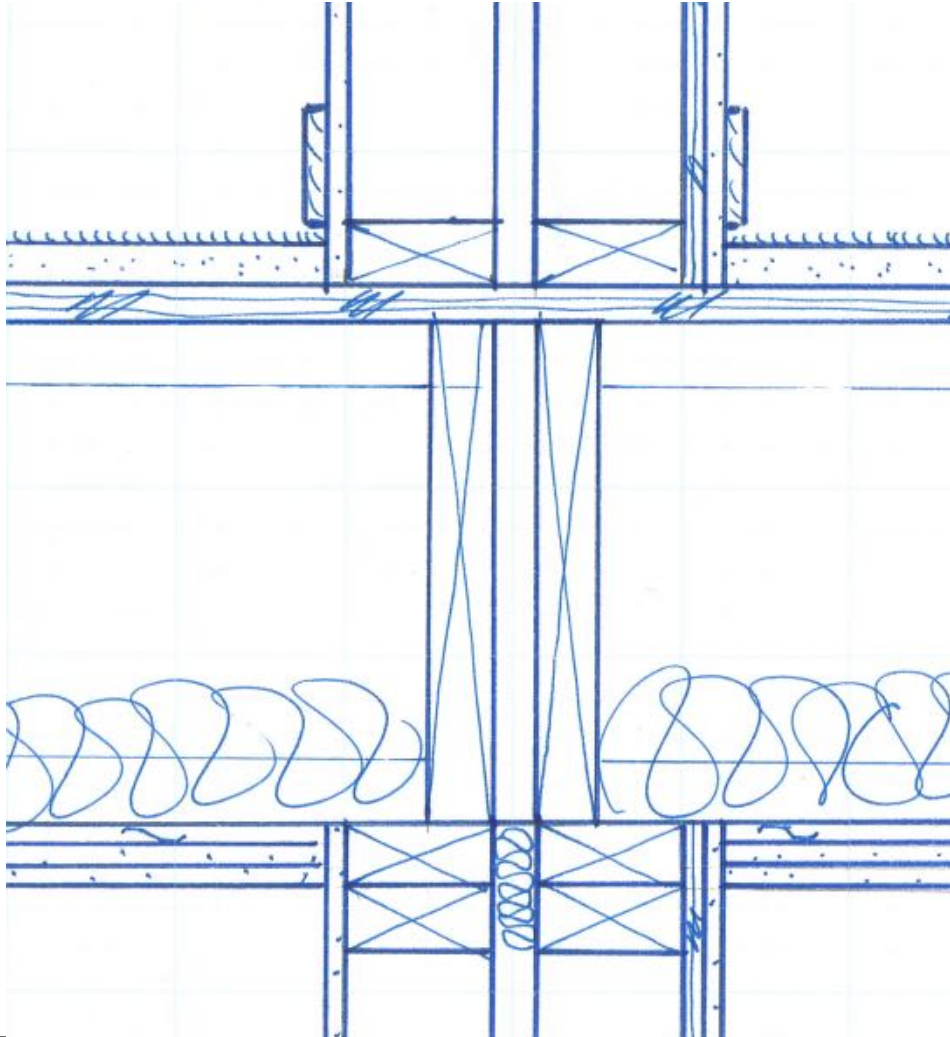
Interior Wall Detailing

- 1 Hour Rated Floor
- 1 Hour Rated Demising Wall
- Fire Blocking Required

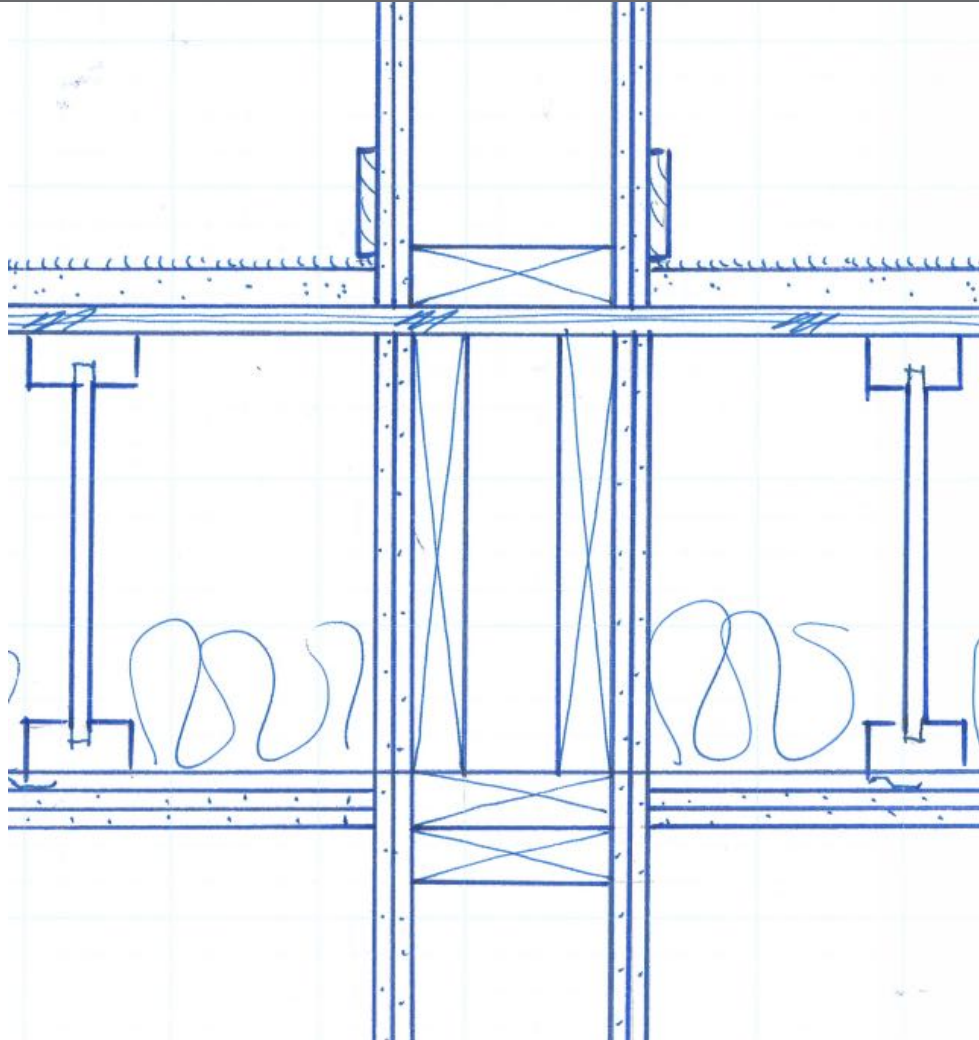
Interior Wall Detailing

- 1 Hour Rated Floor
 - Parallel Framing
- 2 Hour Rated Wall

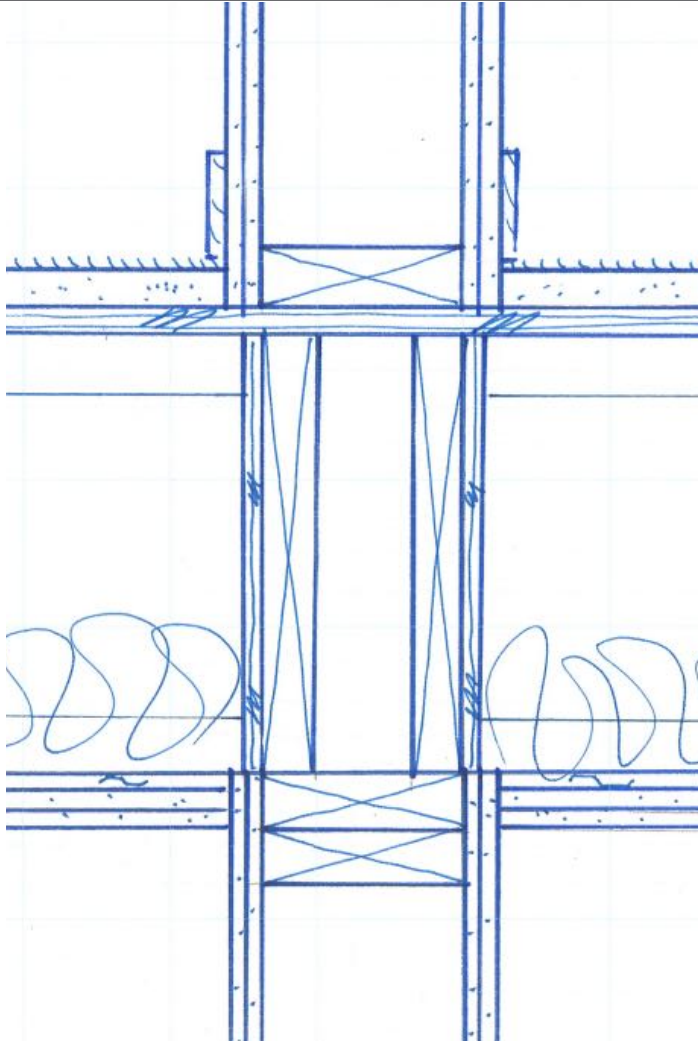
Interior Wall Detailing

- 1 Hour Rated Floor
 - Perpendicular Framing
- 2 Hour Rated Wall
- Fire Coated Plywood

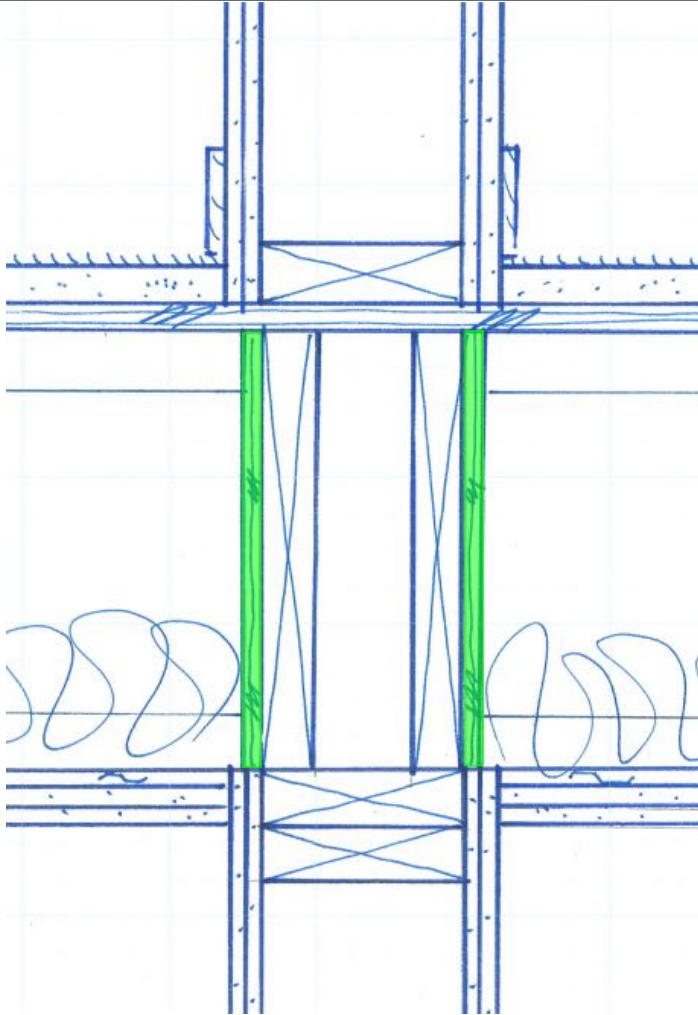
Interior Wall Detailing

- 1 Hour Rated Floor
 - Perpendicular Framing
- 2 Hour Rated Wall
- Fire Coated Plywood

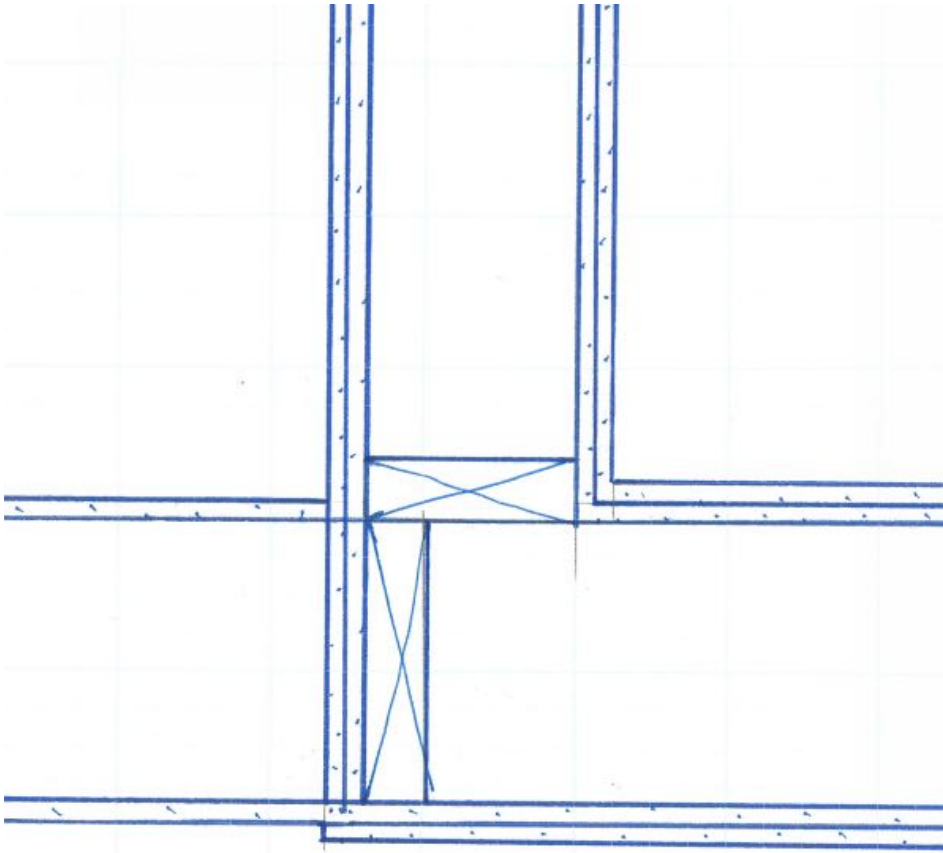
Interior Wall Detailing

- 1 Hour Rated Wall
- 2 Hour Rated Wall

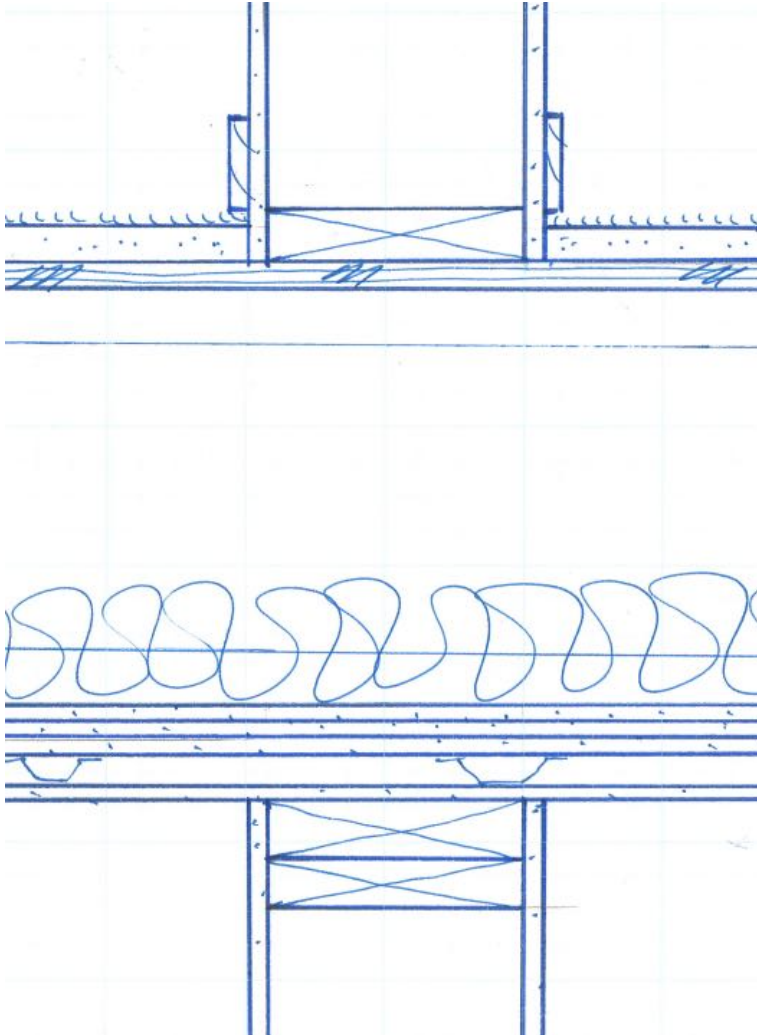
Interior Wall Detailing

- 2 Hour Rated Floor
- 1 Hour Rated Wall - NLB

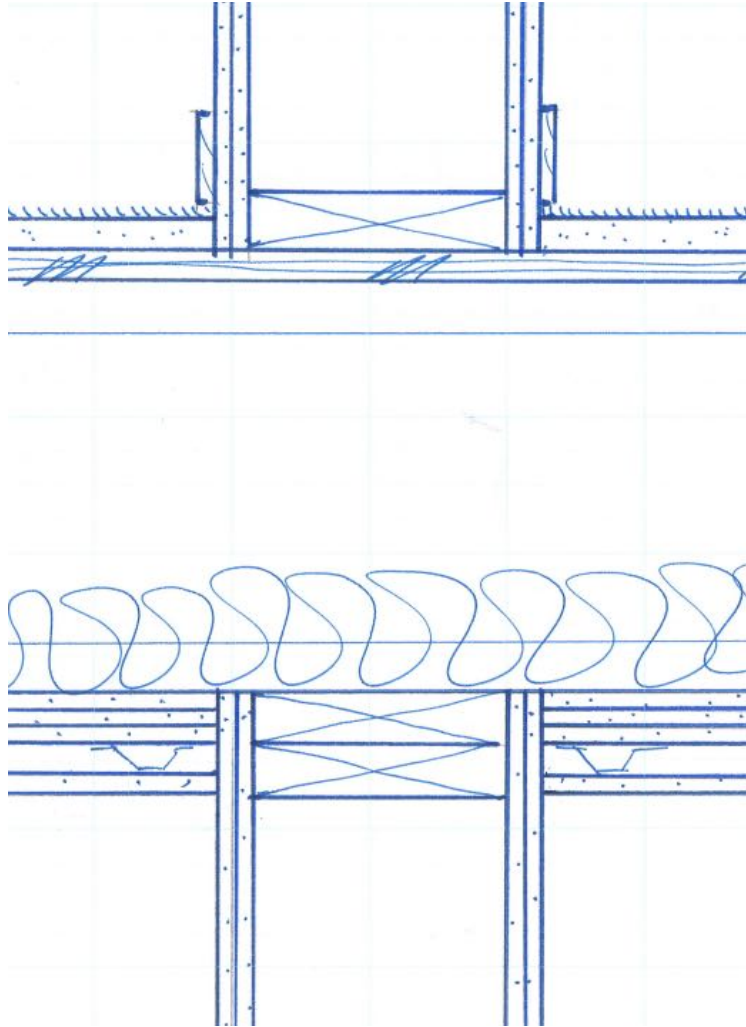
Interior Wall Detailing

- 2 Hour Rated Floor
- 2 Hour Rated Wall – Load Bearing

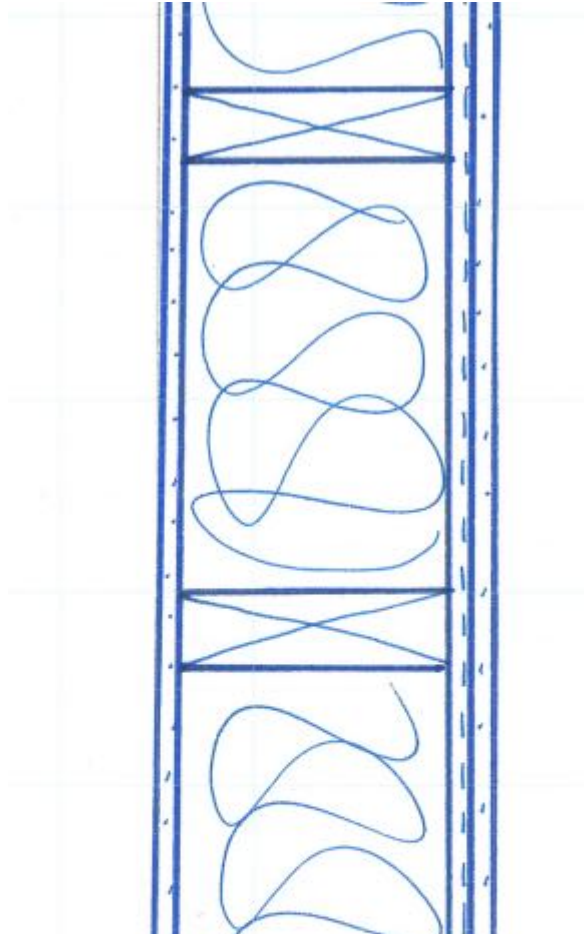
Corridor Wall Detailing

- 1 Hour Rated
- Load Bearing
- STC 50 min
- GA File No WP 3242
 - (For acoustics)

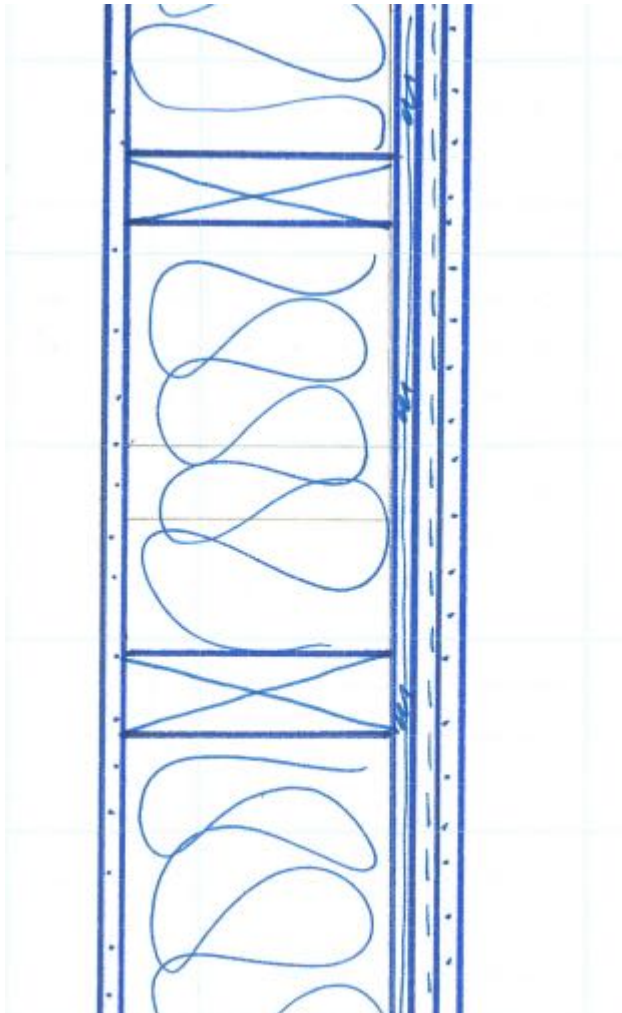
Corridor Wall Detailing

- 1 Hour Rated
- Load Bearing
- Shear Wall
- NOT STC 50 min
- GA File No WP 3242 Sim
 - (For acoustics)

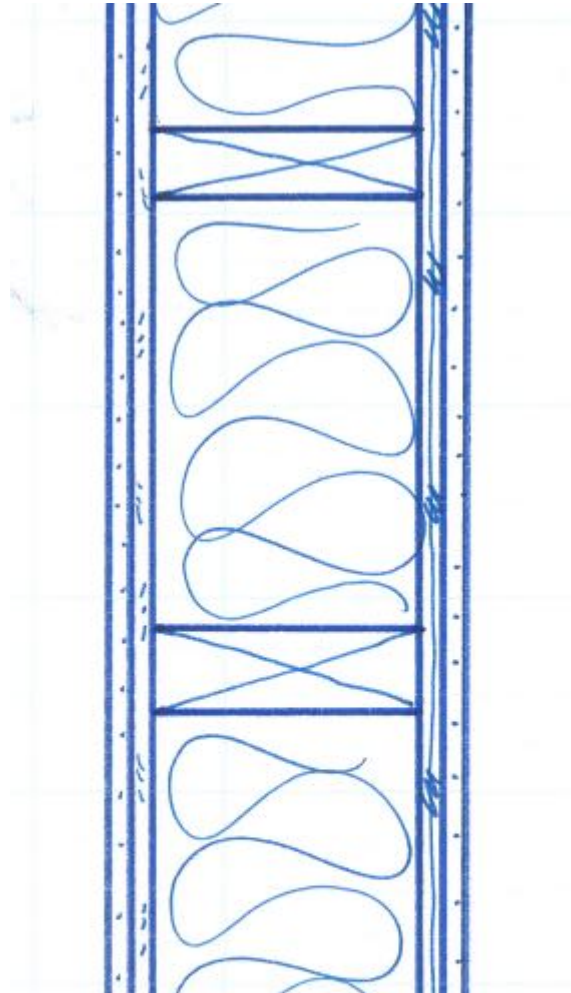
Corridor Wall Detailing

- 1 Hour Rated
- Load Bearing
- Shear Wall
- Sound Board
- STC 50 min
- NGC 2011058
 - (For acoustics)

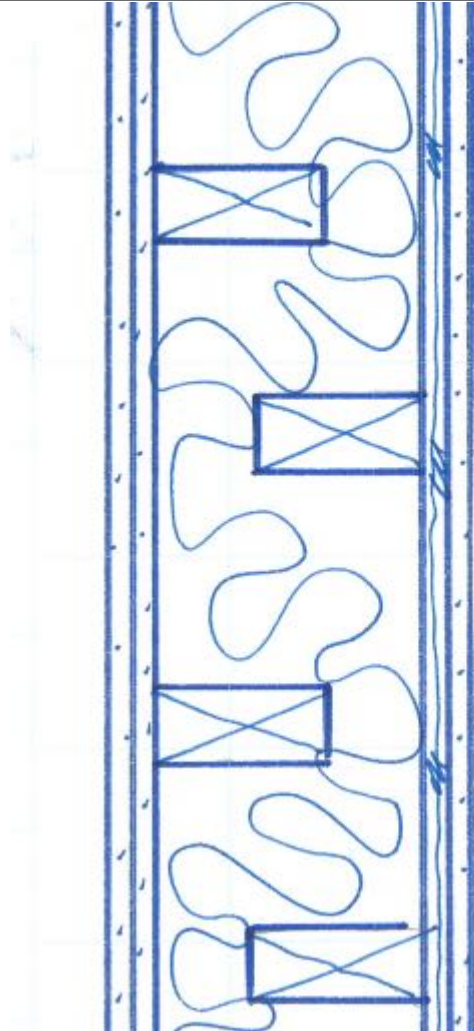
Corridor Wall Detailing

- 1 Hour Rated
- Load Bearing
- Shear Wall
- Staggered Stud
- STC 50 min
- GA File No 3910
 - (For acoustics)

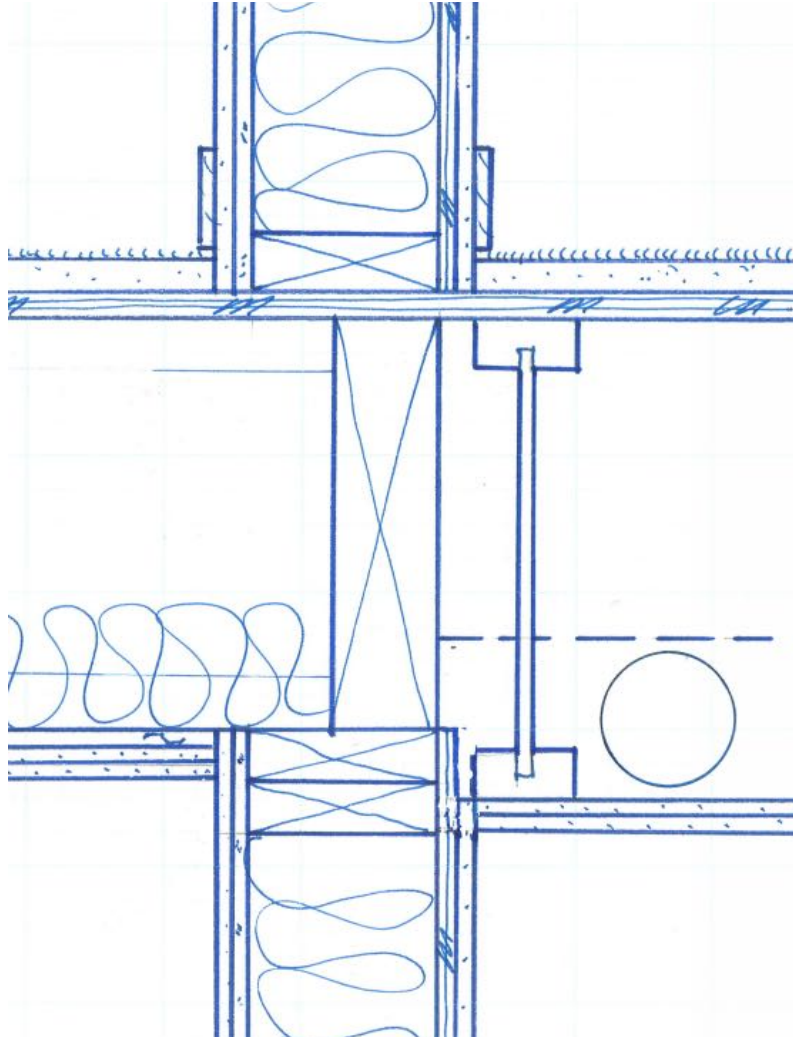
Corridor Ceiling Detailing

- 1 Hour Rated
- 6x10 Beams
- 14" I Joists
- MEPF Within Rated Enclosure

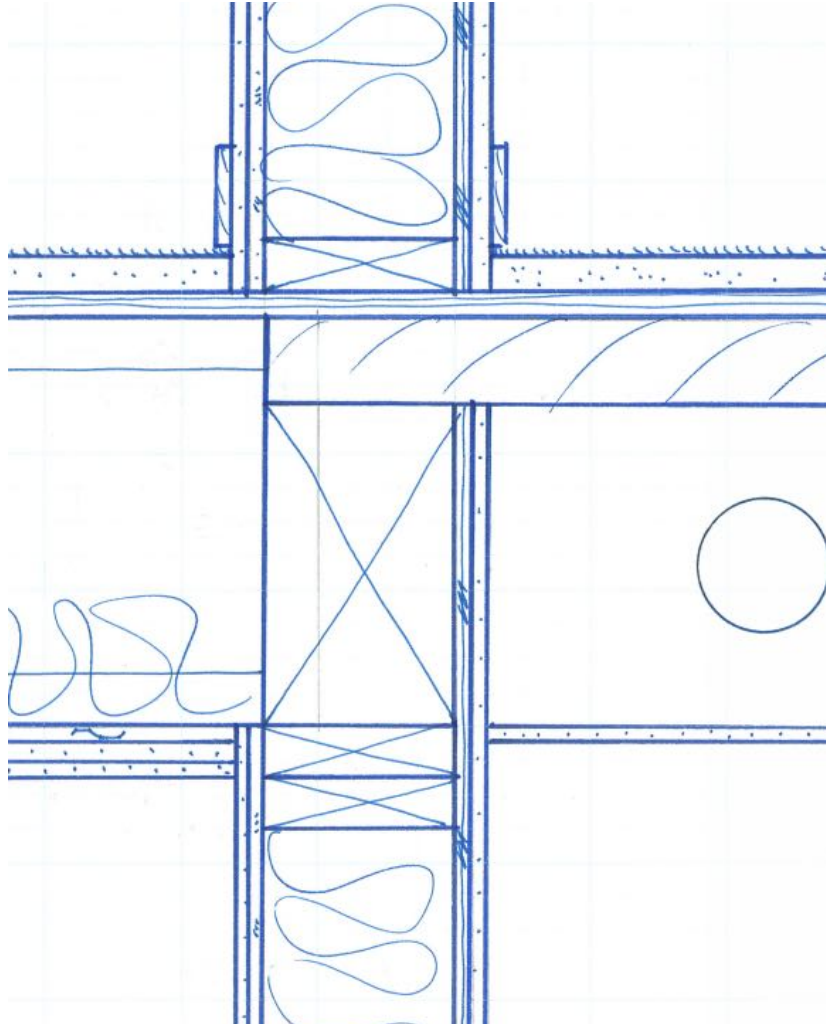
Corridor Ceiling Detailing

- 1 Hour Rated
- Heavy Timber Construction
- 3x Flooring
- MEPF Outside Rated Enclosure

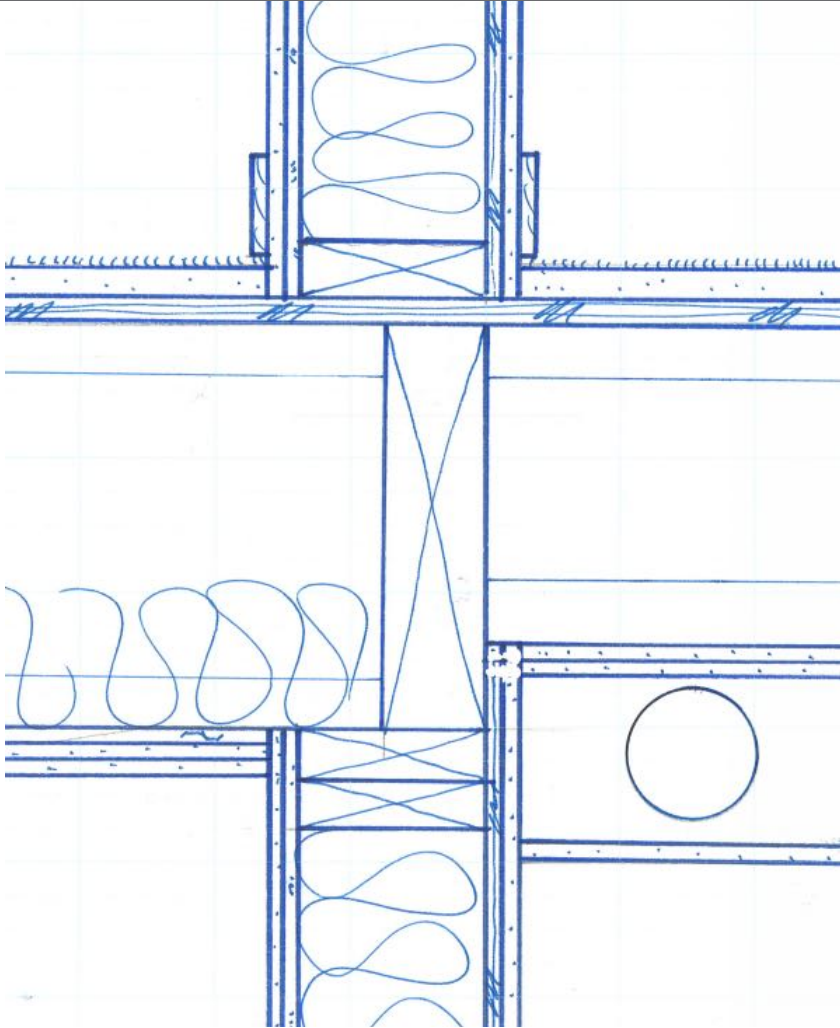
Corridor Ceiling Detailing

- 1 Hour Rated
- 9 ½" I Joists
- Dropped Ceiling
- MEPF Outside Rated Enclosure

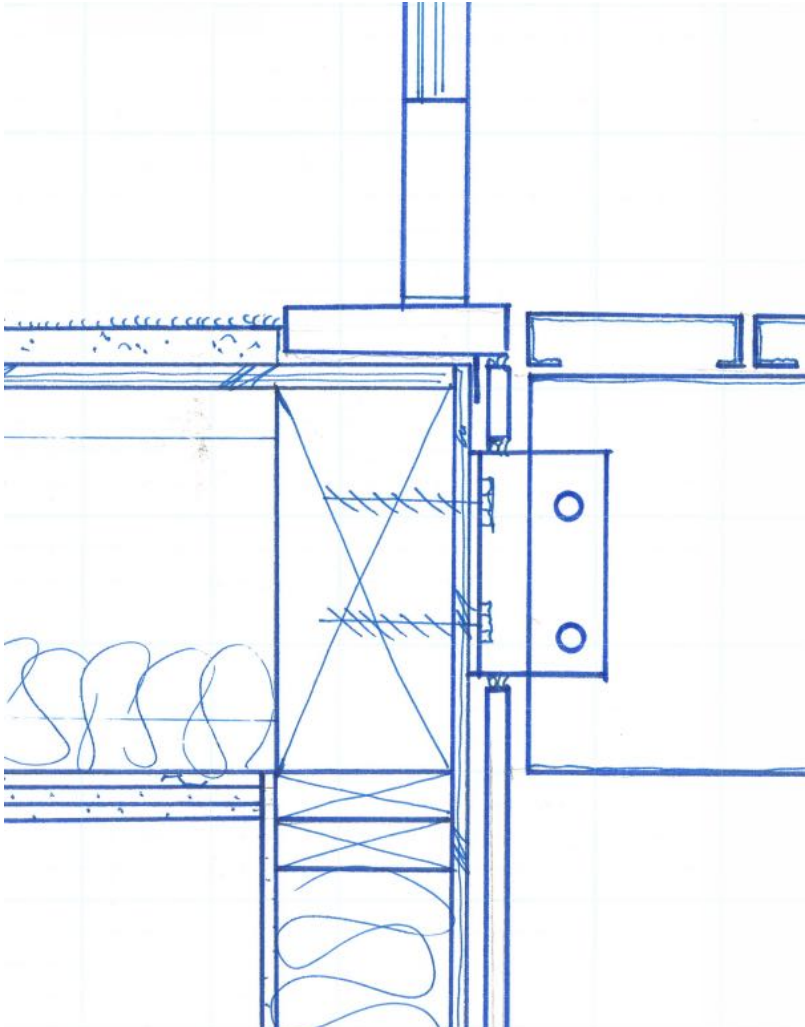
Balcony Detailing

- Bolt On Balcony
 - Aluminum or Steel
 - Sprinkler Requirements
 - Floor Area Implications

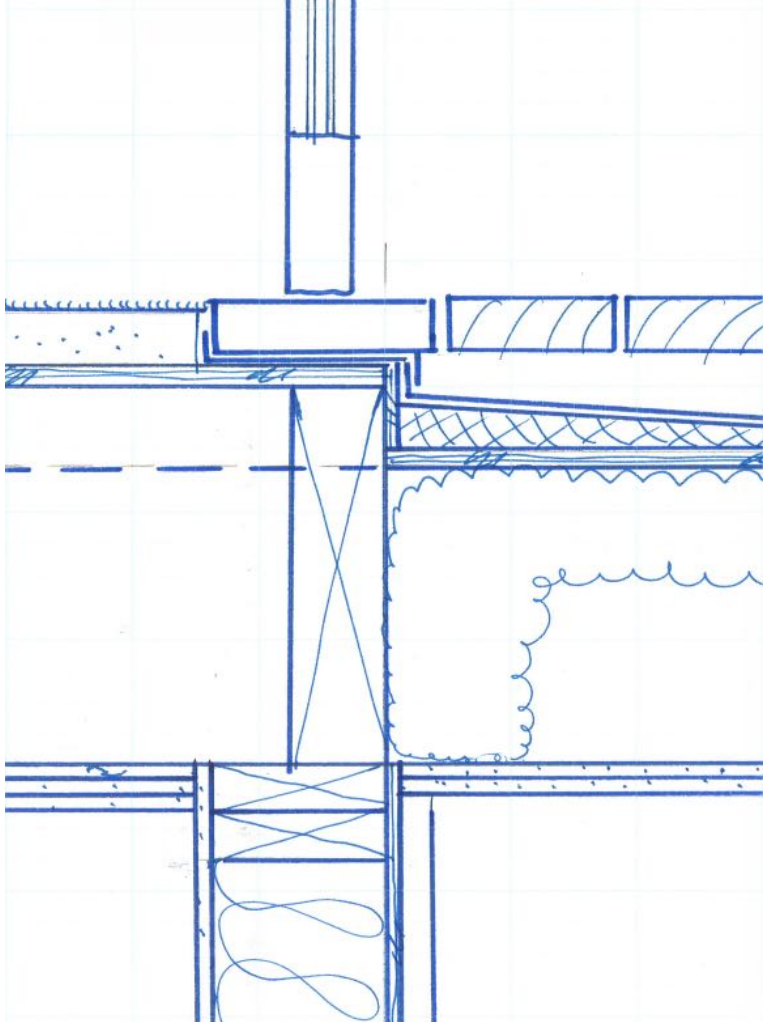
Balcony Detailing

- Framed Balcony
 - Decking Options
 - Review Tested Assemblies
 - Step and Slope Limitations
 - Review for Accessibility
 - Venting Requirements
 - Waterproofing Implications

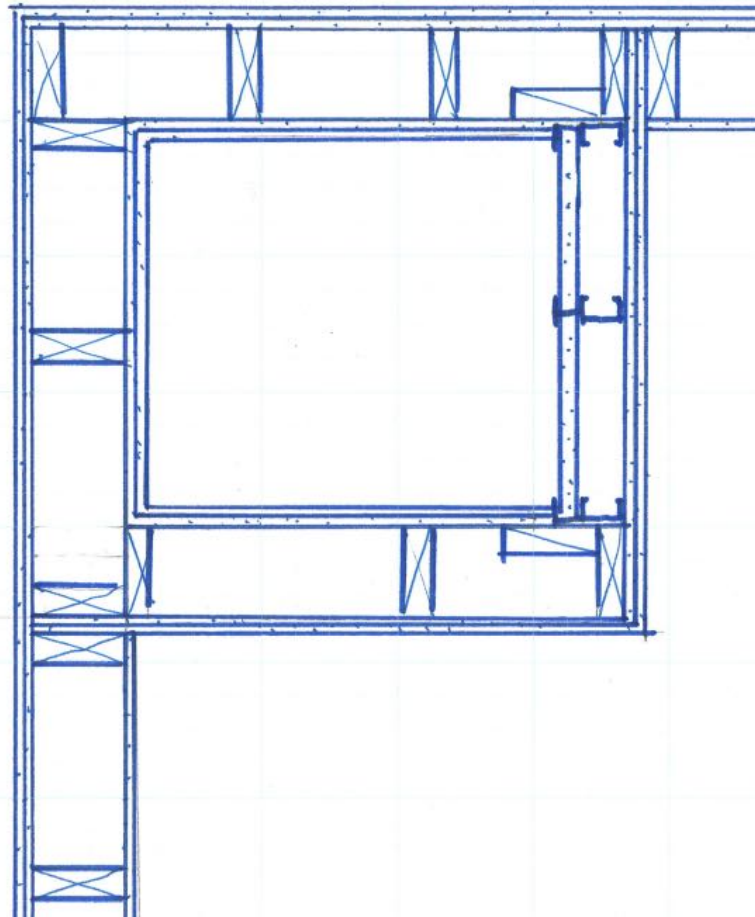
Shaft Wall Detailing

- Mechanical
 - 2 hour rating thru 1 hour wall
 - One side with shaft wall for access

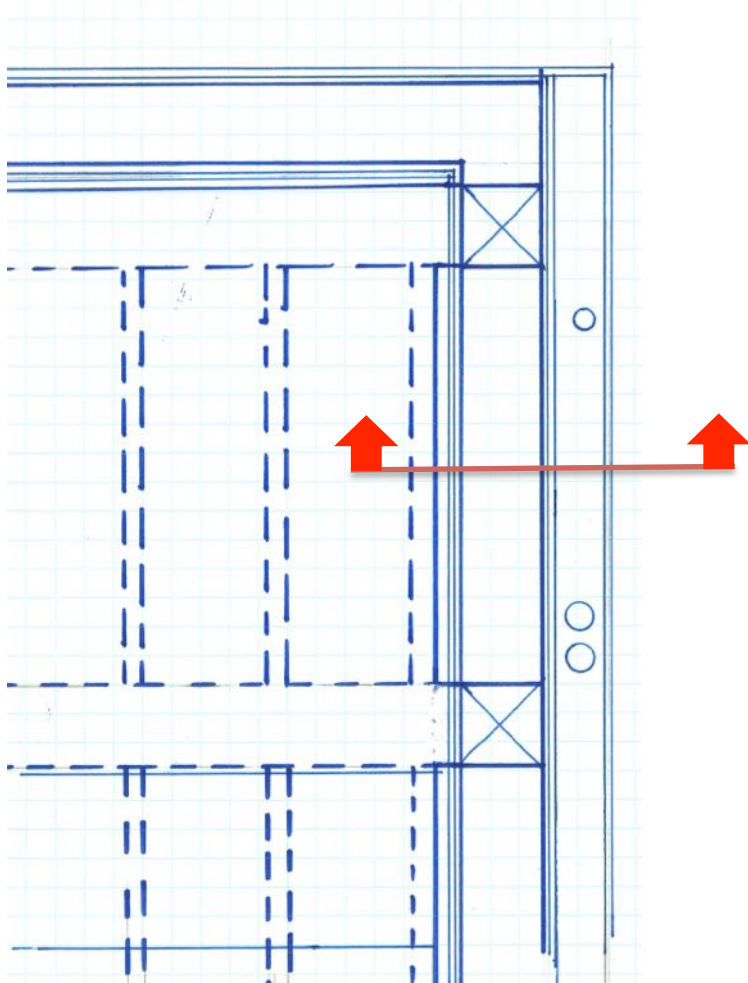
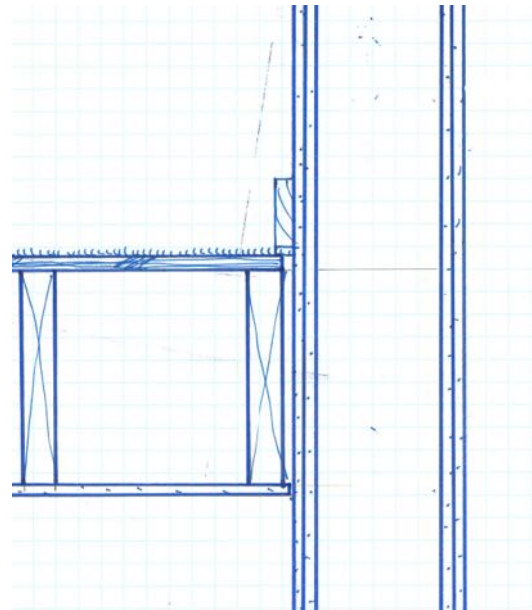
Shaft Wall Detailing

- Stair
 - Rating Continuous
 - Only Beams Penetrate Shaft
 - Secondary Stair Framing
 - Furred wall for MEPF
