Design review report

Code:	AE-33285	
Rev:	6	
Date:	2021-02-11	
Page:	1/ 8

Aim of this document is to describe suggestions and corrections that Telit advises to improve Ovoo Electronics B100AA application that integrates Telit GE910-QUAD V3 and BlueMod S50 modules.

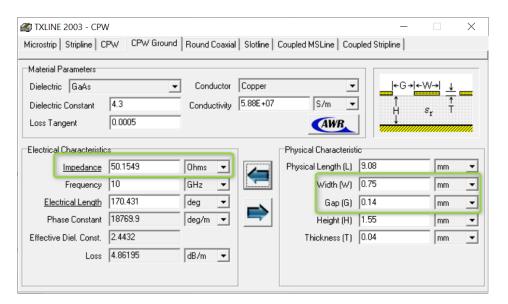
On B151BA PCB, RF line for the BlueMOD S50 module is a waveguide with characteristic impedance of about 50 Ohms. According to our calculations done assuming a **Er=4.3** of the pre-preg, the resulting impedance of your CPWGs is about **51,05 Ohm: too high**. The RF trace impedance must be 50 Ohms. For achieving 50 Ohm impedance, we recommend modifying RF copper trace Width(W) and Gap(G) to 0.75mm and 0.14mm, as shown below.
