Practical Detailing for Mid-Rise Wood Frame Buildings

Jon Hall AIA, Quality Management Director
February 23 & 24, 2016

GGLO DESIGN

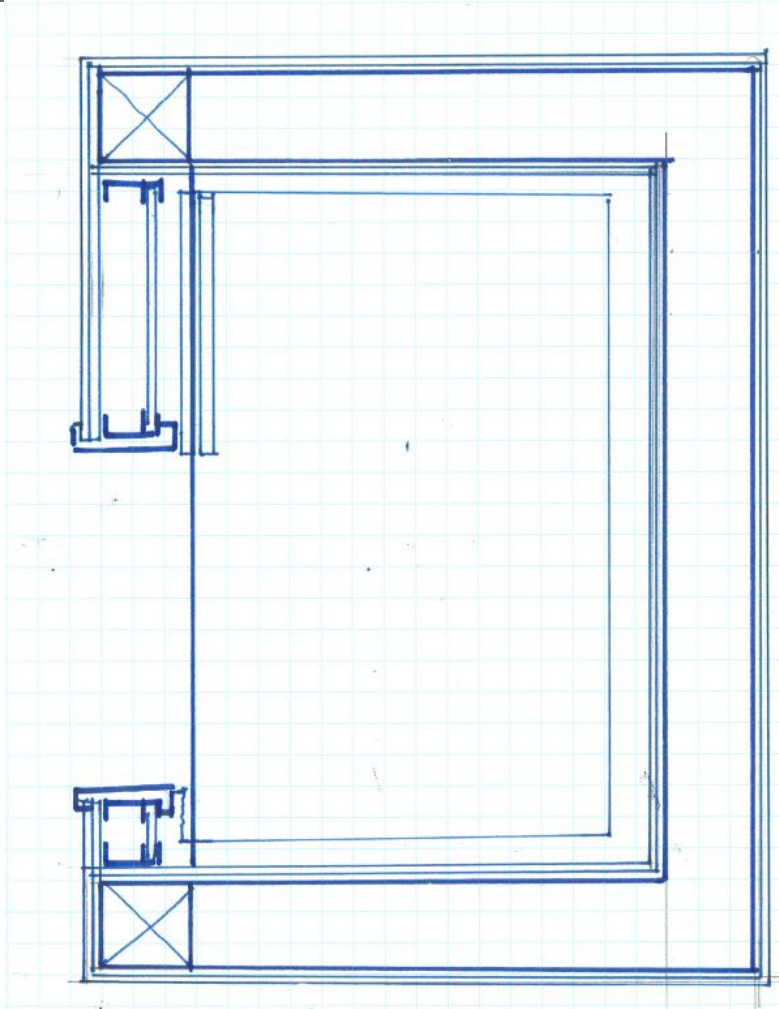
Shaft Wall Detailing

- Elevator
 - Beam at Door Opening
 - C-T Shaft Wall

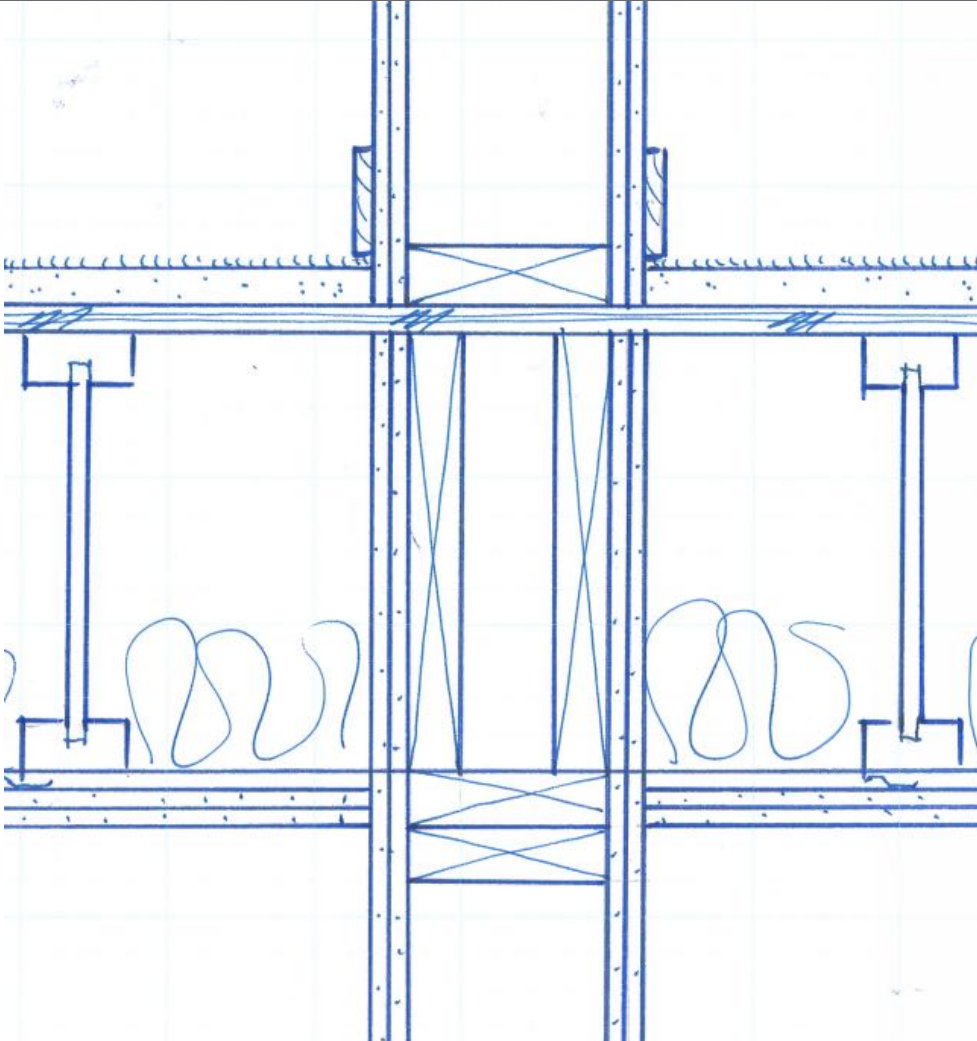
Fire Wall Detailing

- Structurally Dependent
 - Seattle Only

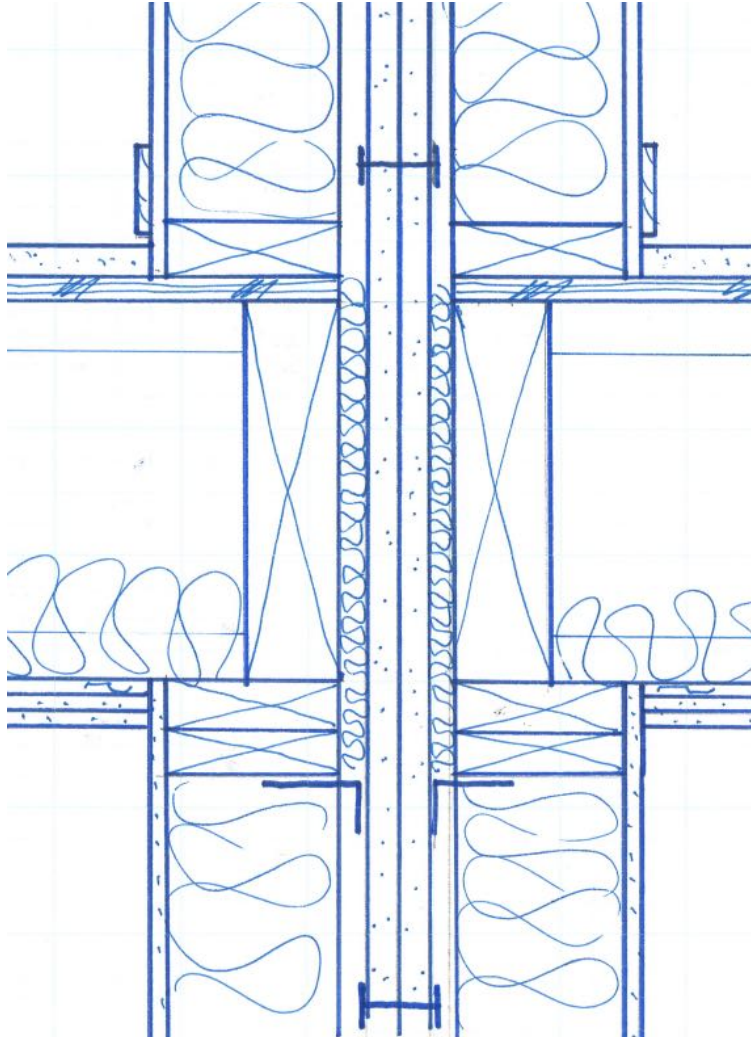
Fire Wall Detailing

- Structurally Independent
- UL U336
 - (2) 1" Shaft Wall
 - H Studs
 - $\frac{3}{4}$ " Air Gap
 - Non rated wood walls
 - Breakaway clips

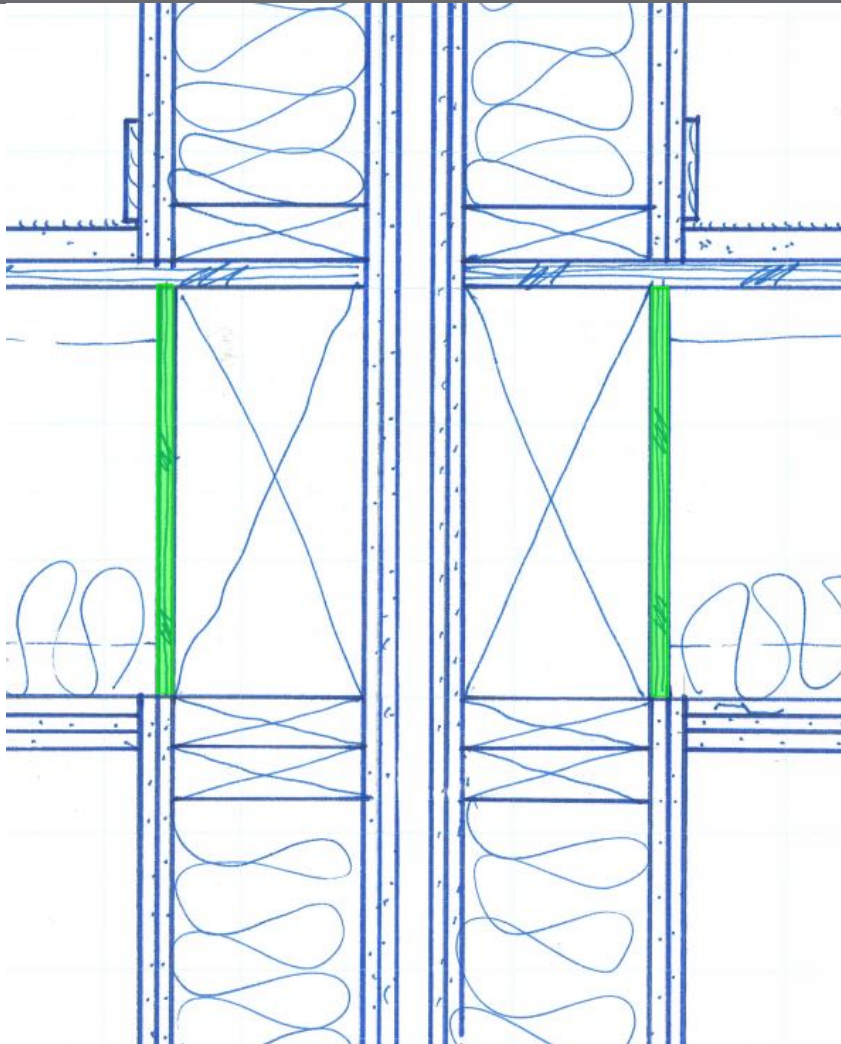
Fire Wall Detailing

- Structurally Independent
- Two Wood Frame Walls
- Plywood Non-continuous
- Fire Coated Plywood at Rim

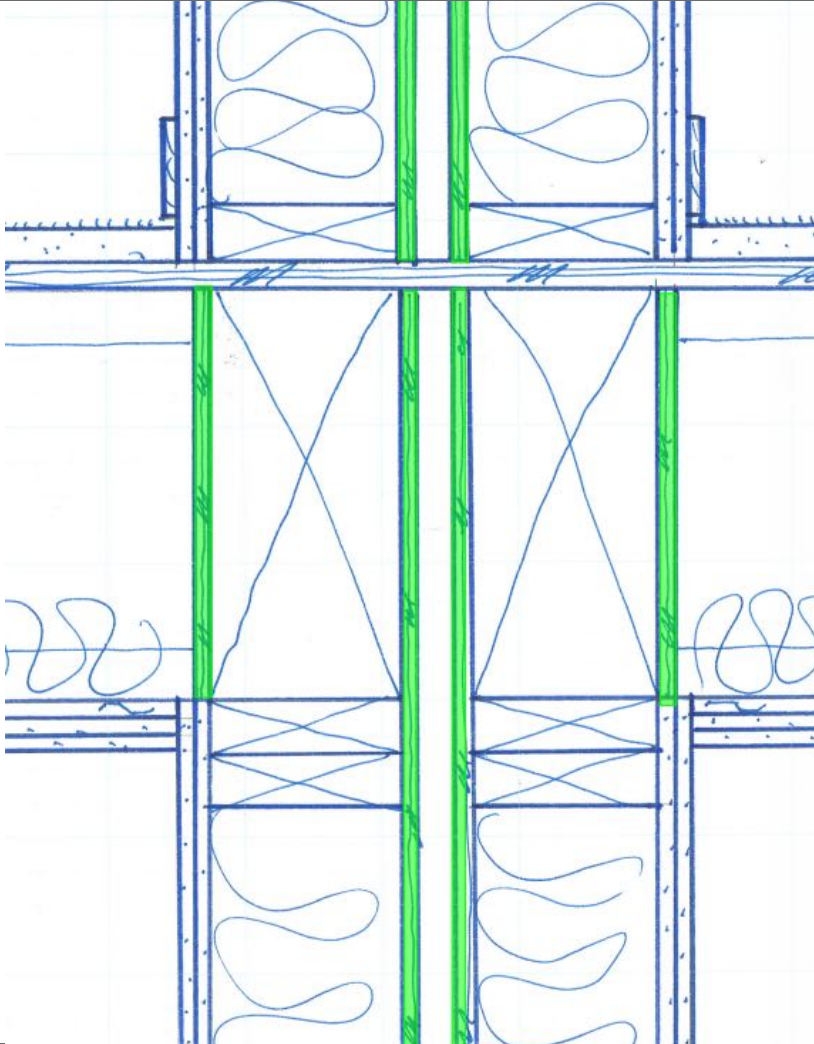
Fire Wall Detailing

- Structurally Independent
- Two Wood Frame Walls
- Plywood Continuous
- Fire Coated Plywood at Rim
- Fire Coated Plywood at Wall Gap

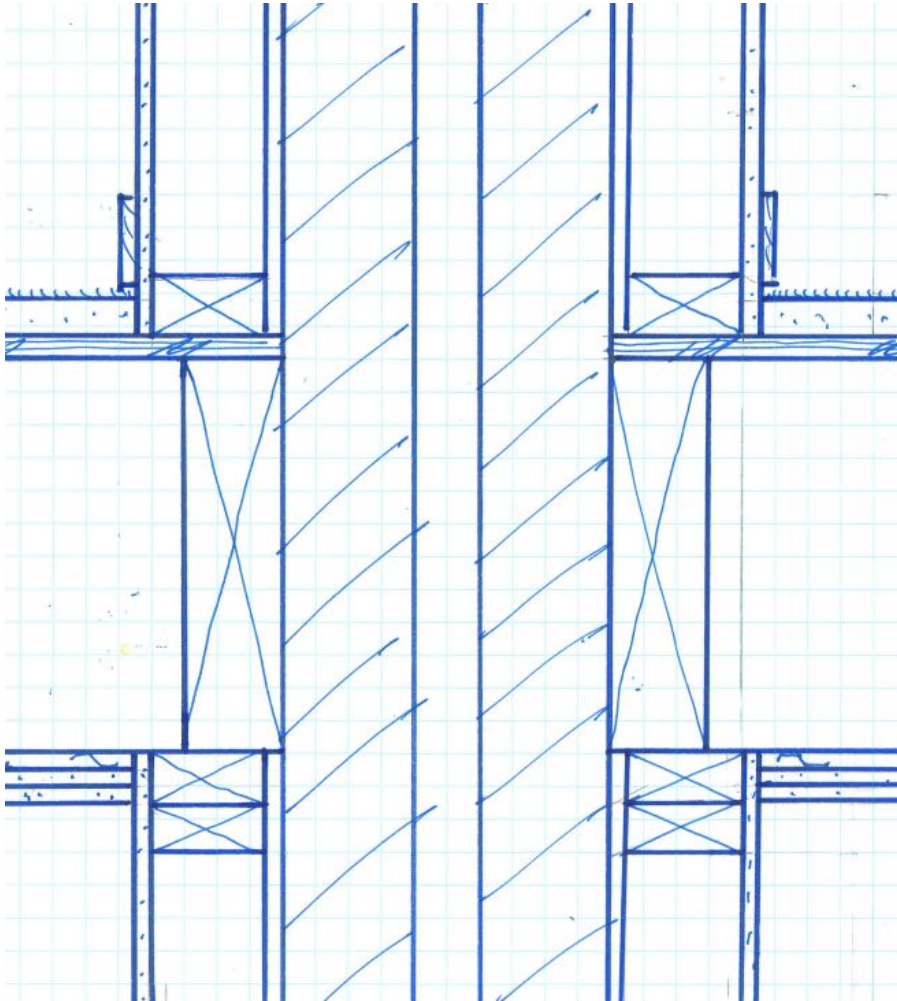
Fire Wall Detailing

- Structurally Independent
- Masonry Walls
- Furred Plumbing Walls

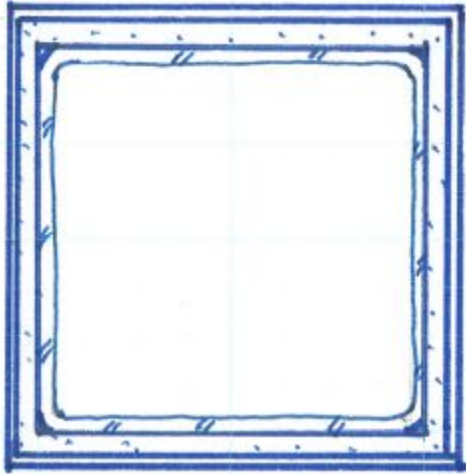
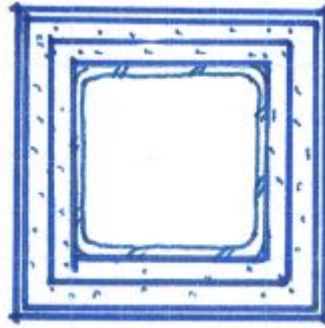
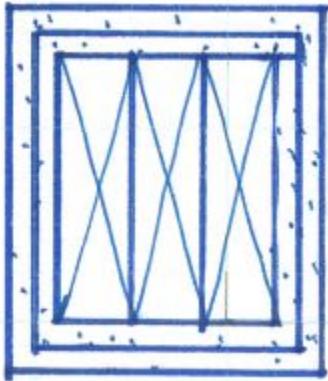
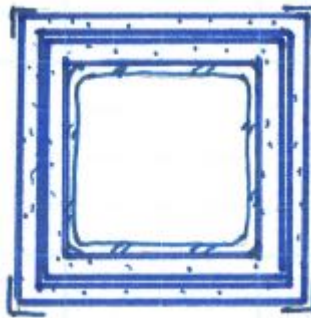
Structural Column and Beam Detailing

- Column Protection
 - 8x8 = 1 layer GWB w/ cover
 - 4x4 = 2 layers GWB w/ cover
 - Wood = ?

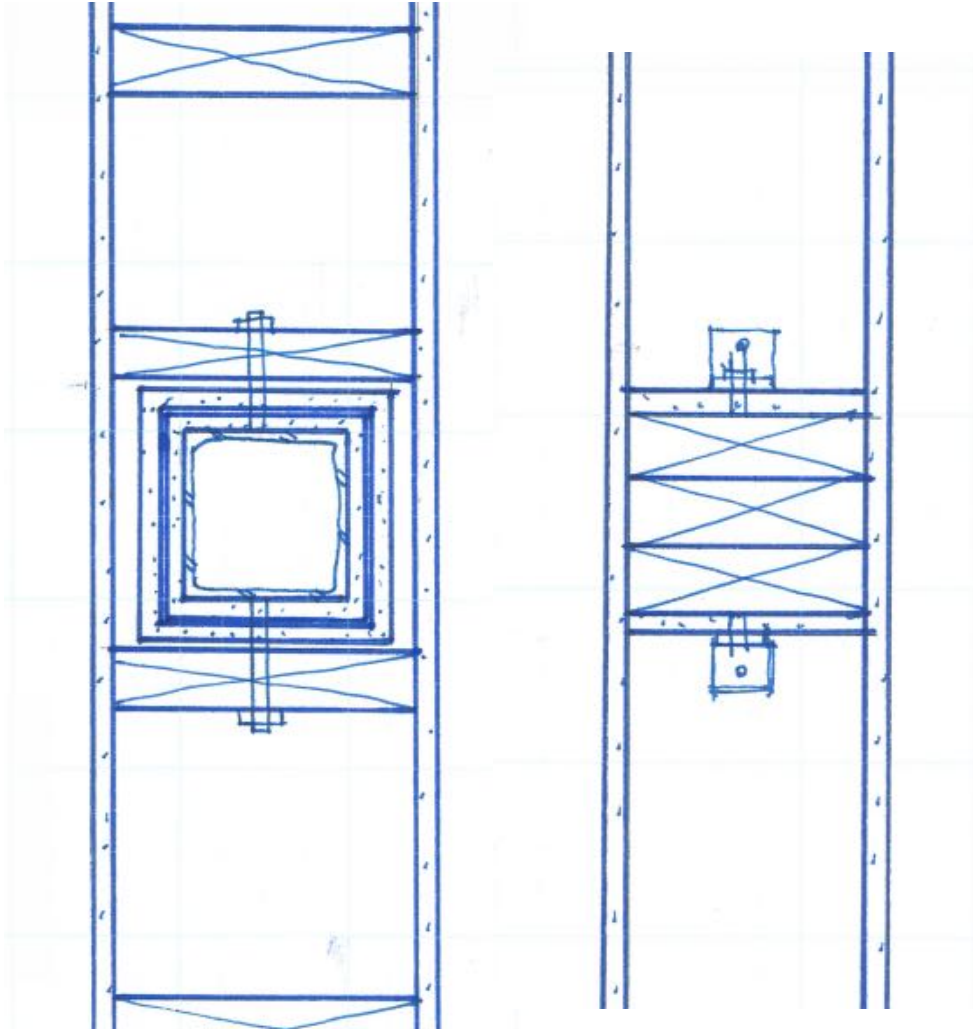
Structural Column and Beam Detailing

Column Protection

- 4x4 = 2x8 wall minimum
- Wood = ?

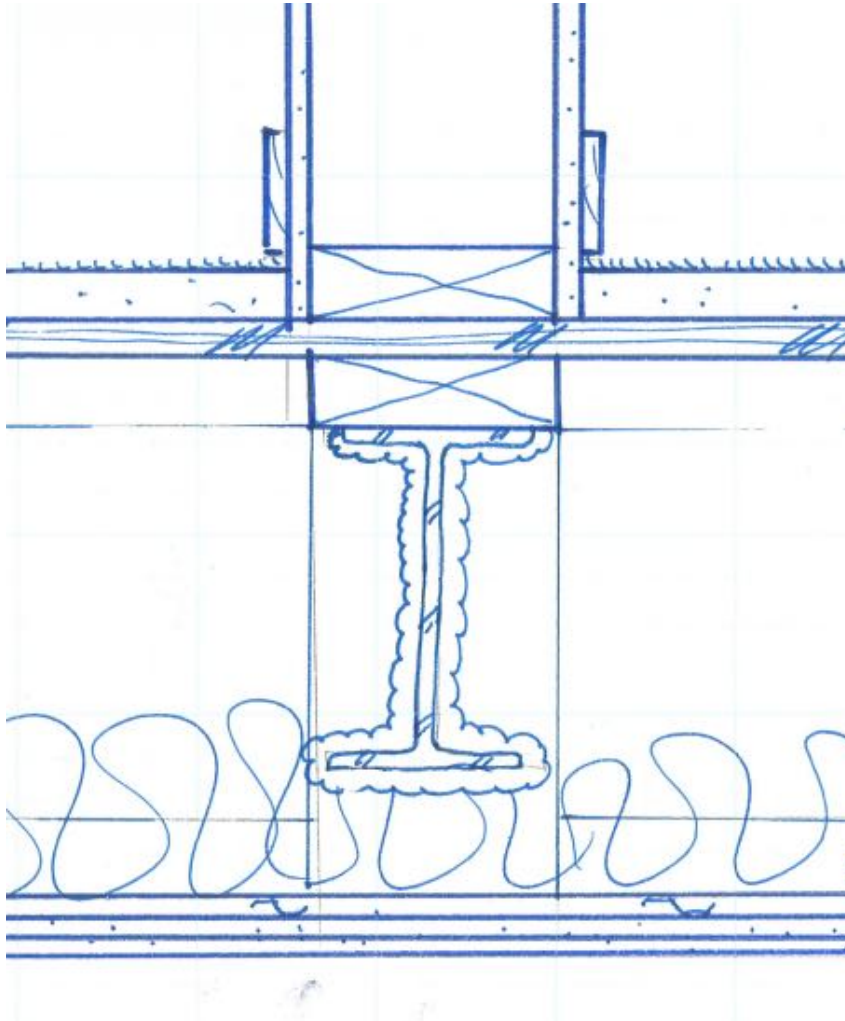
Structural Column and Beam Detailing

- Beam Protection
 - Spray Applied Fire Resistive Material
