FIT PM12
Hardware test dossier

LEGACY-SN1803-UNBOUND

HISTORICAL — full dossier

INCOMPLETE / NOT RELEASED

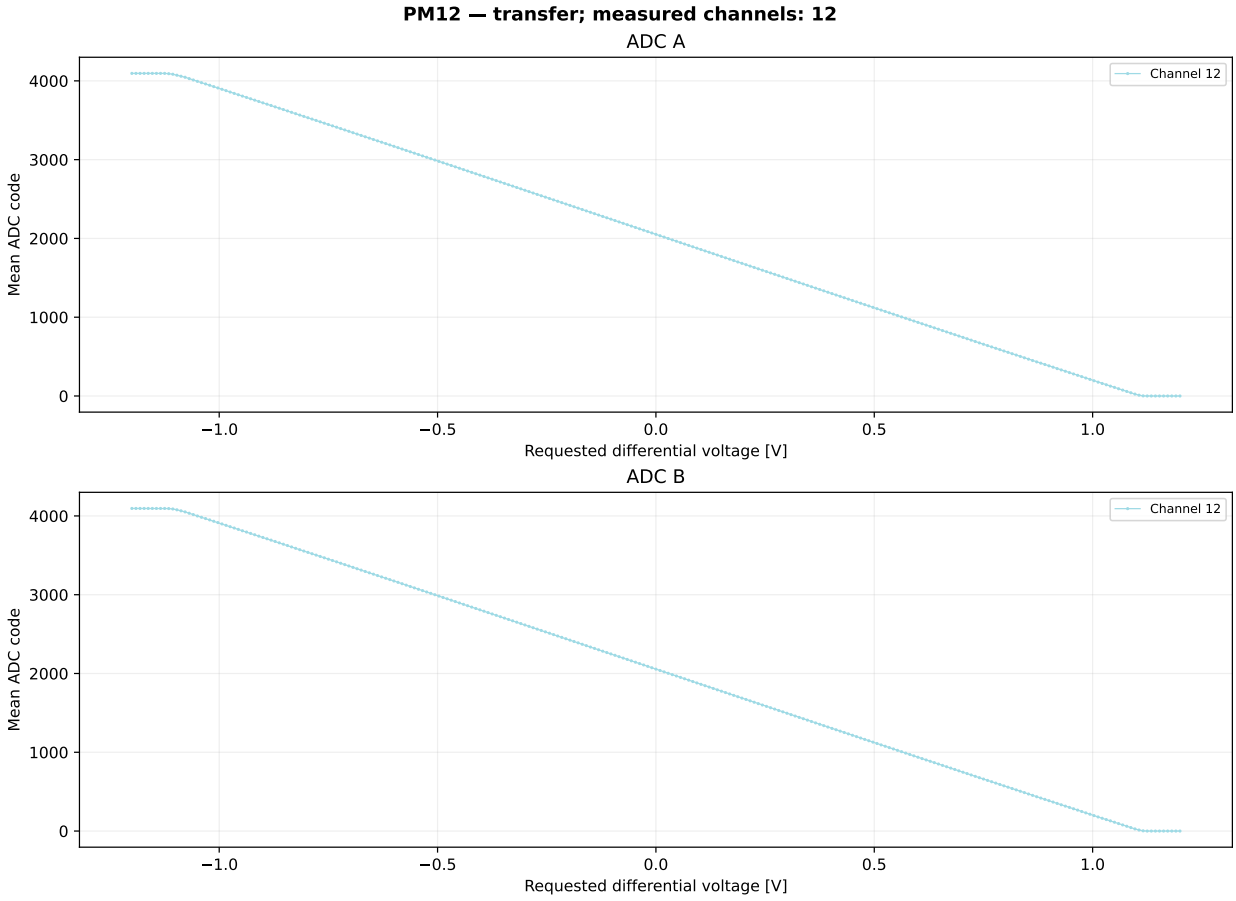
6 CFD and ADC — channel comparison

All measured channels share one overlay per observable, with a fixed channel color and common axes. ADC A/B occupy separate panels. No line is invented for an unmeasured channel. The twelve-channel requirement is independent of the number of connected simulators in a batch.
