CHAPTER 1

Introduction and Purpose of Study

1.1 INTRODUCTION

1.2 PURPOSE AND GOALS OF THIS STUDY

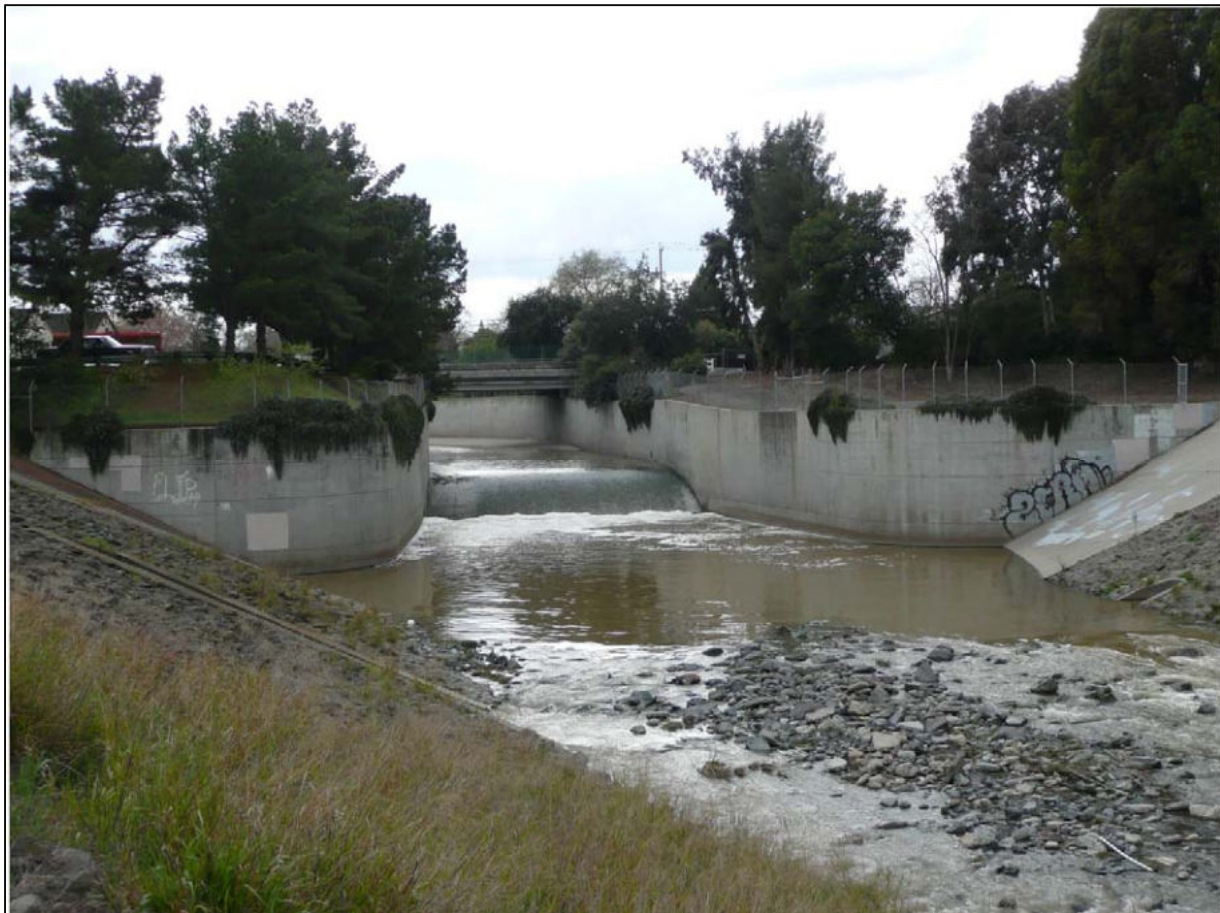
Figure 1-1. Drop Structure 2 at a Relatively Low Flow

Eight people have drowned in the Walnut Creek Flood Control Channel System (WCFCCS), which includes Drop Structure 2 (shown in Figure 1-1) since the WCFCCS was constructed in the 1960s. Additionally, one fire fighter was injured while rescuing a victim from the channel.

At Drop Structure 2, just downstream of Bancroft Road, the water flows from the upstream concrete channel over a 20 foot drop, flows through a stilling basin (to slow the water down) and then up-wells by 8 feet into the downstream earthen lined channel. This results in an overall drop of 12 feet (also see the front cover of this report).

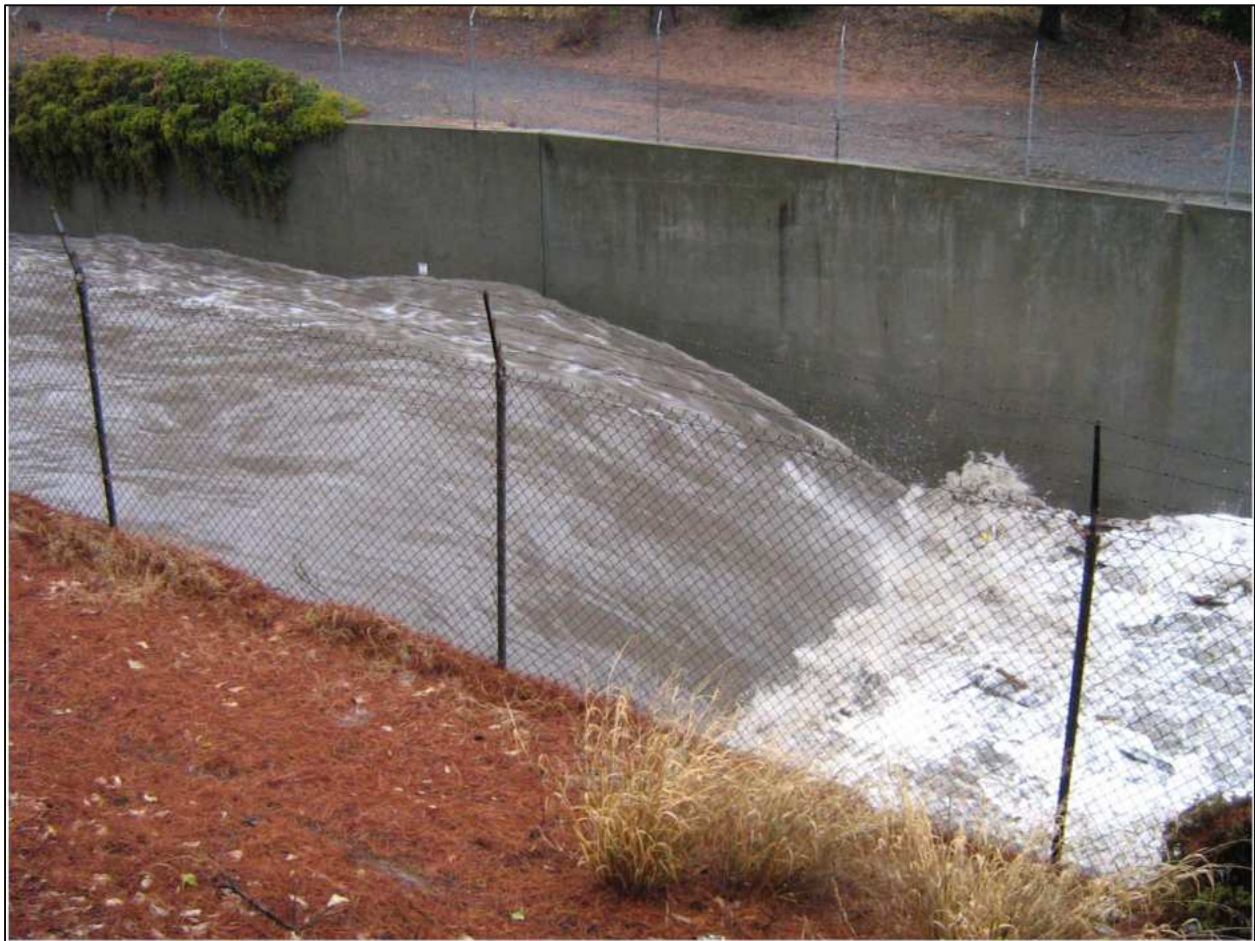
Figure 1-2. Drop Structure 2 at a Flow Rate of about 1,500 cfs on December 13, 2009

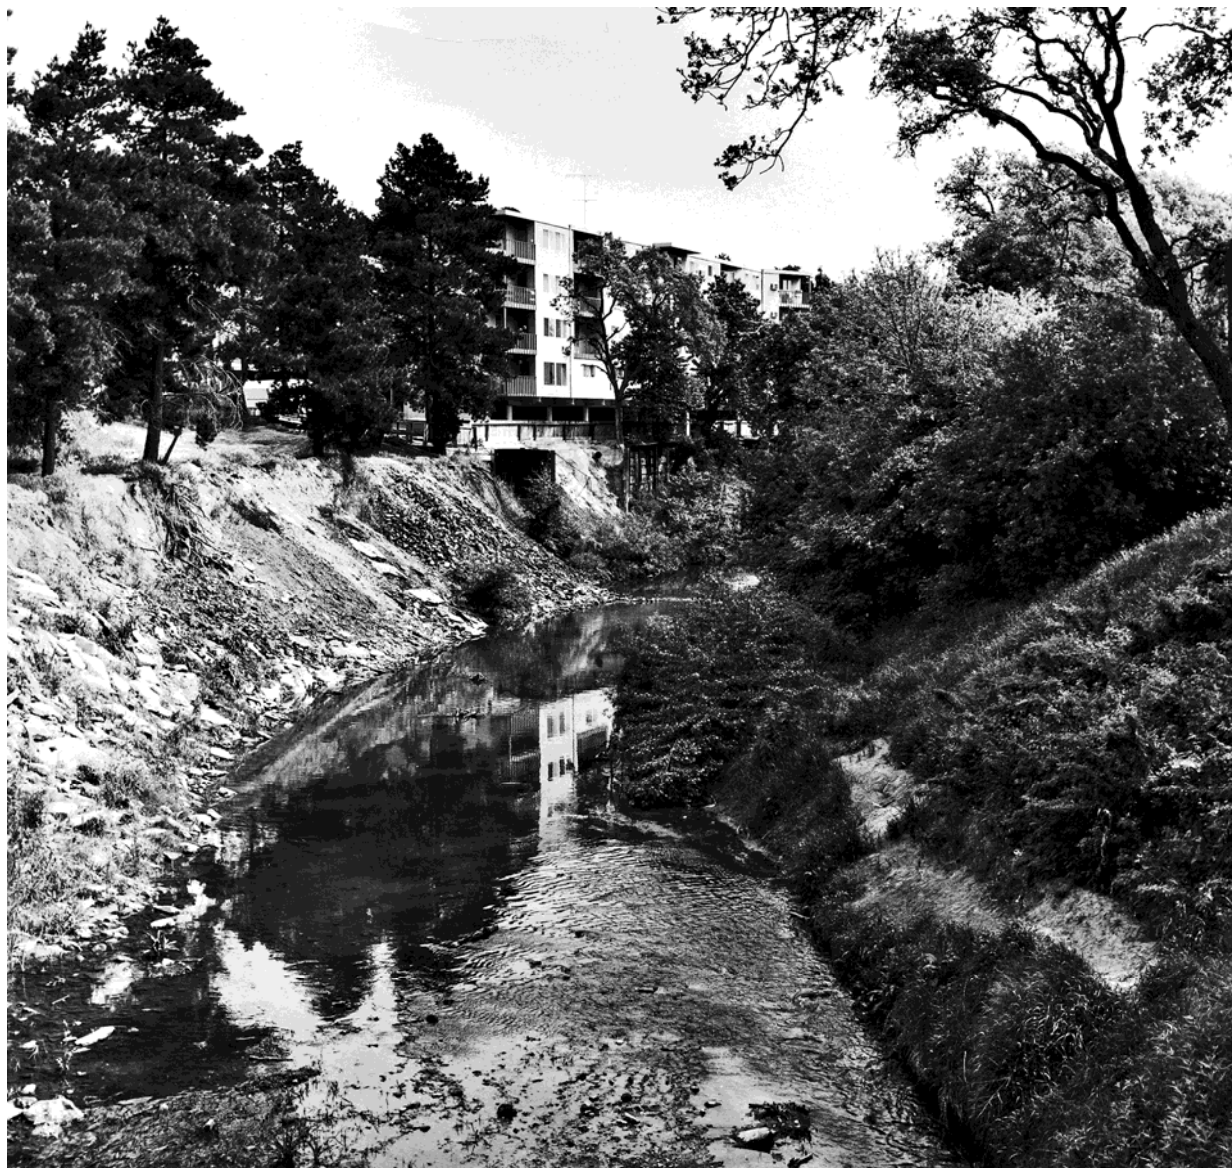
Figure 1-7
CCCFCWCD

Walnut Creek from the old railroad bridge in Civic Park, looking south. Walnut Creek was severely eroding its channel banks, leading to risk of undermining an existing apartment building
