MT7681 Uart Firmware Upgrade SOP

V0.06

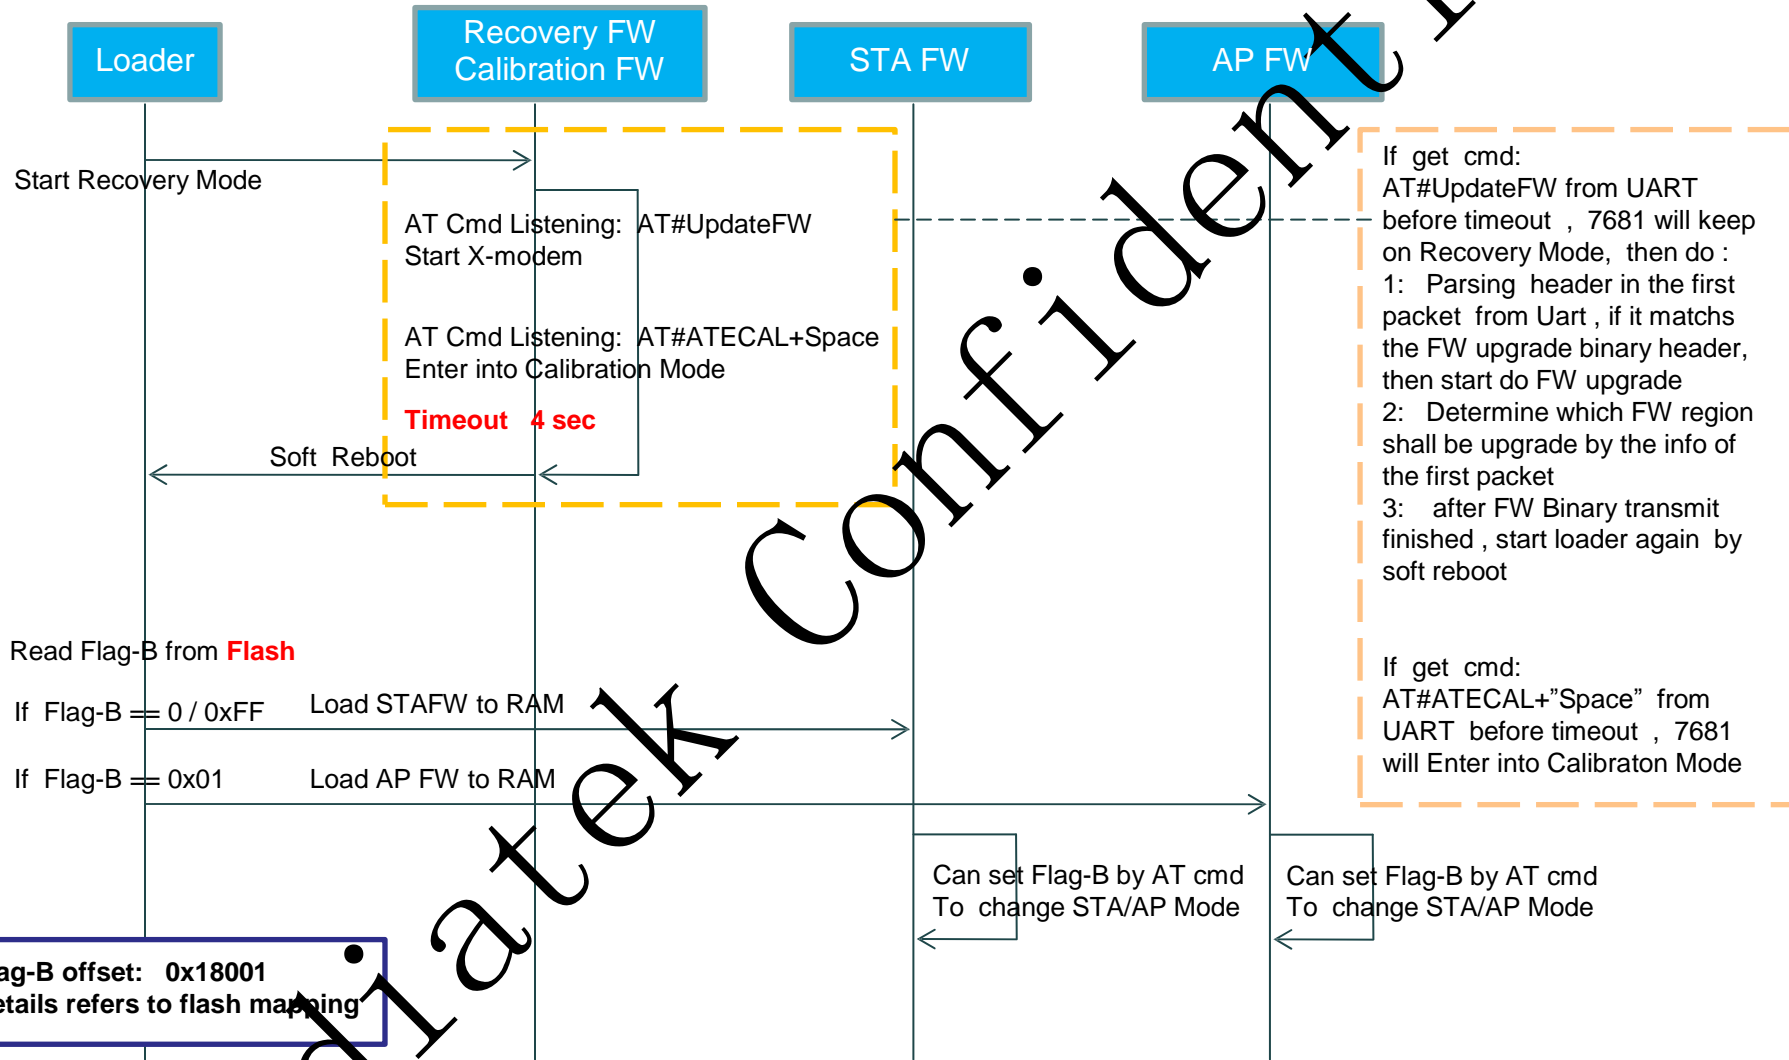
Uart FW Upgrade Flow

Power On

- As description on the chart of "FW Boot Flow"
FW Upgrade by Uart is implemented by Recovery FW,
so FW Upgrade by Uart is only available while Loader + Recovery FW existed in Flash

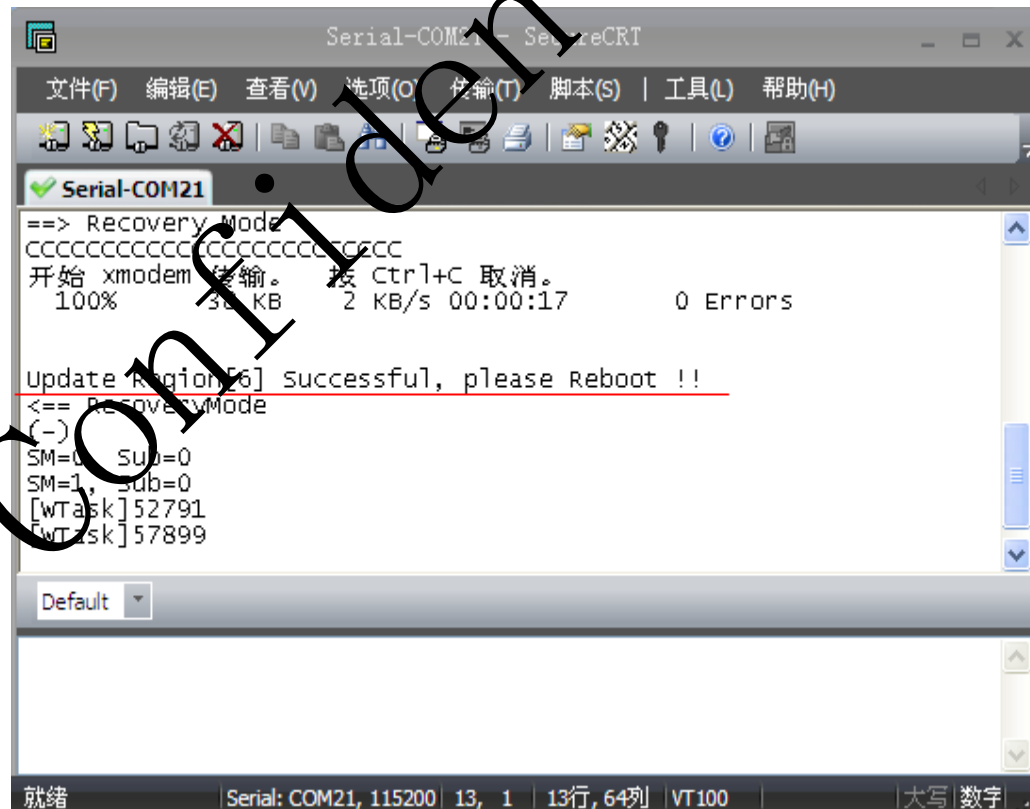
- Step 3: while Binary transmit finished

Show "update Region[N] Successful, please Reboot! "

if upgrade fail, it will show msg

like this : "Err : 205 "

it could be caused by flash write fail

or transmitted FW has an illegal header

```
Serial-COM21 - SecureCRT
文件(F) 编辑(E) 查看(V) 选项(O) 传输(T) 脚本(S) | 工具(L) 帮助(H)

Serial-COM21
==> Recovery Mode
CCCCCCCCCCCCCCCCCCCCCCCC
开始 xmodem 传输。按 Ctrl+C 取消。
100% 36 KB 2 KB/s 00:00:17 0 Errors
