CCPIA

8725 W Amarillo Blvd
Amarillo, TX 79124

Toby Torres
05/19/2026

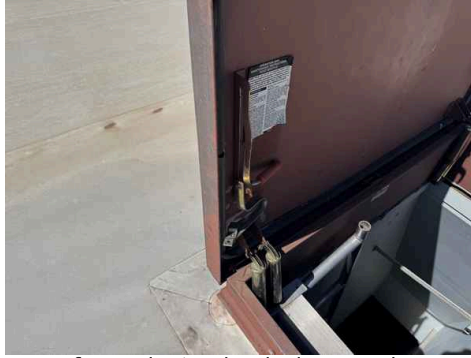
DAMAGED ROOF HATCH

The roof hatch shows signs of damage that compromise its function and weathertightness. This was observed during the roof inspection. Damage to the hatch can allow water infiltration into the building interior and may create a safety hazard when accessing the roof.

Weight assist pistons damaged

Keep from closing latch damaged

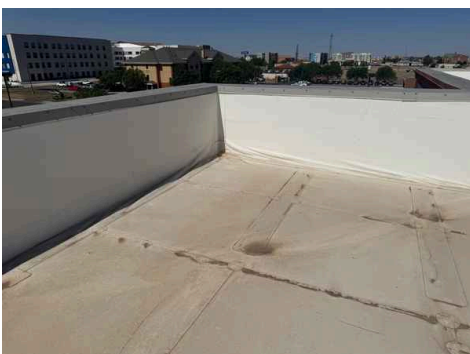
DAMAGED (GENERAL)

Roof coverings showed moderate damage. Recommend a qualified roofing professional evaluate and repair.

Contact a qualified roofing professional.

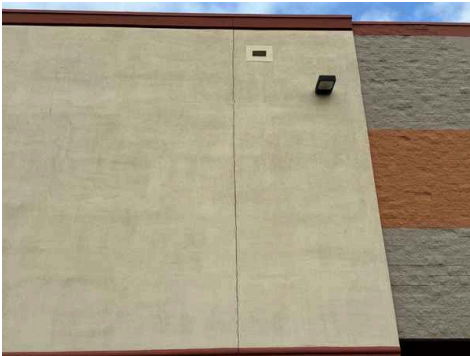
Front

CRACKS IN STUCCO

Cracks were observed in the stucco siding during exterior inspection. Stucco cracks can allow water infiltration behind the siding, potentially leading to moisture damage, mold growth, and structural deterioration.

Recommendation
Contact a qualified professional.

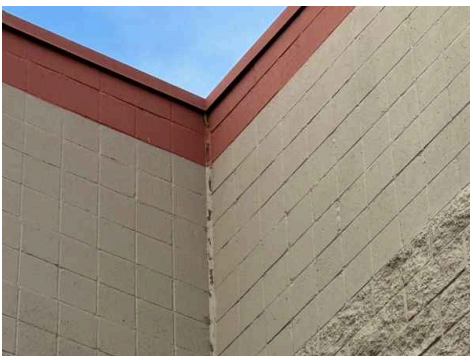
Right

SEPARATION AT EXPANSION JOINTS

Separation observed at expansion joints in the siding and trim during exterior inspection. Expansion joints are designed to allow materials to move with temperature and humidity changes without cracking. When separation occurs, it can allow water infiltration behind the siding, potentially leading to moisture damage, rot, or structural deterioration over time.

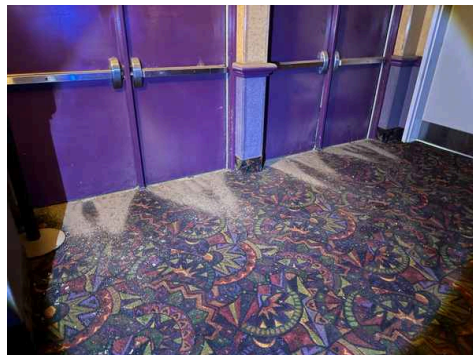
POOR WEATHER STRIPPING

Weather stripping around exterior doors and windows is deteriorated, allowing dirt infiltration. This compromises the seal intended to prevent air and moisture leakage. Worn weather stripping should be replaced to restore proper protection and energy efficiency.

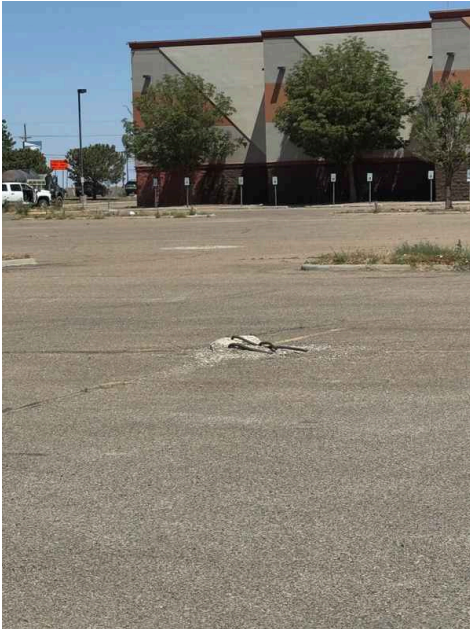
FRONT

DAMAGED/MISSING LIGHT POLES

Multiple light poles in the parking lot are damaged or missing. This creates safety and security concerns for property users accessing the lot at night.

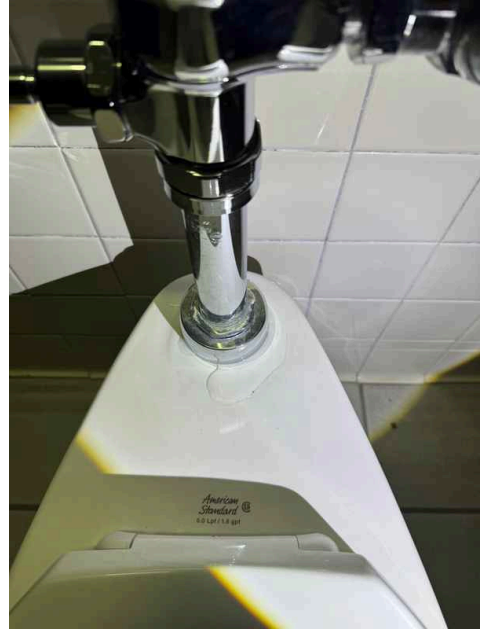
Woman's Lobby Bathroom- Handicap Stall

LEAKING TOILET CONNECTION

A leak was observed at the metal-to-porcelain connection point on a commercial toilet during inspection. This connection failure can lead to water damage to surrounding flooring and substructure, as well as potential mold growth if not addressed promptly.

Contact a qualified professional.

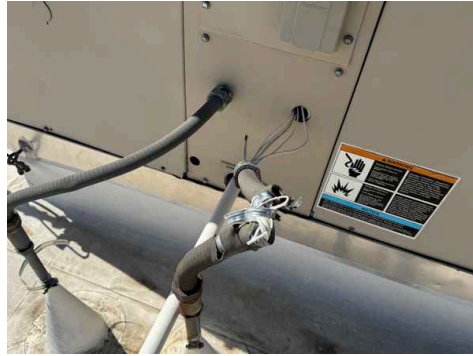
DAMAGED CONDUIT

Damaged electrical conduit was observed during inspection of the branch wiring circuits and breaker system. Conduit damage can expose live electrical wires, creating a shock hazard and potential fire risk.

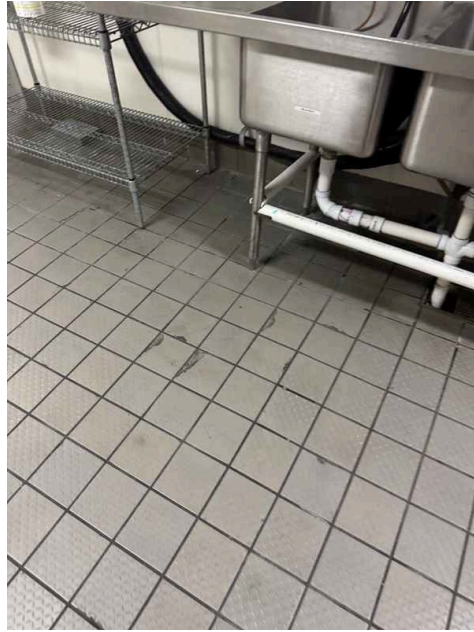
DAMAGED ANTI-SLIP TILES

Anti-slip tiles on the floor surface show signs of damage. Deteriorated anti-slip coating or cracked tiles reduce traction and create a slip hazard for occupants.

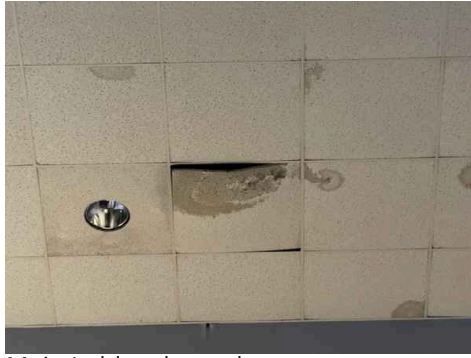
2nd Floor Left

STAIN(S) ON CEILING

There is a stain on ceiling/wall that requires repair and paint. Source of staining should be determined.

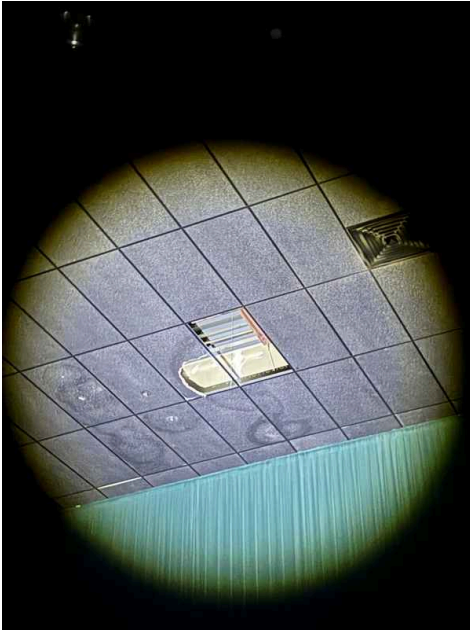
Theater 11

DAMAGED CEILING TILES

Ceiling tiles are observed with damage during inspection. Damaged tiles may indicate water intrusion, impact damage, or deterioration from age or moisture exposure. Tiles should be inspected for the source of damage and replaced to maintain proper ceiling integrity and appearance.

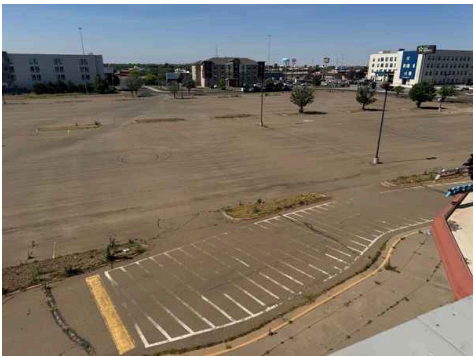
The Elevator was in the keyed-off position with no key present. There is no certification notice in the car.

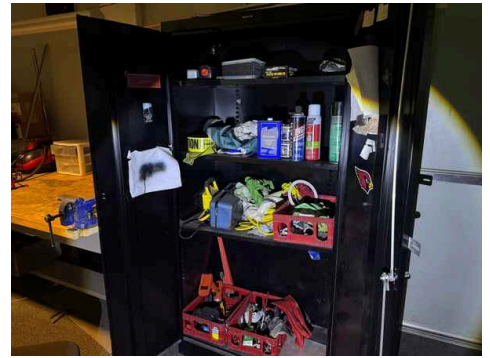
Right Camera Room

Flammable and combustible materials were observed stored improperly during the inspection. Improper storage of these materials creates a significant fire hazard and may pose health risks to occupants. All flammable chemicals should be stored in approved, labeled containers in a designated, well-ventilated area away from ignition sources.

Contact a qualified professional.

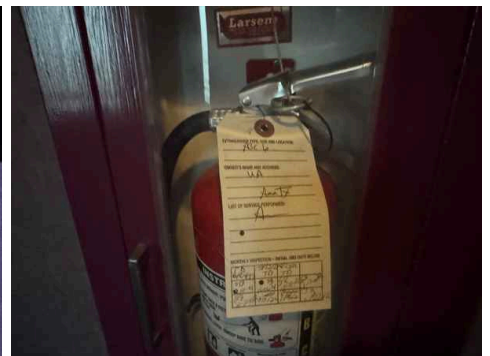
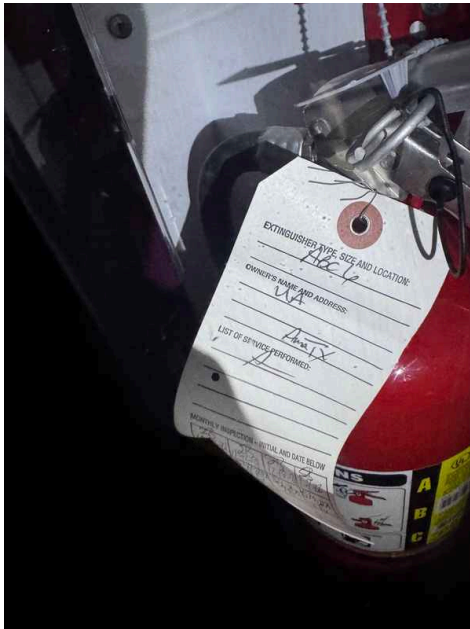
OUT OF DATE TAGS

Observed fire extinguisher tags that were beyond inspection date or did not have an inspection date.

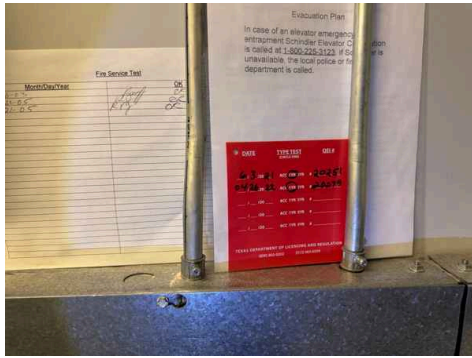
Theater 9

MISSING EXIT SIGN

Contact a qualified professional.

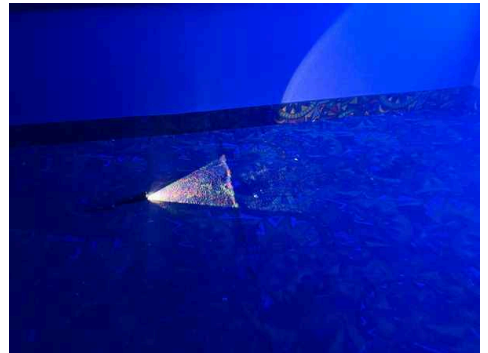
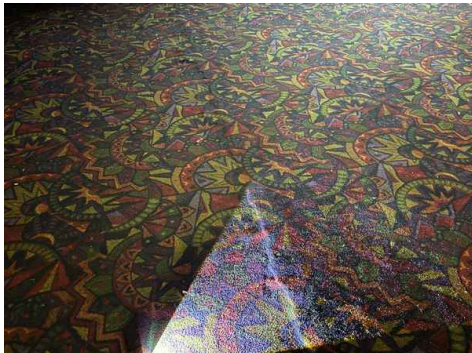
MULTIPLE ENTRAPMENTS PRESENT

Damaged flooring has resulted entrapments that need to be removed for ADA compliance.

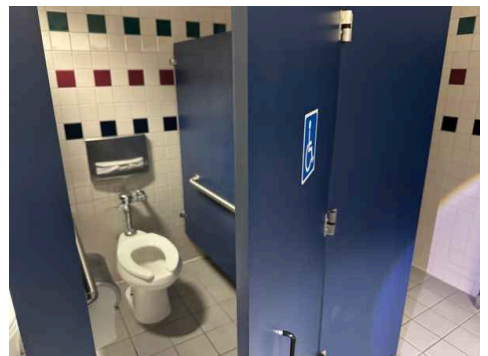
The Smaller Handicap Stall in Left Men's restroom

The Toilet did not have proper clearance for wheel chair.

Contact a qualified professional.
