MT7681

802.11 b/g/n single chip

MT7681 Uart Firmware Upgrade SOP

V0.06

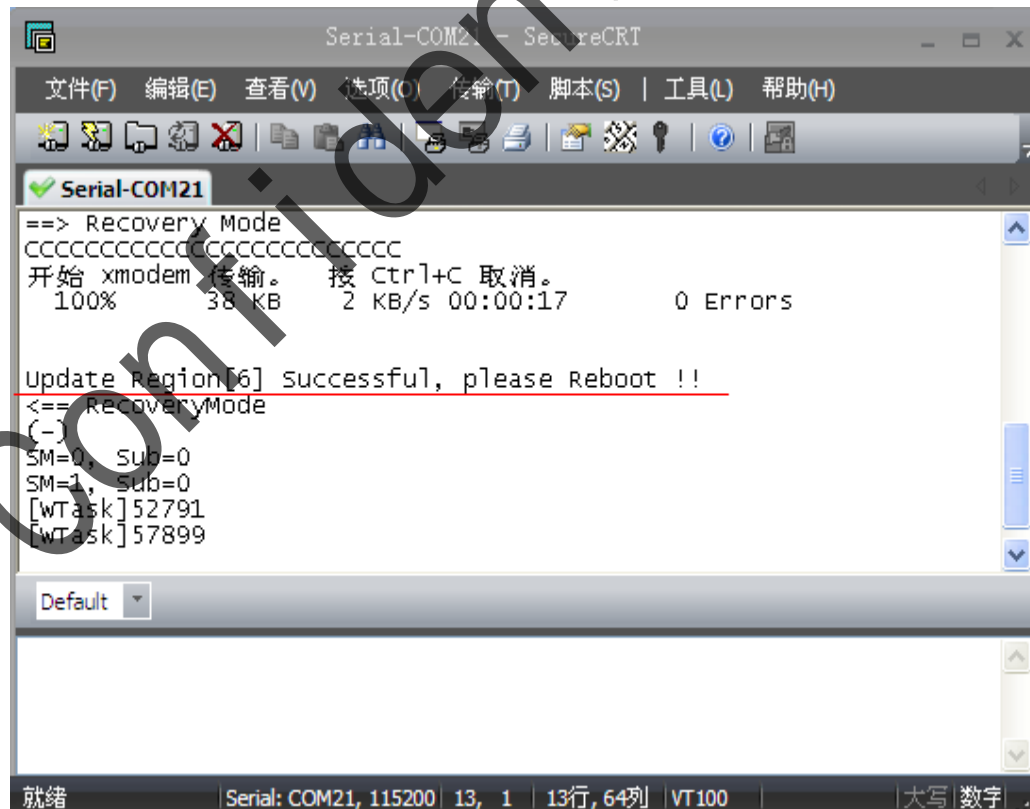
- Step 3: while Binary transmit finished

Show "update Region[N] Successful, please Reboot! "

if upgrade fail, it will show msg

like this : "Err : 205 "

it could be caused by flash write fail

or transmitted FW has an illegal header

```
Serial-COM21 - SecureCRT
文件(F) 编辑(E) 查看(V) 选项(O) 传输(T) 脚本(S) | 工具(L) 帮助(H)

Serial-COM21
==> Recovery Mode
CCCCCCCCCCCCCCCCCCCCCCCCCCCC
开始 xmodem 传输。 按 Ctrl+C 取消。
100% 38 KB 2 KB/s 00:00:17 0 Errors
