CERTIFICATE OF THOROUGH EXAMINATION OF LIFTING GEAR

Certificate No:
N143DHJ0

Name and Address of the Owner: M/s. SULZER ROTATION EQUIPMENT SERVICES DOHA, STATE OF QATAR	Place of Inspection: DUTEST YARD, INDUSTRIAL AREA DOHA, QATAR W.O# 17462209530 DNV Order No.: A1961956
Manufacturer OR Supplier: DUTEST QATAR W.L.L	Reference Standard: BS EN 13155:2020

Subject: Plate Clamp

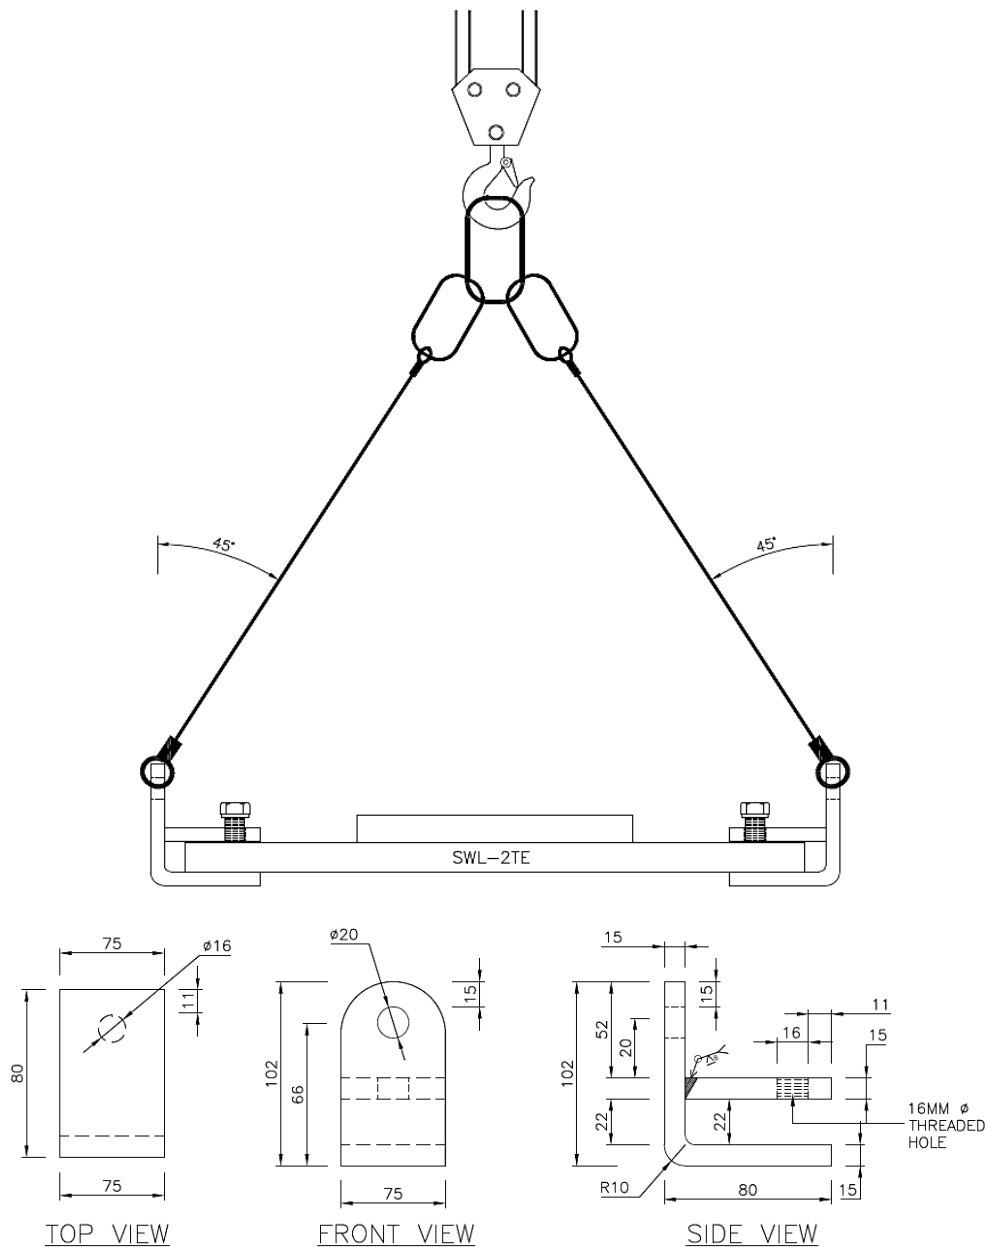
Figure 4.1: Details of Plate Clamp

- (2) As shown in Figure 4.1 above, the vertical load of 2 tonnes will be lifted using two plate clamps with sling angle from vertical of 45° (maximum). This is considered as the final and maximum loading condition. It is the responsibility of the client to ensure that

the actual lifting operation will not involve loads that could potentially results to stress greater than the design loading condition as permitted in BS EN 13155:2020. Such condition deemed beyond the scope of this design review.

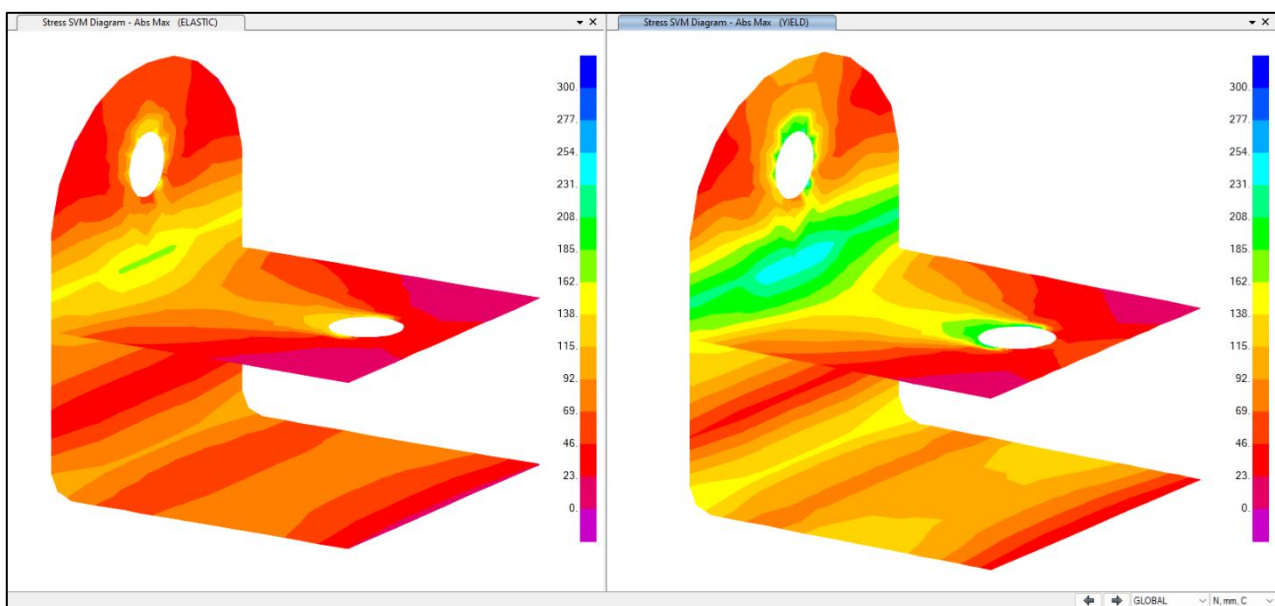
Figure 4.2: Von Misses stresses in Plate Clamp at Elastic and Yielded Condition per BS EN 13155:2020

- (3) The Plate Clamp shall be limited for use up to 16,000 load cycles only.
- (4) The design assumptions, boundary conditions and acceptance criteria were reviewed and found acceptable.
- (5) The Client is to ensure that the securing bolts are tight enough to secure the load during lifting.
- (6) TUVR has performed an independent analysis and design verification of the Plate Clamp following the design requirements of BS EN 13155:2020 and other relevant design standards (see list in Part 3.2). Based on the results of the analysis and design verification, it was found that the Plate Clamp sufficient mechanical strength to carry the load of 2 tonnes.
