## Isolation Check – Basic Procedure

## Localizing the Source of the Ground Fault

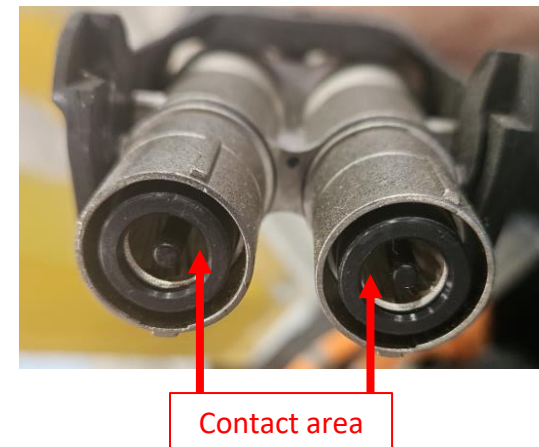
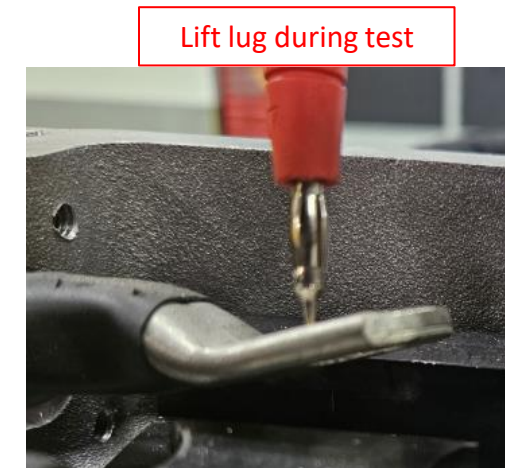
## Isolation Check – Drive Inverter

1. Disconnect high voltage cable from the “Drive Inv X” port of the PDU corresponding to the inverter being tested
2. Using a multimeter set to “Insulation Test” at 1000V, contact the inner conductor on the harness side of the HV cable with the red lead and chassis ground with the black lead

1. Perform the insulation test on the cable by contacting the metallic lug of the cable with the red lead while holding the lug away from the inverter terminal block. Ensure the black lead of the multimeter is contacting an unpainted part of the chassis

2. Perform the insulation test with the multimeter
    3. If either cable insulation measurement is below  $1\text{M}\Omega$ , replace that cable
4. Perform the insulation test on the inverter itself by contacting the five inner terminals of the high voltage terminal block one at a time with the red probe and an unpainted section of the chassis with the black probe

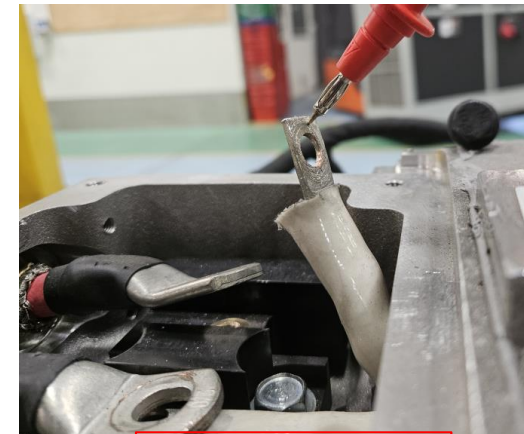
Motor winding lug

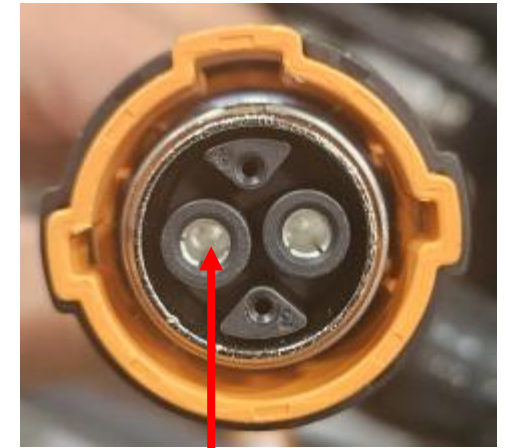
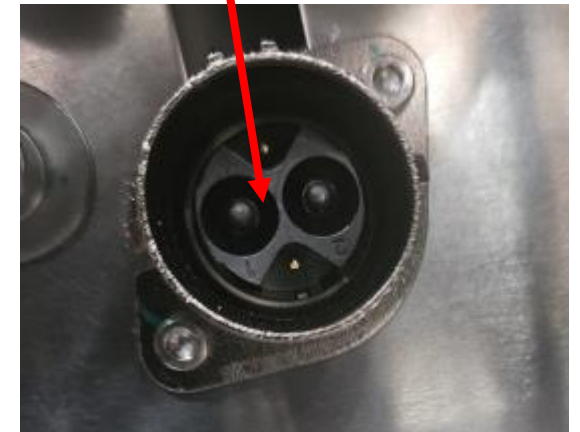
## Isolation Check - Chiller

1. Disconnect high voltage cable (110821) from the AUX 7 port of the PDU
2. Using a multimeter set to “Insulation Test” at 1000V, contact the inner conductor on the harness side of the HV cable with the red lead and chassis ground with the black lead

2. Perform the insulation test on the chiller itself by contacting the inner terminals of the high voltage connector of the compressor
4. If either the cable or the chiller measure below  $1\text{M}\Omega$ , replace the component

Contact area

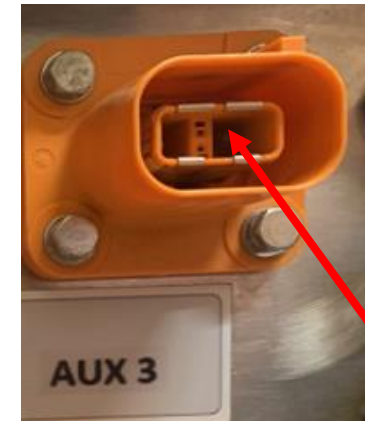
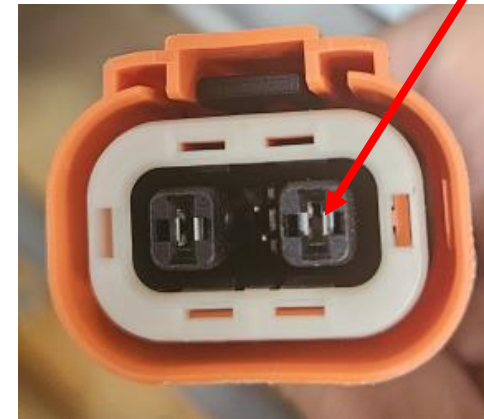
## Isolation Check – DCDC Converter

1. Disconnect high voltage cable (107159) from the AUX 3 port of the PDU
2. Using a multimeter set to “Insulation Test” at 1000V, contact the inner conductor on the harness side of the HV cable with the red lead and chassis ground with the black lead

2. Perform the insulation test on the DCDC Converter itself by contacting the inner terminals of the high voltage connector of the compressor
4. If either the cable or the DCDC Converter measure below  $1\text{M}\Omega$ , replace the component

Contact area

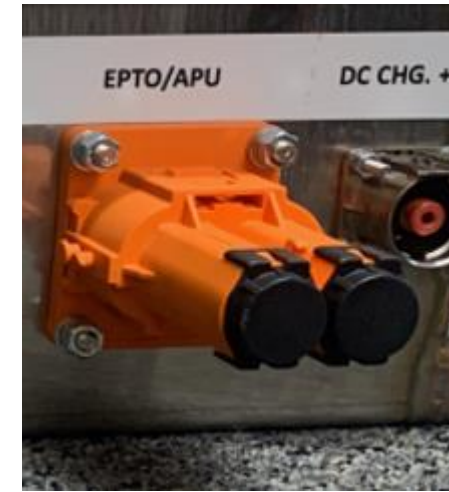
## Isolation Check – ePTO (Part 1)

2. If the measurement is below  $1\text{M}\Omega$ , remove the two DC Link cable lug bolts from the ePTO inverter and repeat the test on the cable alone while lifting the lugs away from the inverter terminal block

1. Replace the cable if the measurement is below  $1\text{M}\Omega$
4. Remove high voltage phase cable lugs from the ePTO inverter
5. Perform the insulation test on the ePTO inverter phase cables by contacting the three lugs one at a time with the red lead while the black lead is contacting an unpainted part of the chassis

Lift lug during test

Motor  
Phase  
Cables

DC Link  
Cables

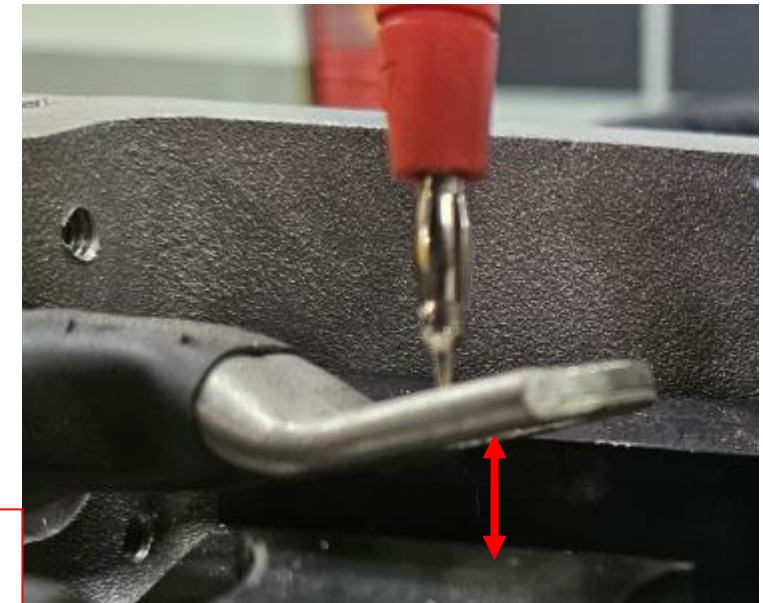
## Isolation Check – ePTO (continued)

7. Using a multimeter set to “Insulation Test” at 1000V, contact each of the three lugs on the inverter side of the HV phase cables (110426, 110427 and 110428) with the red lead and chassis ground with the black lead one at a time

2. If the measurement is below  $1\text{M}\Omega$ , disconnect the cable from the ePTO motor and repeat the test on the cable individually
    1. Remove the cable lug bolt from the motor electrical junction box and lift the cable lug away from the motor terminal block while performing the insulation test

1. Perform the insulation test on the motor windings by contacting the inner terminals of the motor winding lugs
    1. If the motor winding lugs measure below  $1\text{M}\Omega$ , replace the motor

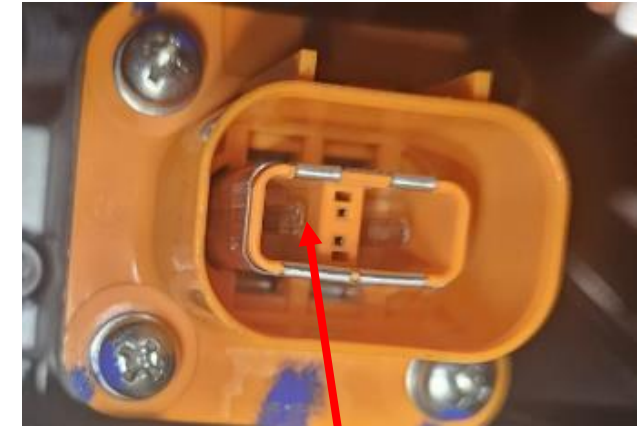
## Isolation Check – Air Conditioning Compressor

1. Disconnect high voltage cable (107154) from the AUX 1 port of the PDU
2. Using a multimeter set to “Insulation Test” at 1000V, contact the inner conductor on the harness side of the HV cable with the red lead and chassis ground with the black lead

2. Replace the cable if the measurement is below  $1\text{M}\Omega$
4. Perform the insulation test on the compressor itself by contacting the inner terminals of the high voltage connector of the compressor

Contact area

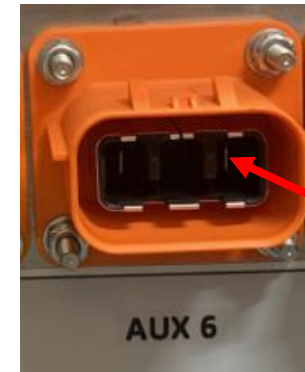
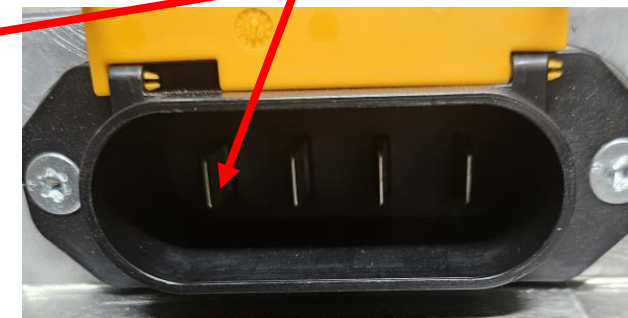
## Isolation Check – Accessory Inverter

1. Disconnect high voltage cable from the Aux 6 port of the PDU
2. Using a multimeter set to “Insulation Test” at 1000V, contact the inner conductor on the harness side of the HV cable with the red lead and chassis ground with the black lead

2. Replace any cable with an insulation measurement below  $1\text{M}\Omega$
  3. Perform the insulation test on the inverter itself by contacting each of the inner terminals of the accessory inverter connectors one at a time with the red probe and an unpainted section of the chassis with the black probe

Contact area

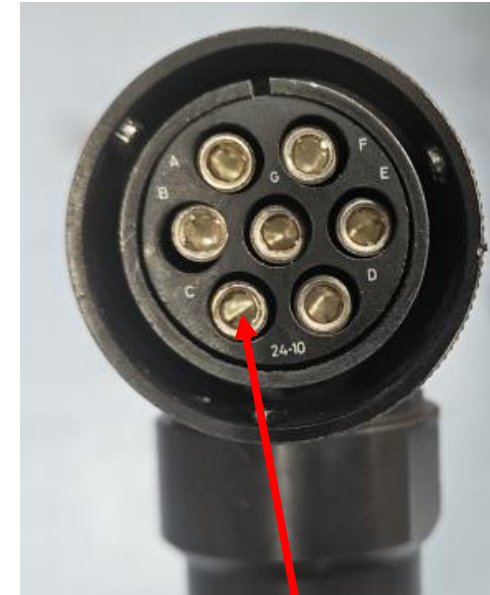
1. Remove the protective cover on the charge port and identify both the DC and the AC charging ports
2. Using a multimeter set to “Insulation Test” at 1000V, contact the inner conductor with the red lead and chassis ground with the black lead

Contact area

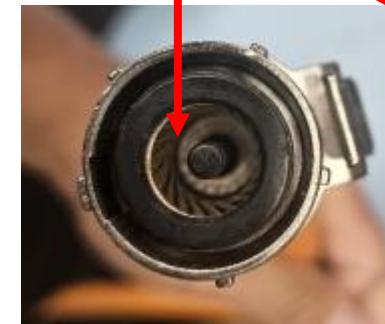
3. Press the measurement button and perform the test on each of the charge port connection points **except for the AC terminals “PE”, “CP” and “CS”**
  1. If the measurement is above 1MΩ for each of the four positions, the cable can be eliminated as the source of the ground fault

DO NOT TEST  
THESE THREE  
TERMINALS!

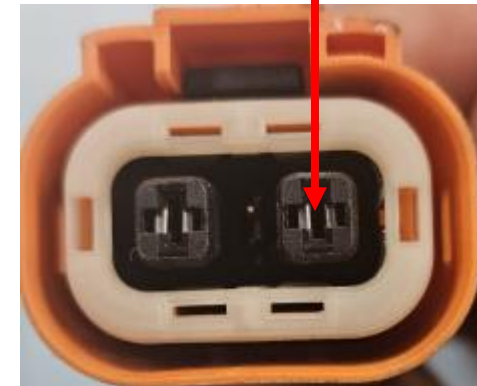
## Isolation Check – Cabin Heater

1. Disconnect high voltage cable (107155) from the AUX 5 port of the PDU
2. Using a multimeter set to “Insulation Test” at 1000V, contact the inner conductor on the harness side of the HV cable with the red lead and chassis ground with the black lead

2. Perform the insulation test on the cabin heater itself by contacting the inner terminals of the high voltage connector of the compressor
4. If either the cable or the cabin heater measure below  $1\text{M}\Omega$ , replace the component

Contact area

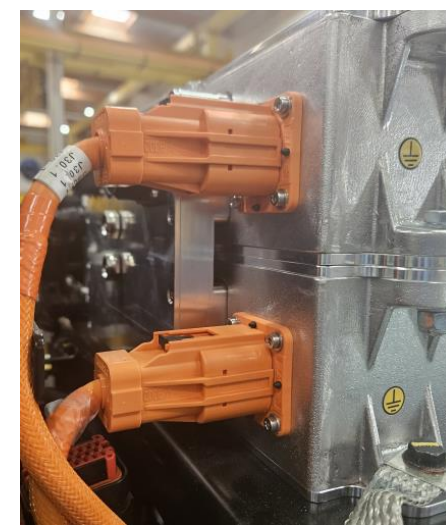
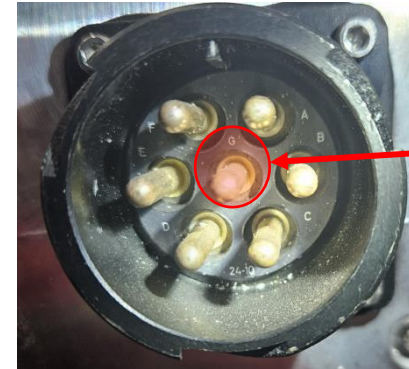
AC Charging

4. Remove the cover of the charge port and identify the AC charging contacts
  1. Perform an insulation test on the two inner conductors on the charge port marked “L1” and “L2/N”, one at a time, using the red lead with the black lead on chassis ground

DO NOT TEST THESE  
TERMINALS!

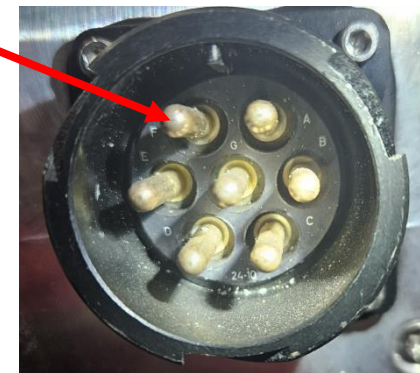
2. If either post measures less than 1MΩ, replace the charge cable
5. Perform the insulation test on the charger itself by contacting the six inner metallic terminals of the high voltage connector, one at a time, with the red lead while the black lead is contacting an unpainted part of the chassis – do not test terminal “G” as it is a ground connection

Contact area

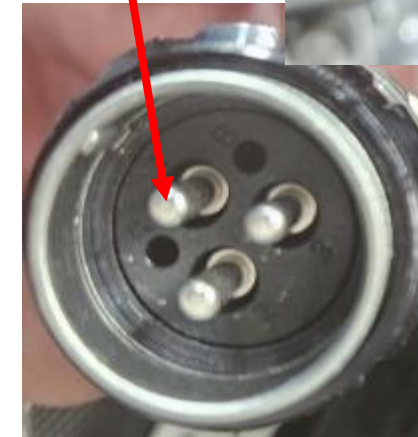
Contact area

3. Press the measurement button and perform the test.
  1. If the measurement is below  $1\text{M}\Omega$ , replace the power steering motor
  2. If the measurement is above  $1\text{M}\Omega$ , the power steering motor can be eliminated as the source of the ground fault

1. If the measurement is below  $1\text{M}\Omega$ , replace the high voltage cable
  2. If the measurement is above  $1\text{M}\Omega$ , the cable can be eliminated as the source of the ground fault

6. If both the cable and the power steering motor insulation measurements are above  $1\text{M}\Omega$ , test the accessory inverter for loss of isolation

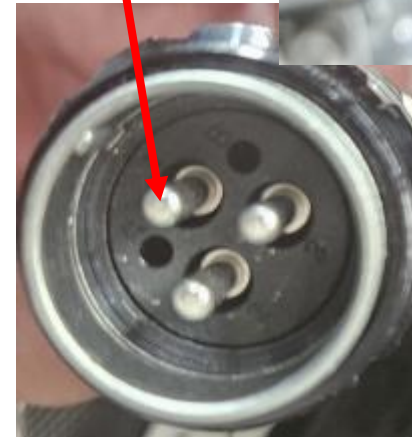
Contact area

3. Press the measurement button and perform the test.
  1. If the measurement is below  $1\text{M}\Omega$ , replace the air brake compressor motor
  2. If the measurement is above  $1\text{M}\Omega$ , the air brake compressor motor can be eliminated as the source of the ground fault

1. If the measurement is below  $1\text{M}\Omega$ , replace the high voltage cable
  2. If the measurement is above  $1\text{M}\Omega$ , the cable can be eliminated as the source of the ground fault

6. If both the cable and the air brake compressor motor insulation measurements are above  $1\text{M}\Omega$ , test the accessory inverter for loss of isolation
