1 · What we did with the microphones: substitution calibration

SoundVisualizer · chamber report, 2026-10-05 · calibrator session 2026-09-16

2 · Main waterfalls and the day 3 evaluation

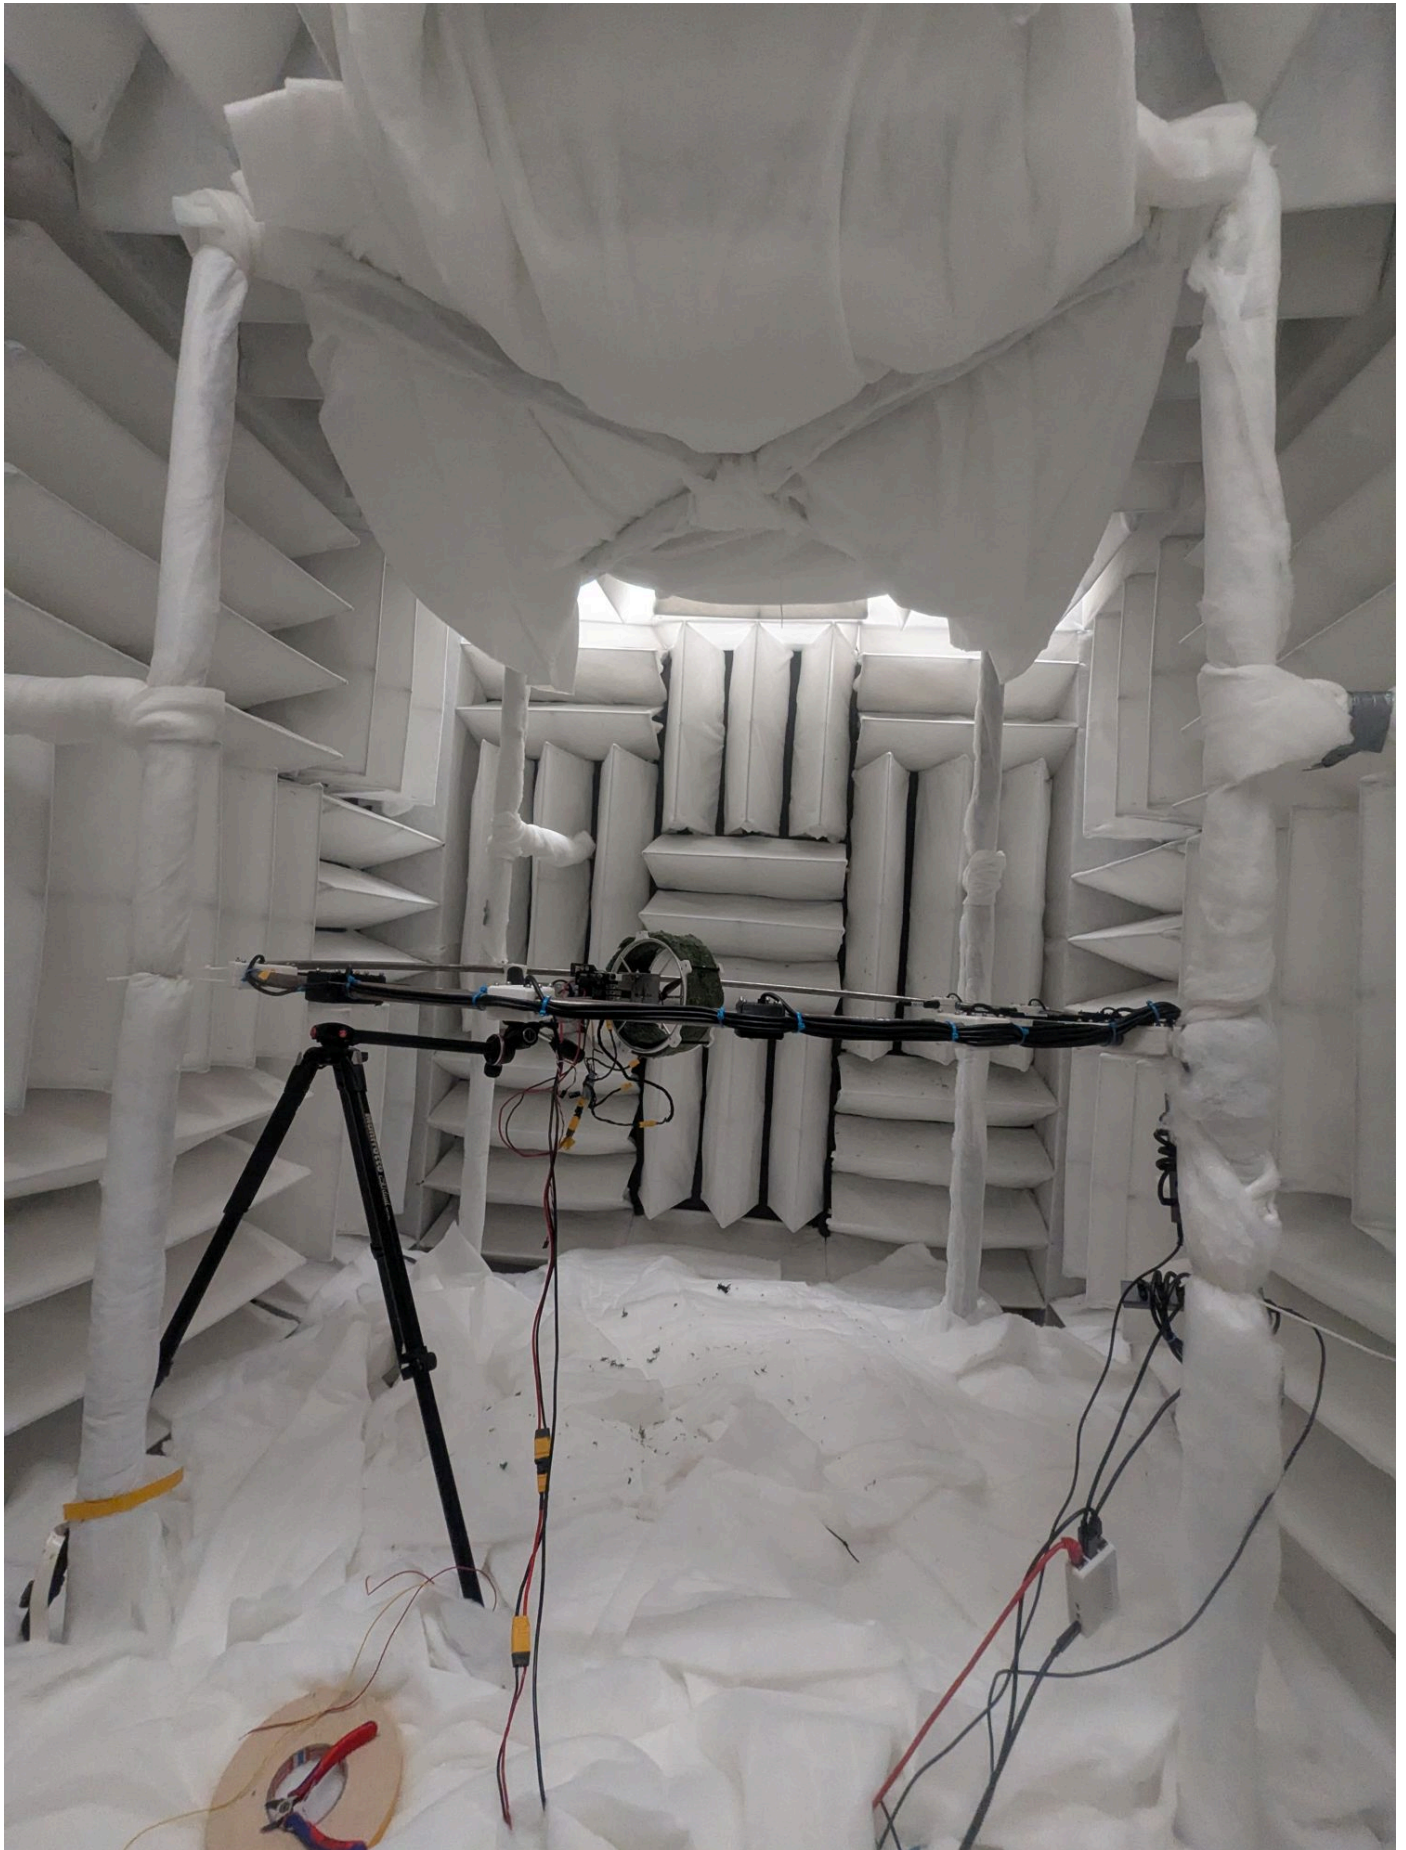
2.1 the chamber

The chamber in the final configuration (carpet - reordered, photographed 5 Oct): the arc ring laid flat around the propeller rig at the hub, the speaker tripod on the left, batting on the floor and ceiling, wedges and lined pillars on the walls. The waterfall on the next page compares the start of day 3 with this state.

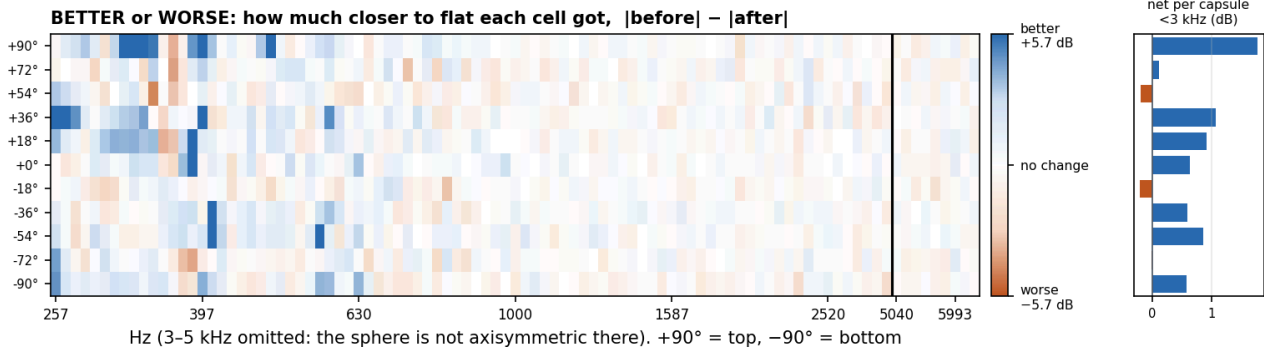
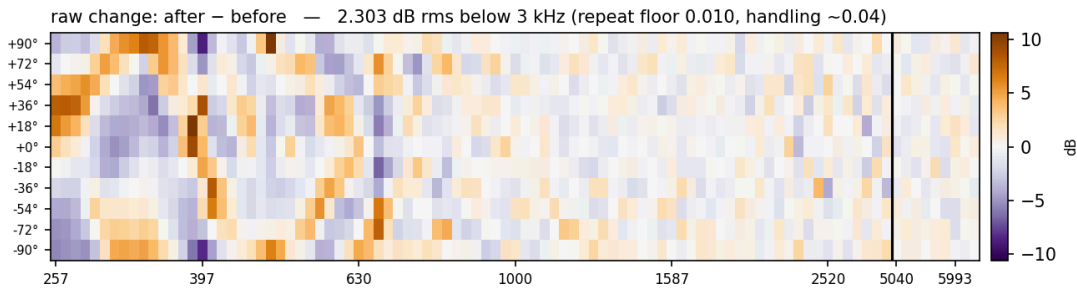
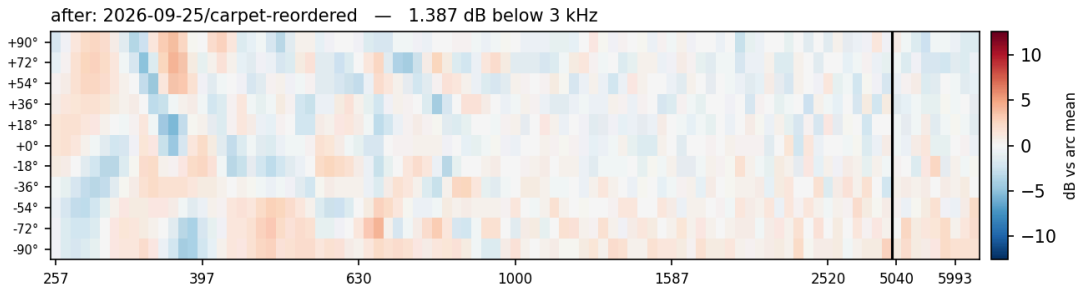
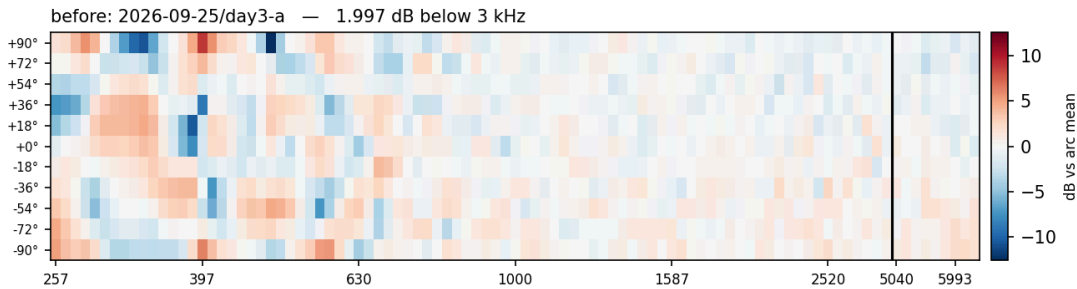
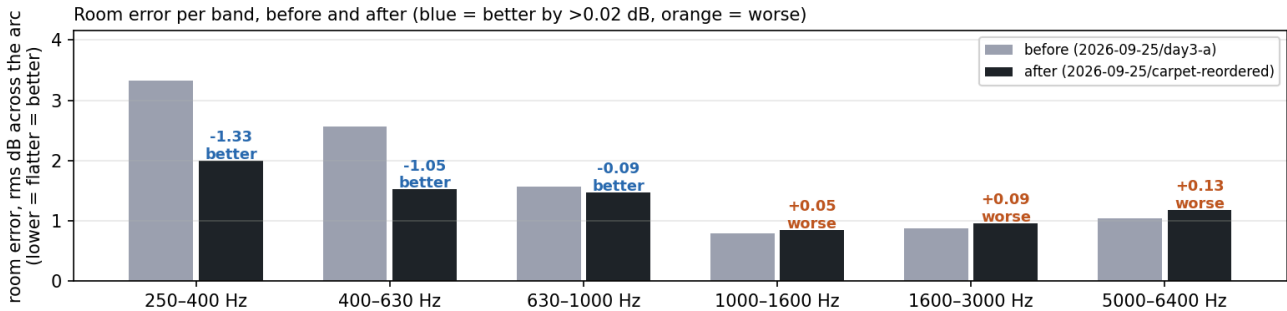
2.2 main waterfall: day 3 start against the final state

Both runs are from 25 Sep with the corrected microphones. The source was moved between them (page 4).

Day 3 start (worst) vs final · source moved in between: room error below 3 kHz 1.997 → 1.387 dB (-0.610, better)

2026-09-25/day3-a → 2026-09-25/carpet-reordered · below 3 kHz, 492 of 946 cells moved >0.05 dB toward flat and 415 away from it · 95 tones · 11 calibrated capsules
