The arc is fine above 4 kHz. Below 2 kHz the room bends it by up to 8 dB.

2026-09-08
data: laptop backup of 2 Sept
script: scripts/arc_error_map.py
full guide: docs/arc-validation-guide.html

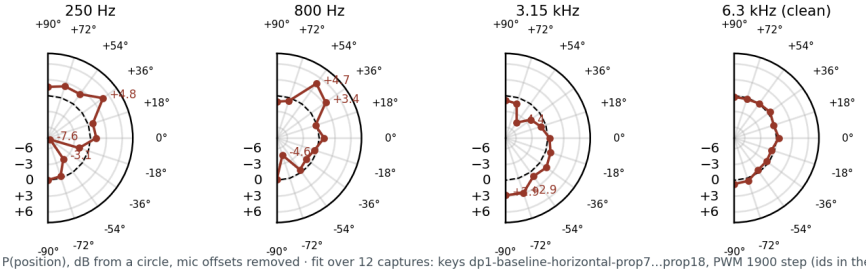
Fig. 1 · room error P(position), dB from a circle, mic offsets removed · fit over 12 captures: keys dp1-baseline-horizontal-prop7…prop18, PWM 1900 step (ids in the table below)

The level at −72° is 2.4 to 5.7 dB too low between 500 and 2000 Hz, in all twelve runs. The dip is deepest at 630 and 800 Hz (−4.5 dB). It stays when a different microphone sits there (811-1896 in eight runs, 810-8901 in the four runs with the arc turned around). This position is the one closest to the chamber corner.

The level at +36° and +54° is 3 to 7 dB too high, at 200–250 Hz and at 630–1000 Hz. Three different microphones sat at +54° over the twelve runs. The bump stayed the same.

Around the blade tone (200–250 Hz) the two halves of the arc disagree: −36° reads −7.6 dB, +36° reads +4.8 dB; −54° reads −3 dB, +54° and +72° read +2 dB. The negative-angle half of the arc (−36°, −54°) is too low, the positive-angle half (+36°, +54°, +72°) is too high. The dip also moves with motor speed (−9 dB at PWM 1900, −2 dB at 2000). A sound wave that bounces off a surface and adds to the direct wave does exactly this: it cancels at some frequencies and adds at others, and the tone slides through those frequencies as the speed changes.

Above 4 kHz the arc reads a circle within ±1 dB at every position. The positions 0°, ±18° and ±90° are within about 1 dB in every band.

1. Take 811-1892 off the arc.
2. Put a small loudspeaker on the stand instead of the propeller. Play short tone bursts at 250 and 800 Hz and record all microphones. The delay of the second arrival at each microphone, times 343 m/s, is the extra path length. Only one surface fits all eleven delays. With no airflow, anything left is the room.
3. Write down the geometry in docs/mic_arc.md: arc radius, propeller height, which wall or corner is at the −90° end, distances from the −72° and +72° microphones to the nearest wall.
4. Cover or move that surface, then run scripts/arc_error_map.py again. Foam only helps at 3 kHz. At 250 Hz the only fix is distance.

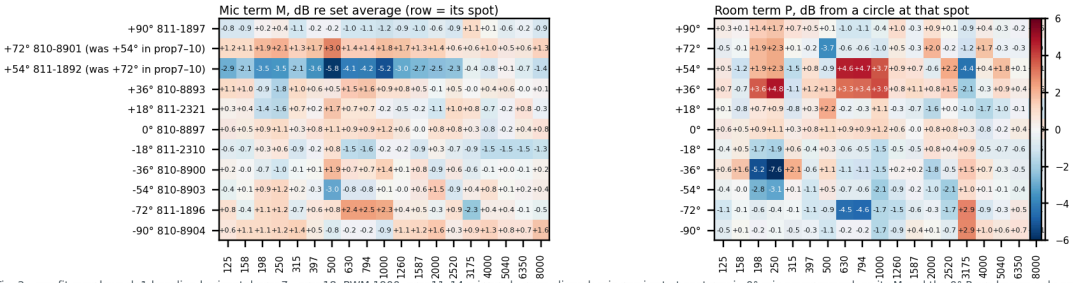
Not the microphones, with one exception. Because the microphones at +72° and +54° were swapped after prop10, and the arc was turned around for prop11–14, we can tell apart what belongs to a microphone and what belongs to a position. Ten microphones agree within ±1.8 dB in every band. **Microphone 811-1892 reads 2–6 dB too low from 125 Hz to 2.5 kHz.** Its calibration file does not match the capsule (its sensitivity value, −10.63 dB, is the least negative of the set, while the raw capsule is only about 1 dB low). When it sat at +54° it made the room error look like 7 dB. Take it off the arc or measure it again.

Not one frequency. The error sits in three separate bands, 200–250 Hz, 630–1000 Hz and 3150 Hz, and nowhere else (Fig. 2). Rajmane and Baumann (DAGA 2016) found a steel plate in a chamber only shows up once the wavelength is shorter than the plate (35 cm from 1.25 kHz, 10 cm from 3.15 kHz). So three bands point to three object sizes: about 1.5 m (floor, table or wall), about 0.4 m (stand base or a bar of the arc frame), about 0.1 m (a microphone clamp or mount).

Fig. 2 · Microphone error map (left) and room error map (right), same fit, same scale

Fig. 2 · one fit over keys dp1-baseline-horizontal-prop7…prop18, PWM 1900, prop11–14 mirrored · rows aligned: mic row i sat at spot row i · 0° mic never moved, so its M and the 0° P are known only as a sum · third-octave centre, Hz
