ESP32 Series SoC

Errata

Version 2.6
Espressif Systems
Copyright © 2023

This document details hardware errata and workarounds in the ESP32.

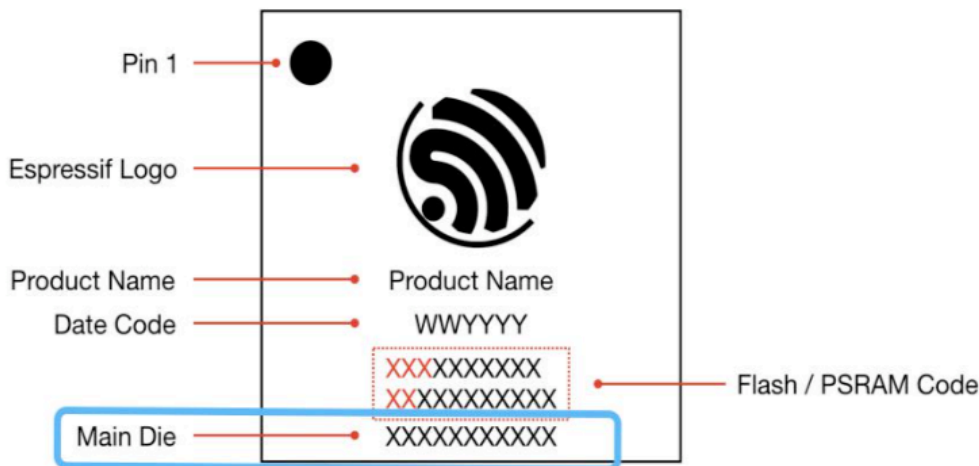
Figure 1-1: Chip Marking Diagram

- Main Die** line in chip marking, see the figure below.

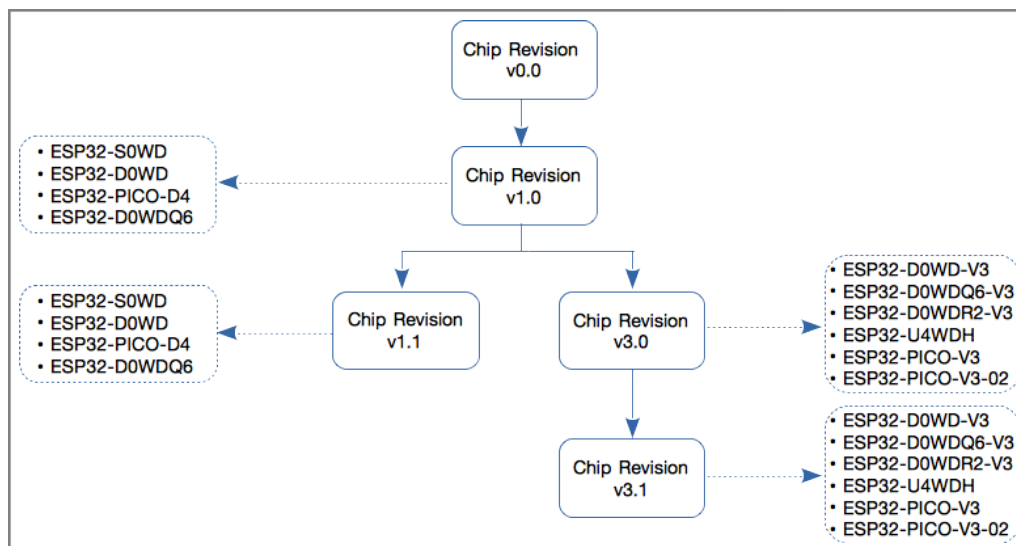
Figure 1-2: Chip Revisions and Chip Variants

The figure below shows the relation between chip revisions and chip variants.

- ESP32-S0WD, ESP32-D0WD, ESP32-PICO-D4, and ESP32-D0WDQ6 will be produced with chip revision v1.1 inside, see [PCN20220901](#).
- ESP32-D0WD-V3, ESP32-D0WDQ6-V3, ESP32-D0WDR2-V3, ESP32-U4WDH, ESP32-PICO-V3, and ESP32-PICO-V3-02 will be produced with chip revision v3.1 inside, see [PCN20220901](#).
