A comparison of surface preparation techniques for wind turbine field repairs

Ariel Lusty*, Douglas Cairns, David Miller, and Daniel Samborsky

Department of Mechanical and Industrial Engineering, Montana State University, Bozeman, MT, 59715, USA

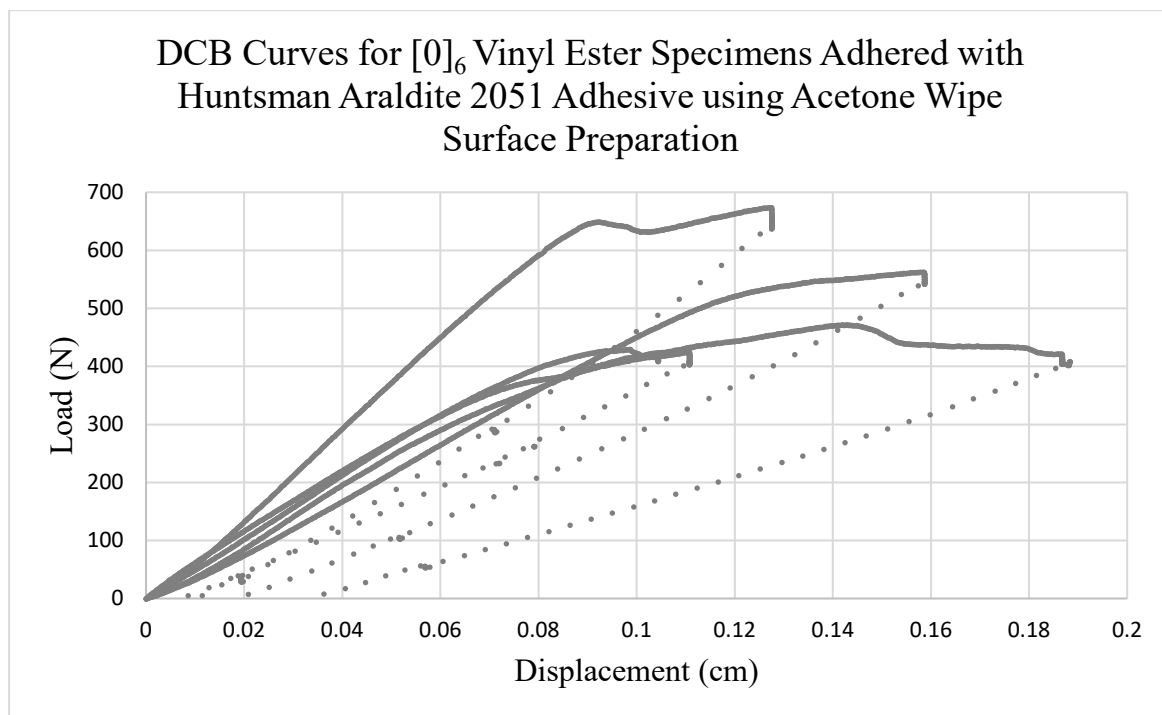
Figure 4. An example of five load-displacement curves from DCB tests.

Mode I and mode II fracture toughness values are presented, and DCB and ENF failure modes are discussed. DCB and ENF results for the Huntsman Araldite 2051 adhesive are in Table 6, and DCB and ENF results for the Loctite 9396 Aero adhesive are in Table 7. Five test results were averaged for each tabulated value. Figure 3 is an example of DCB load-displacement curves for specimens wiped with acetone.
