Root Causes and Mechanisms of Failure of Wind Turbine Blades: Overview

Leon Mishnaevsky, Jr.

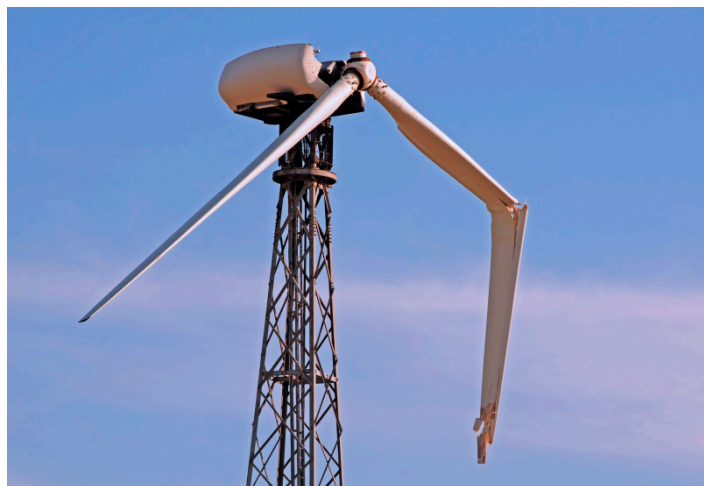
Figure 1. Wind turbine with broken blades. The photo from Bigstock© collection is reproduced according to the Bigstock content usage agreement.

However, the maintenance of wind turbines remains an important cost factor, influencing the energy price and competitiveness of renewable energy [4]. For instance, onshore wind farm operators spent around USD 15 billion on operations and maintenance services in 2019, 57% of which was on unplanned repairs [5]. Further, the number of wind turbines reaching 20 years of operation annually, for instance, in Spain and Germany will be of the order of 800 per year in the next decade [6]. An ageing fleet leads to increased repair requirements [7,8]. With an estimated 700,000 blades in operation globally, there are, on average, 3800 incidents of blade failure each year. The total repair budgets in Europe increased from 2019 to 2020 from USD 4.7 to 8.6 mil, and unplanned repairs also increased slightly in Europe (2%) and even by 10% in America [6]. Failure events of different degrees take place relatively often. Figure 1 shows a wind turbine with broken blades.

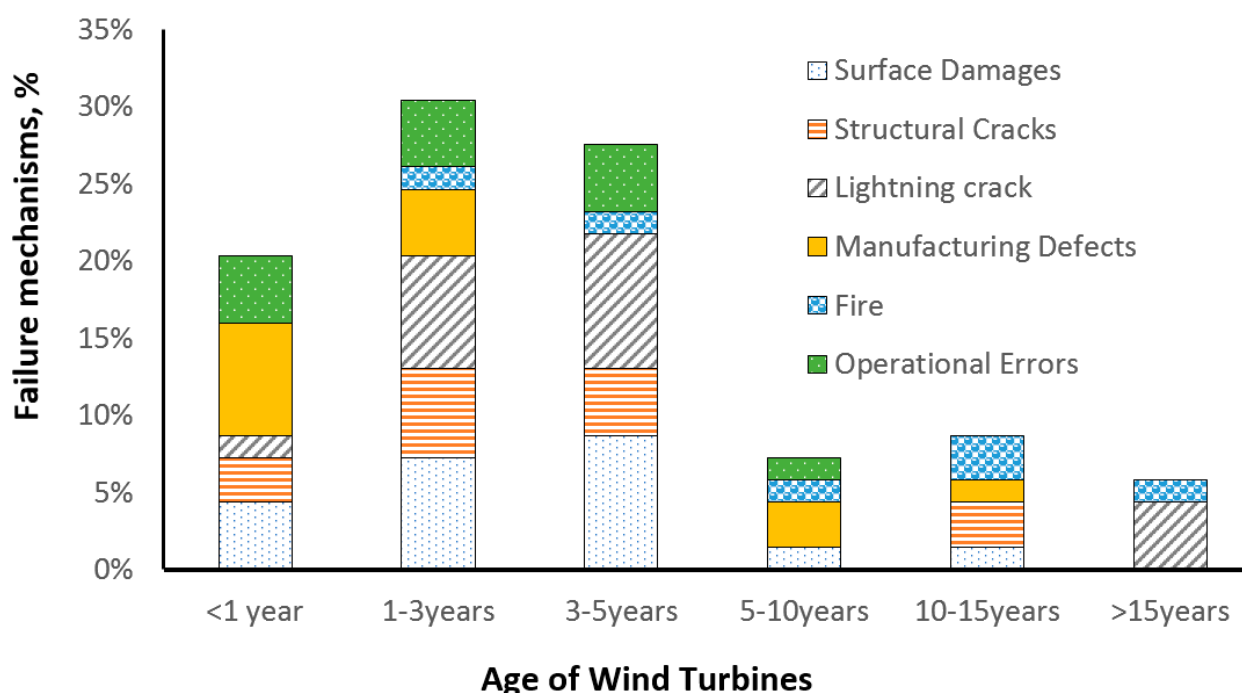
Figure 2. Results of the survey of blade service companies: Frequency of wind turbine blade failure mechanisms depending on the age of wind turbines. Reprinted from [19] with kind permission from John Wiley and Sons.

Boopathi, Sumatraa and colleagues [19] carried out a survey among the wind turbine service teams regarding the frequency of the observed damage mechanisms in different regions in Europe and India. Figure 2 shows the results of the survey of blade service companies, presenting the frequency of wind turbine blade failure mechanisms depending on the age of wind turbines based on data from [19]. They observed that leading edge erosion and lightning strikes are the two most often observed damage mechanisms. Leading edge erosion can occur from the first year after wind turbine installation. The lightning strike is observed especially often in monsoon areas. In Europe, fire and even operational errors determine the failure of wind turbines, reaching 5 . . . 10 years and more. In India, the wind energy industry is generally younger and less “crowded” than in Europe, and therefore, operational errors and manufacturing defects are among the main failure mechanisms of recently installed wind turbines, even after installation or 1–3 years old. That leads to structural failure even in young, recently installed wind turbines (1–5 years, which is not observed in Europe).

Figure 2 shows the frequency of observing different blade damage mechanisms over years, according to the survey of service companies [19]. It can be seen that surface erosion is the most often observed damage mechanism (for those turbines that survived the risks caused by initial manufacturing defects during the first years and were not subject to lightning strikes). In fact, it is above the structural failure risks, which combine spar buckling, trailing edge failure and adhesive joint failure (i.e., most other failure mechanisms). Surface erosion is also the damage mechanism which most often requires repair and is most expensive for wind turbine owners [4]. According to [4], the costs of minor repairs of wind turbine blades are more than 12 times higher than the costs of major repairs or replacements.

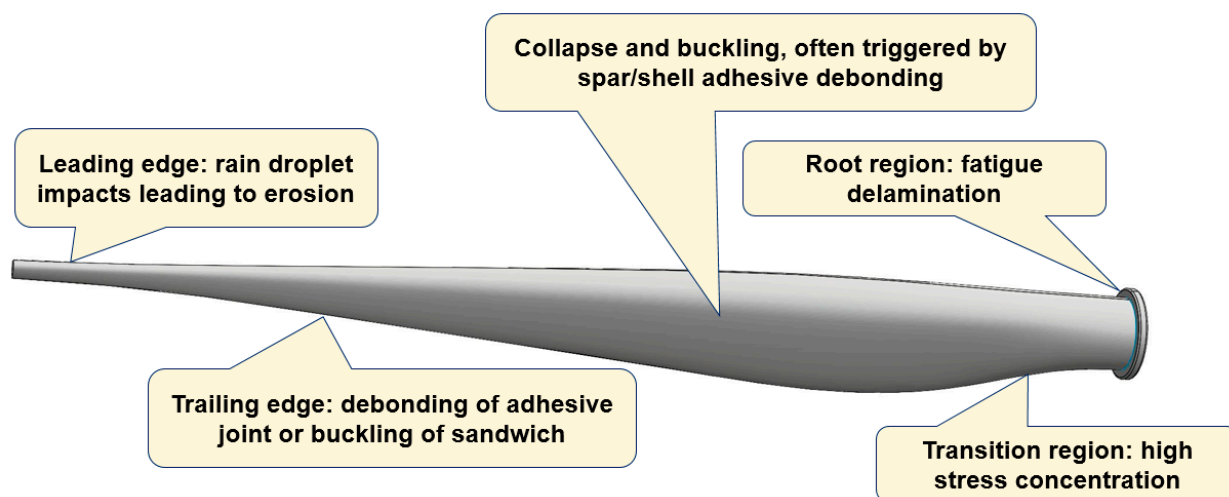
Figure 3. Schema of locations of often-observed damage mechanisms of a wind turbine blade [3,7].

Therefore, the most endangered regions of the blades include the outstanding and high velocity region (tip), the transitional and tapered areas and the interface regions. Figure 3 shows a schema of the locations of the often-observed damage mechanisms of a wind turbine blade.

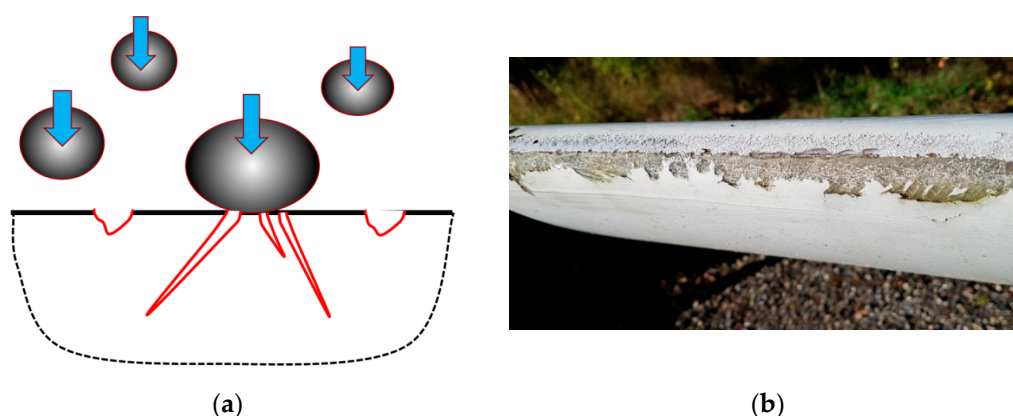
Figure 4. Schema of leading edge erosion of blades (a) and eroded blade (b).

Figure 4 shows a mechanism of the leading edge erosion of blades, and a micrograph of severely eroded blade. Due to the complexity and microscale and multiphysical mechanisms of erosion, the relationships between laboratory studies and field observations are not straightforward, and computational models are often required to interpret and link the test observations with the field results.

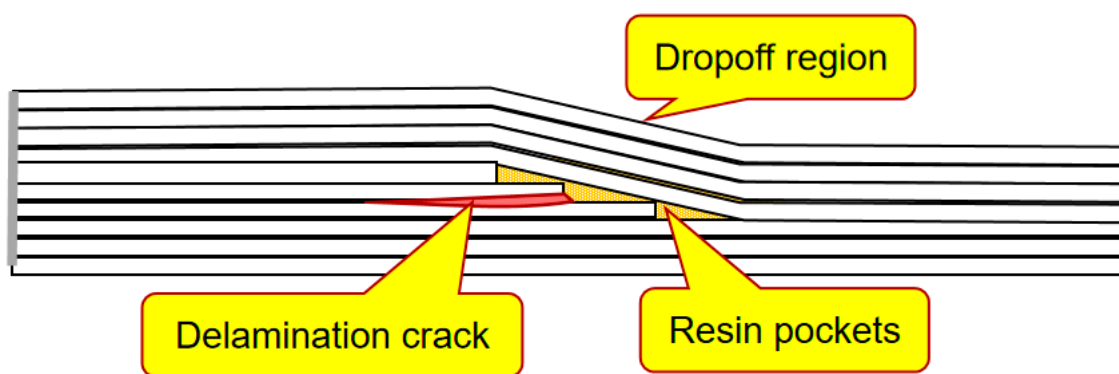
Figure 5. Schema of a delamination crack in the plydrop region.

Tapered areas and plydrops in the blades are necessary in the blades to ensure an optimal, aerodynamic shape. Plydrops are formed by terminating some of composite plies. The tapered structures create local stress concentrations, in particular, interlaminar stresses in the vicinity of the ply drop-off which can lead to the delamination of plies and the failure of these regions [50]. Figure 5 shows a schema of a delamination crack in the plydrop region, starting from a resin pocket.

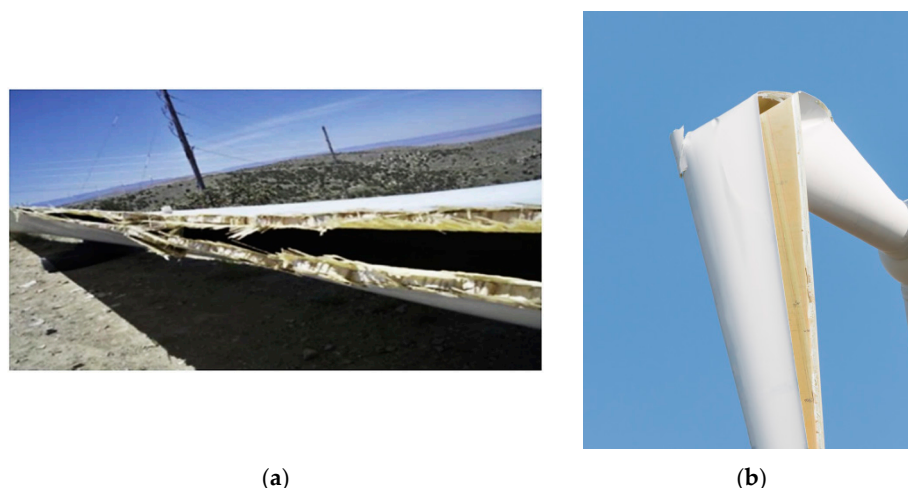
Figure 6. Blade failure: (a) Failure of edges in 24 m wind turbine blade. Reprinted from [27,84] with kind permission from Elsevier, and (b) Collapsed blade.

The trailing edge is another critically important structural part depending on the reliability of adhesive bond. Figure 6 shows the failed trailing edge of a 24 m wind-turbine blade.

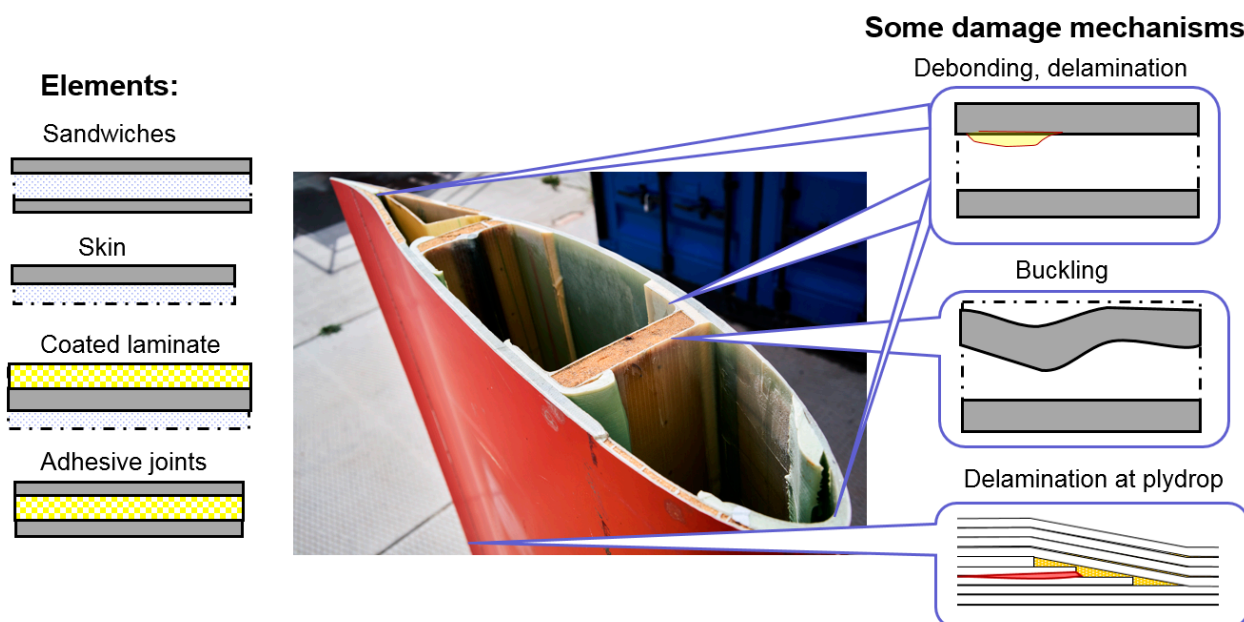
Figure 7. Elements of the blade structure (**left**), blade cross section (**middle**) and some common damage mechanisms (**right**). On the blade cross section, white adhesive layers and brown/white sandwiches can be seen. The photo from Bigstock© collection is reproduced according to Bigstock standard content usage agreement.

Wind turbine blades are structures built from fiber-reinforced composites, including various elements such as single skins, sandwich structures and adhesive layers [38]. Figure 7 (middle) shows a cross section of a wind turbine blade, with white adhesive layers and brown/white sandwiches in shear web and shell.

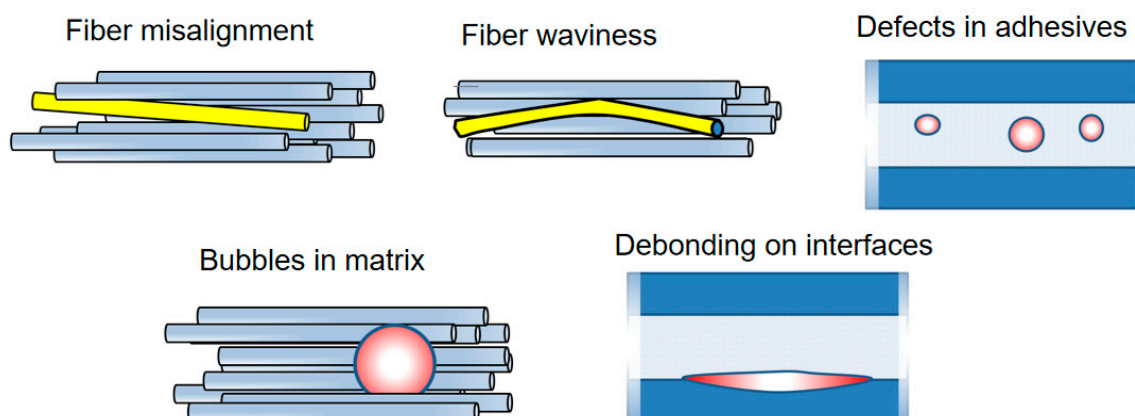
Figure 8. Schema of the typical manufacturing defects on wind turbine blade composites: fiber misalignment and waviness, voids in adhesives and in matrix, debonding on interfaces.

Figure 8 shows schematically the common defects observed in wind turbine blade composites: fiber misalignment and waviness, voids in adhesives and in matrix and debonding on interfaces.

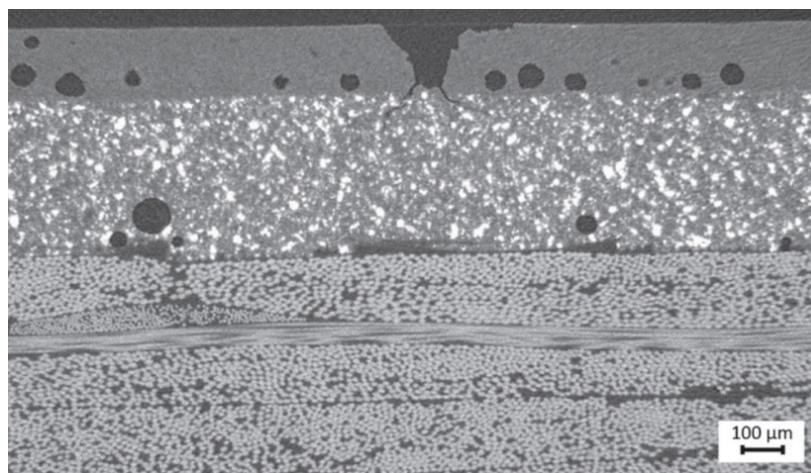
Figure 9. Voids in leading edge protection layers: Sites of damage initiation. Reprinted from [15] with kind permission from Wiley.

Leading edge erosion. The microscale mechanisms and factors controlling the leading-edge erosion have been studied in [15,16,48,49]. Wind turbine blades from old wind turbines from Vindeby wind farm, established in 1991 and decommissioned in 2015–2017, were cut and investigated using X-ray tomography [15,16]. The interesting observation was that the erosion damage starts in fact not from the contact surface (where a rain droplet hits the blade and the highest stresses are expected), but from voids and debonded particles inside the coating. Figure 9 shows the voids in the leading edge coatings and the start of the damage from the voids. Further, computational models of coatings have been developed, which include the real observed defects inside the coatings [15,16]. In the computational simulations, it was again observed that the erosion microcracks start from voids or debonded particles in the coatings, and not from the high stress regions of the contact area on the coating surface (as one could expect). In Refs. [48,49], the authors ran simulations of rain droplet impact on intact and voided coatings and observed that even small voids drastically increase local stresses, and reduce the lifetime of coatings.

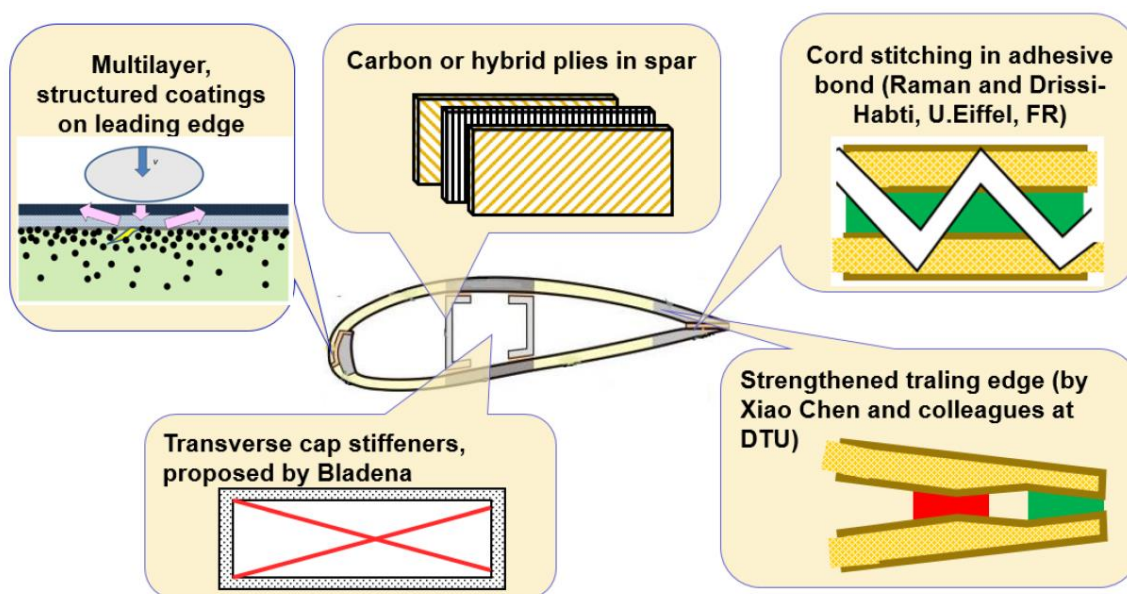
Figure 10. Schema: Some technical solutions for preventing or mitigation of different damage mechanisms of wind turbine blades, discussed in Section 5: (**upper left**) multilayered, architected coatings to mitigate leading edge erosion [39,117] (the figure shows the blade coated with multilayer leading edge protection, reinforced by black particles, with rose arrows showing the stress wave direction after rain droplet impact) (**upper in the middle**) carbon or hybrid plies in spar laminates, increasing the strength [121], (**lower left**) transverse stiffeners proposed by Bladerna to prevent buckling [31,32], (**lower right and upper right**) strengthened trailing edge by Chen and colleagues [136] and cord stitching in adhesive layers, preventing the layer degradation [84].

Figure 10 shows schematically some technical solutions for the prevention or mitigation of different damage mechanisms of wind turbine blades, discussed in this section.
