Two errors: bent tones on a broadband floor

The blade tones are bent by up to 8 dB below 1 kHz; notching them leaves a smaller error that is still systematic and present in every band. What the arc-validation runs actually say once tones and broadband are separated, what the chamber literature says about each problem, and which remedies are possible. One chapter per problem, each ending in a verdict. Derived from docs/arc-validation-onepager.pdf and the September 2026 horizontal runs; the measurements and the cited PDFs govern where this report disagrees.

2026-09-08 · rev 2026-09-09
data: laptop backup of 2 Sept
scripts: arc_validation_diagnostics.py
numbers: docs/analysis/remedies-
papers: papers/arc-validation/
status: working draft

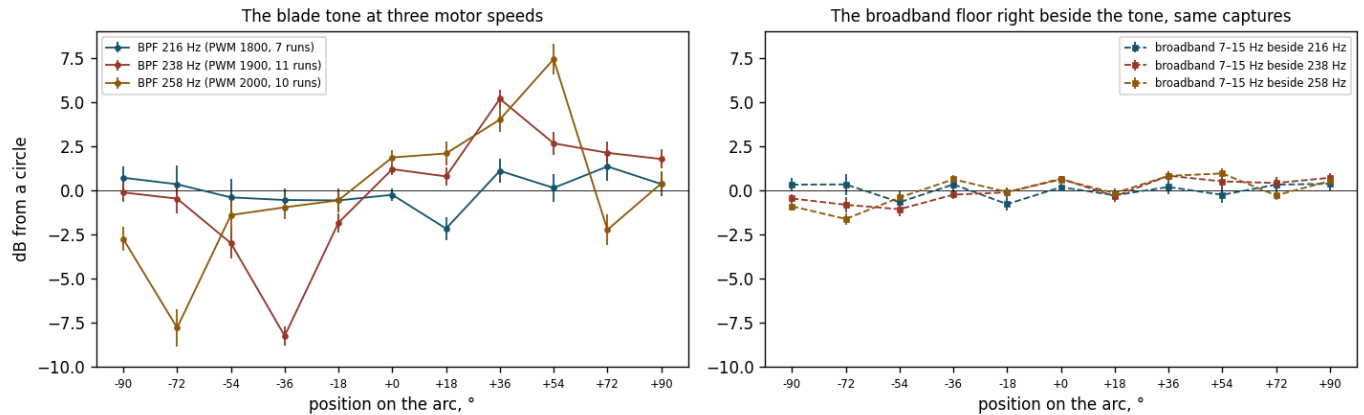
Fig. 1 · Left: the blade-tone position term at three motor speeds (BPF 216, 238, 258 Hz; 7, 11 and 10 runs). Right: the broadband floor 7–15 Hz on either side of the same tone, same captures, same fit. Error bars ± 1 standard error. Data: docs/analysis/remedies-tone-probe-map.csv, remedies-diagnostics.json.

With every multiple of the shaft frequency notched (± 9 Hz below 1.1 kHz, ± 35 Hz above), the position term over all 55 usable captures is within ± 1.3 dB in 92 % of the 209 position $\times$ band cells (98 % within ± 2 dB). The largest: +2.7 dB at +72°/2 kHz, -2.6 at -72°/397 Hz, +2.6 at +54°/5 kHz, +2.0 at -36°/315 Hz. Standard errors 0.15–0.45 dB. This is the polar the room gives a broadband source at this radius: usable to ± 1.5 dB from 125 Hz up, with two positions (-72°, +54°/+36°) to watch in 400–800 Hz. It is a floor, not a clean sheet — 99 of the 209 cells exceed three standard errors, and the residual does not shrink with frequency (92.2 % of cells within ± 1.3 dB below 3.15 kHz against 92.7 % above, worst 2.69 against 2.58 dB), so a reflection averaging out in a wide band is not the whole story.

Spread of the tone position term across the eleven positions: 0.9 dB at 216 Hz, 3.4 dB at 238 Hz, 3.8 dB at 258 Hz. Between 238 and 258 Hz the deepest cell moves from -36° (-8.3) to -72° (-7.8) and the highest from +36° (+5.2) to +54° (+7.4). Correlation of the eleven-position pattern between neighbouring probes: 0.41 (216→238), 0.41 (238→258), then 0.76 (647→714), 0.59 (714→775), 0.73 (863→952), -0.92 (952→1034). The room error is frequency-sharp at 240 Hz and frequency-smooth at 700 Hz.

Spread of the broadband-beside-the-tone term: 0.4/0.6/0.8 dB at 216/238/258 Hz against 0.9/3.4/3.8 dB for the tone; correlation with the tone pattern 0.52/0.62/0.86. At the third harmonic, 647/714/775 Hz: broadband spread 1.3/1.8/0.6 dB, correlation 0.94/0.98/0.68, with -72° reading -5.1 (tone) and -3.2 (broadband) at 714 Hz, +54° reading +5.3 and +3.5. At 700 Hz whatever bends the tone bends the floor beside it; at 240 Hz it bends the tone only, or only within a few hertz of it.

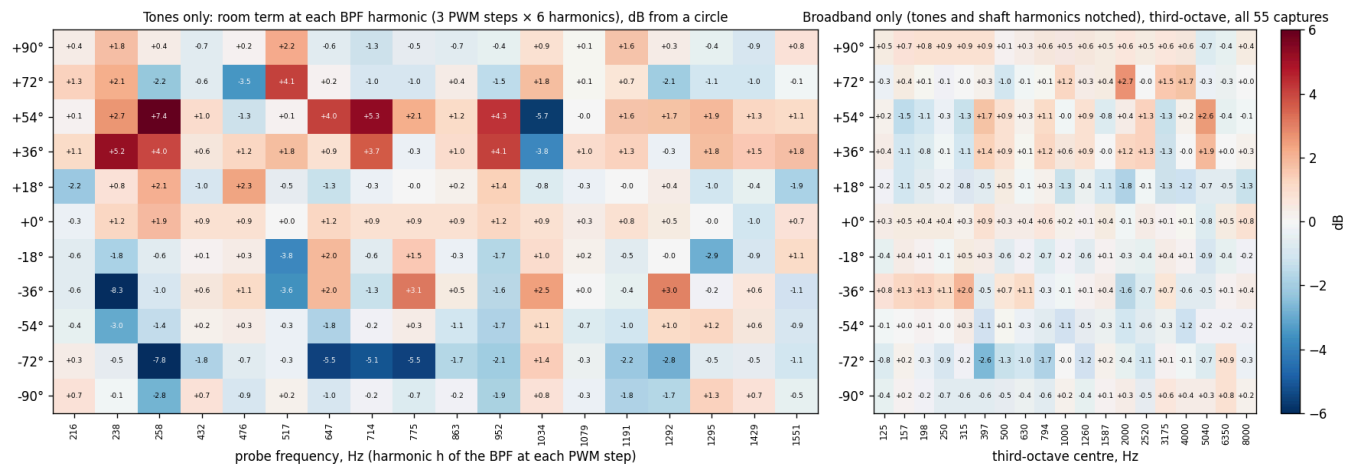
A one-echo comb fitted to each position's 18 probes: +36° extra path 1.50 m, amplitude 0.35, residual 2.4–1.3 dB; +54° 1.49 m, 0.43, 3.3–2.1 dB; -72° 0.68 m, 0.23, 2.3–1.7 dB. The other eight positions fit nothing better than 2–4 m at amplitude ≤ 0.23 with little improvement. An amplitude of 0.4 after a 1.5 m longer path needs a reflection coefficient near 1: a hard surface, not foam. Fitting one plane to all eleven extra paths fails (residual 0.9 m for any arc radius 0.6–1.5 m).

Fig. 2 · Left: the tone position term at each of the 18 probe frequencies (3 speeds $\times$ 6 harmonics; prop7 and PWM 1200 excluded). Right: the broadband position term, tones and shaft harmonics notched, third-octave, all 55 usable captures at all speeds. Same colour scale. The left panel is the one-pager's problem; the right panel is the room for a broadband source.

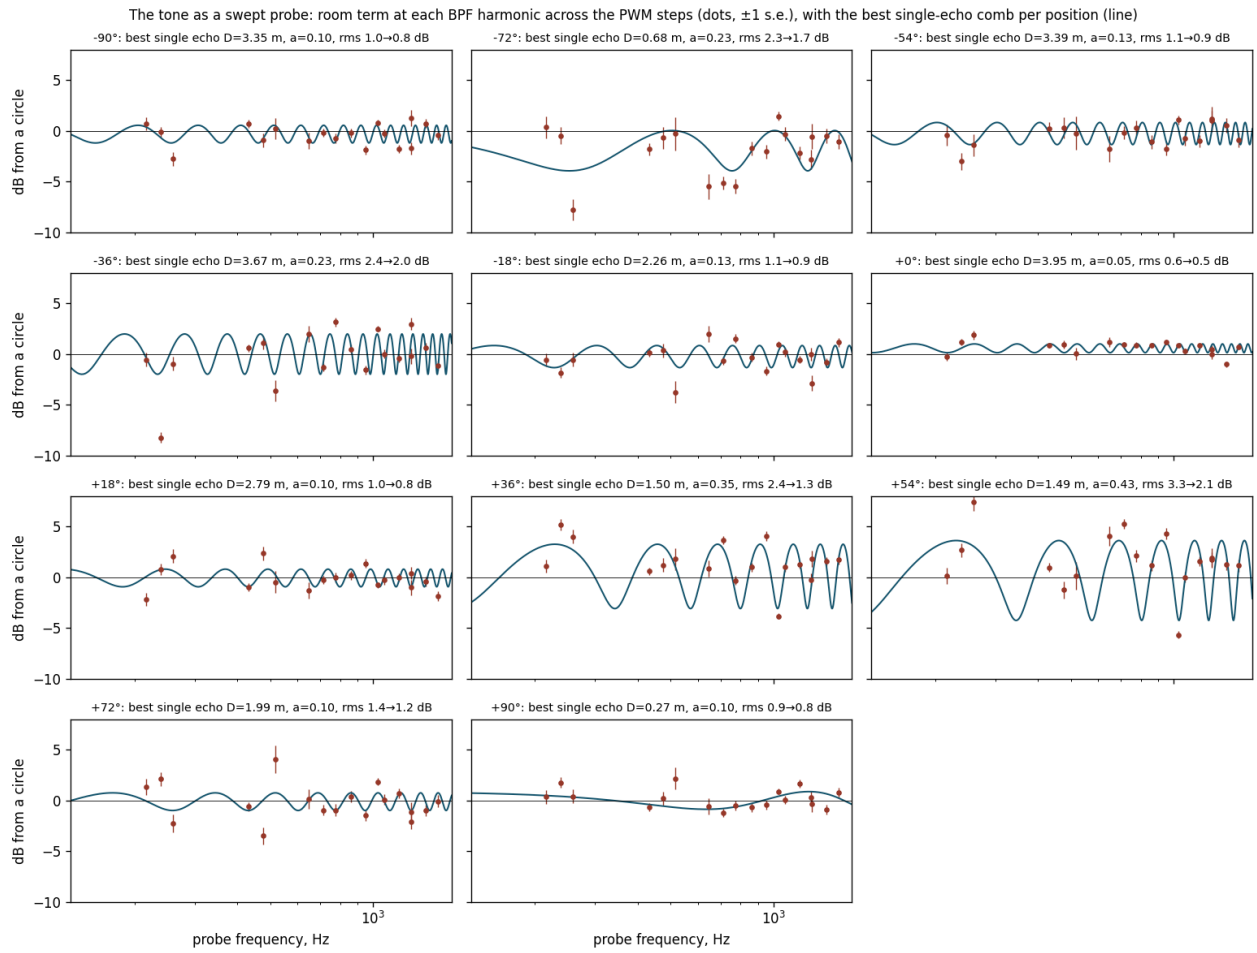
Fig. 3 · The tone as a swept probe: room term against probe frequency at each position (dots, ± 1 s.e.) with the best single-echo comb (line). Only +36°, +54° (extra path 1.5 m) and -72° (0.7 m) are fitted by one echo. Note -36°: -8.3 dB at 238 Hz between -0.6 at 216 and -1.0 at 258, a notch no single echo at this radius can make.
