1 · What we did with the microphones: substitution calibration

SoundVisualizer · chamber report, 2026-10-05 · calibrator session 2026-09-16

2 · Main waterfall: day 3 start against the final state

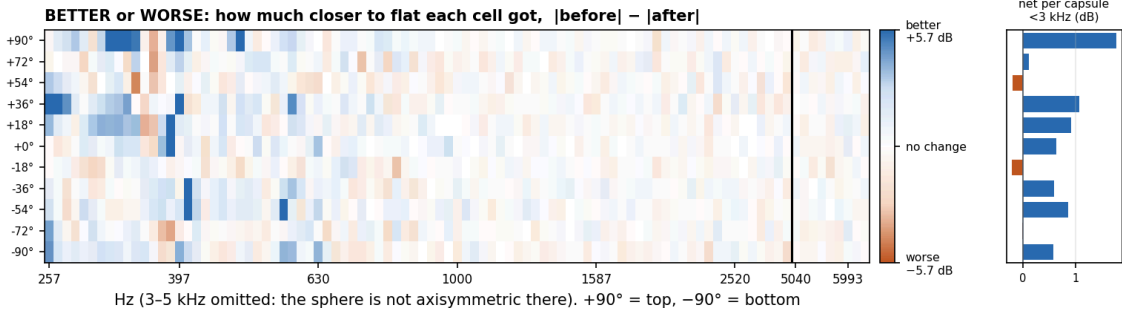
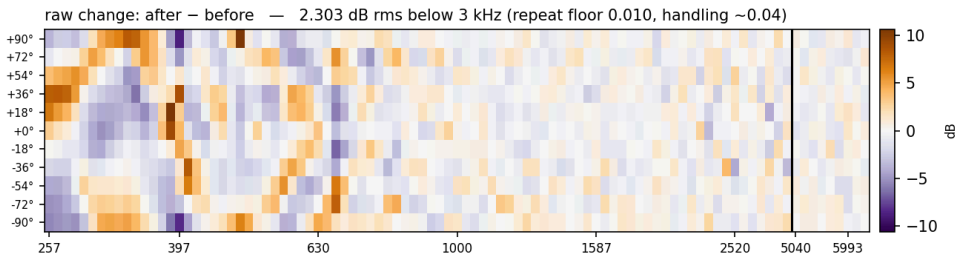
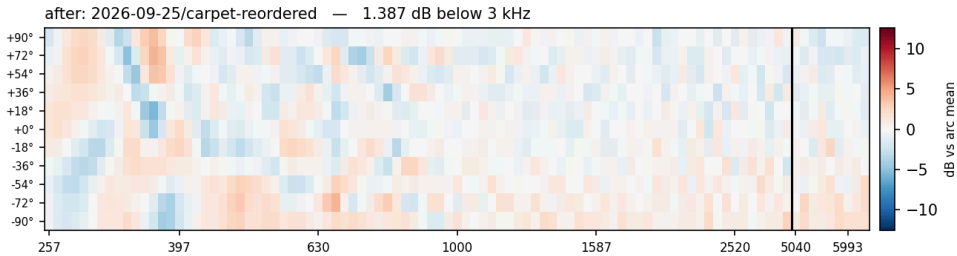
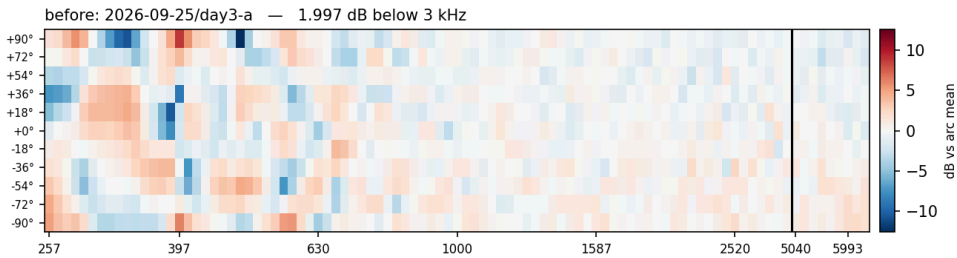
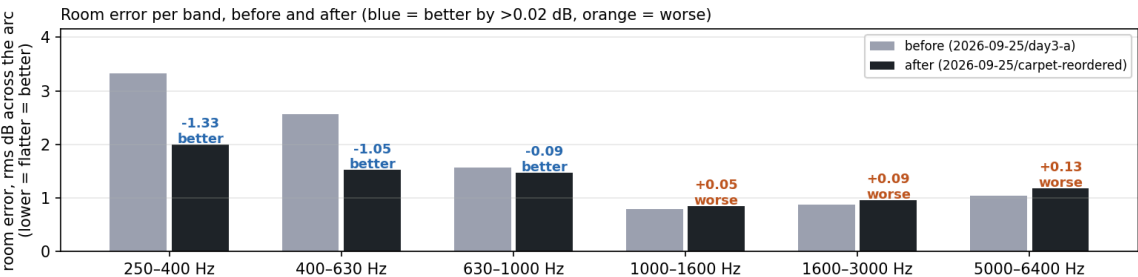
Before and after, on two captures from this report

- **Seven of the eleven factory files were wrong by 0.6–3.6 dB**, clustered by serial prefix.
- The corrections went into each capsule's calibration curve. The spread across the eleven, for the same sound, fell from **4.01 dB to 0.02 dB**. Repeatability of the method: 0.08 dB sd.
- The datum is the four capsules whose files agree with measurement. Still open: the absolute level, which needs a 94 dB calibrator.
- On the 30 Sep prop-plane polar the corrections cut the roughness from 3.3 to 1.0 dB.

Same two captures, calibrated two ways: the factory files (top) and the measured corrections (middle); “span” is the range of the capsules' mean levels. The factory files add a different offset to each capsule, which shows up as horizontal stripes across every frequency; the span of the capsules' mean levels is **4.3 $\rightarrow$ 0.8 dB** at the start of day 3 and **4.1 $\rightarrow$ 1.0 dB** in the final configuration. Room error below 3 kHz changes **2.277 $\rightarrow$ 1.997 dB** and **1.736 $\rightarrow$ 1.387 dB**. The change is a per-capsule offset, so it moves rows, not the frequency structure of the room; every room-error number elsewhere in this report uses the corrected files.

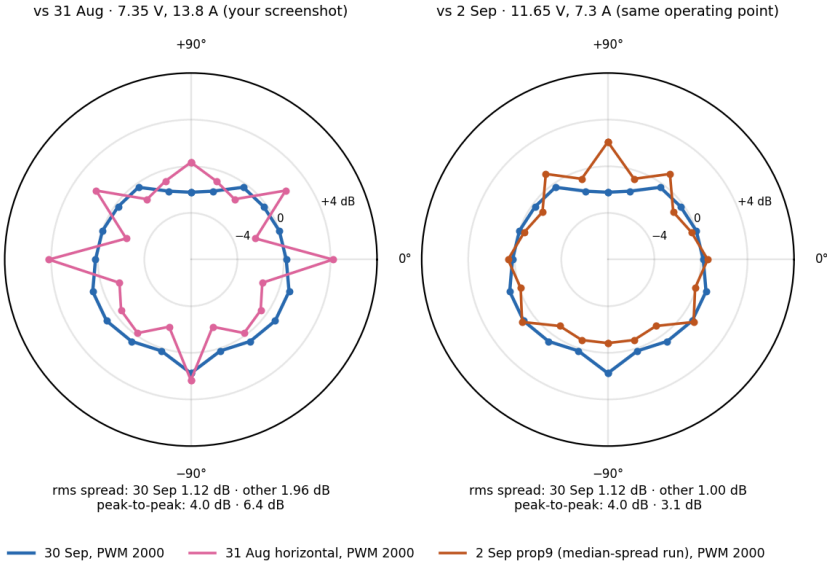
3 · Polars: is the prop-plane polar rounder than before?

Tone-notched broadband 315 Hz-1 kHz, relative to each curve's own mean, zoomed to ±8 dB (on the full 0–80 dB SPL scale all three are near-round)

- **Rounder than 31 Aug where it counts:** worst capsule 3.1 dB off the mean instead of 7.5 dB; the 31 Aug runs go down to 38 % of cells in tolerance. That run is the one in the screenshot, whose total level (tones included) is equally spread, 1.39 vs 1.41 dB; the gain is in the broadband.
- **Not rounder than 2 Sep** (same voltage, current, thrust): 66 % against a median of 71 % (65–79), inside the scatter of the 2 Sep runs.
- **Prop-plane measurement:** ends of the arc read louder than the centre at 2 and 4 kHz by +2.3 and +2.2 dB today, and by +1.5 and +4.3 dB (median) in the flat-arc runs where the true difference is zero: position-fixed error, not directivity.
