1 · Microphone calibration

SoundVisualizer · chamber report, 2026-10-05 · calibrator session 2026-09-16 (97 tones per capsule, amplitude 0.03)

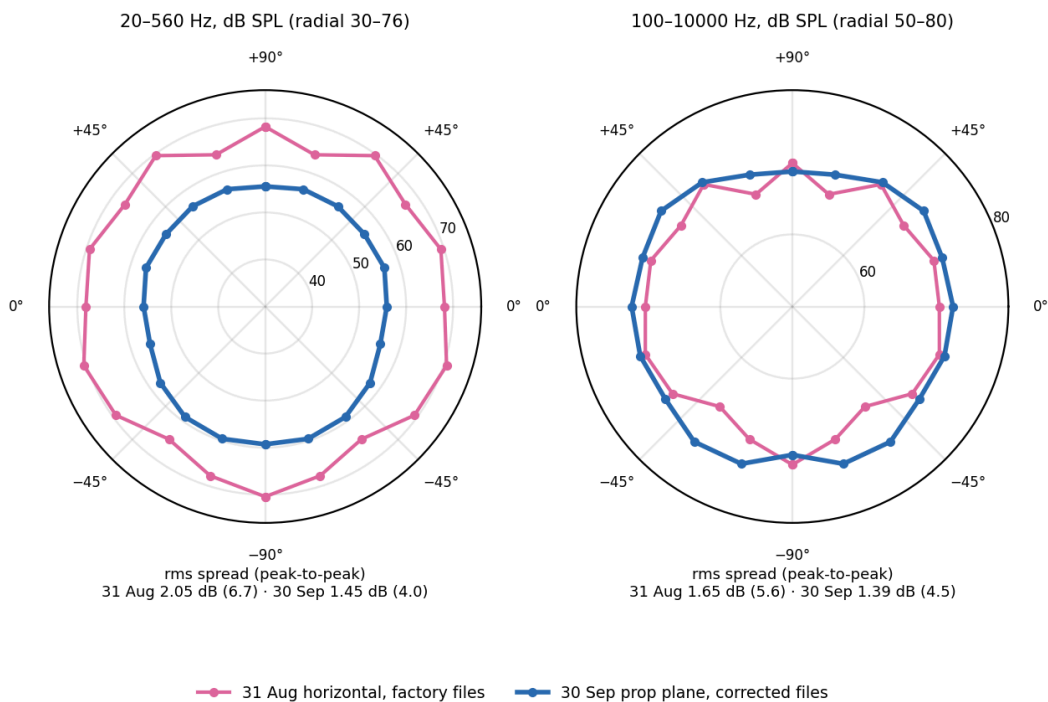
Caveat: the loudspeaker position is not documented for these two runs. During day 3 the loudspeaker was moved on purpose (20 cm closer at 13:44, into the ring plane at 14:03, 5 cm back at 15:29) and then returned to about its starting mounting point. The final point was meant to repeat the starting one, but this was not recorded. The data show the match is not exact: the top-to-bottom tilt of the map went from -0.41 to -0.63 (a 5 cm move changes it by about 0.25) and the mean level rose by 1.16 dB. The map changed by 2.30 dB rms; for comparison, re-arranging the 24 Sep carpet (chaotic-carpet→chaotic-carpet-2) changed it by 0.14 dB and a 5 cm source move by 0.80 dB. The gain is therefore the treatments plus a small, unknown difference in source position. The final tilt is closer to the 24 Sep afternoon runs (-0.57 to -0.60). The one pair with a documented, unmoved source is from 24 Sep: empty floor 2.054 → carpet 1.317 (three carpet arrangements: 1.317 / 1.318 / 1.324).
