Two errors: bent tones on a broadband floor

The blade tones are bent by up to 8 dB below 1 kHz; notching them leaves a smaller error that is still systematic and present in every band. What the arc-validation runs actually say once tones and broadband are separated, what the chamber literature says about each problem, and which remedies are possible. One chapter per problem, each ending in a verdict. Derived from docs/arc-validation-onepager.pdf and the September 2026 horizontal runs; the measurements and the cited PDFs govern where this report disagrees.

2026-09-08 · rev 2026-09-09
data: laptop backup of 2 Sept
scripts: arc_validation_diagnostics.py
numbers: docs/analysis/remedies-
papers: papers/arc-validation/
status: working draft

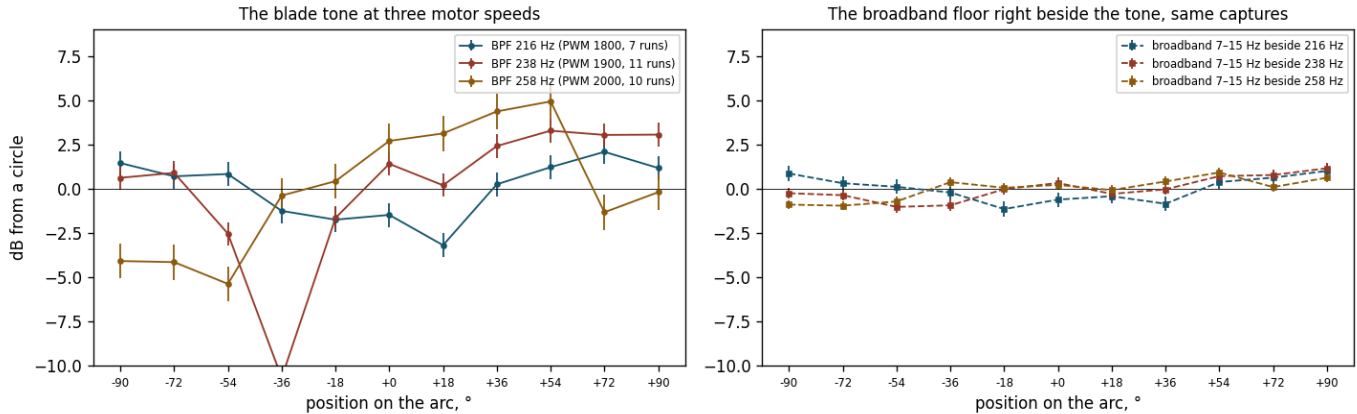
Fig. 1 · Left: the blade-tone position term at three motor speeds (BPF 216, 238, 258 Hz; 7, 11 and 10 runs). Right: the broadband floor 7–15 Hz on either side of the same tone, same captures, same fit. Error bars ± 1 standard error. Data: docs/analysis/remedies-tone-probe-map.csv, remedies-diagnostics.jsjon.

Spread of the tone position term across the eleven positions: 0.9 dB at 216 Hz, 3.4 dB at 238 Hz, 3.8 dB at 258 Hz. Between 238 and 258 Hz the deepest cell moves from -36° (-8.3) to -72° (-7.8) and the highest from $+36^\circ$ ($+5.2$) to $+54^\circ$ ($+7.4$). Correlation of the eleven-position pattern between neighbouring probes: 0.41 (216→238), 0.41 (238→258), then 0.76 (647→714), 0.59 (714→775), 0.73 (863→952), -0.92 (952→1034). The room error is frequency-sharp at 240 Hz and frequency-smooth at 700 Hz.

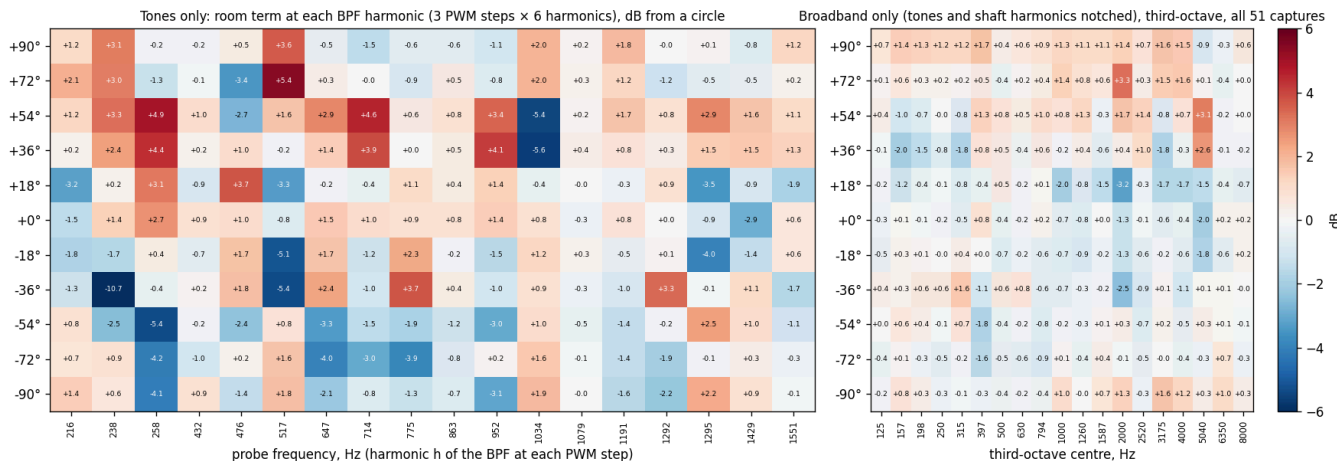
A one-echo comb fitted to each position's 18 probes: $+36^\circ$ extra path 1.50 m, amplitude 0.35, residual $2.4\text{--}1.3$ dB; $+54^\circ$ 1.49 m, 0.43, $3.3\text{--}2.1$ dB; -72° 0.68 m, 0.23, $2.3\text{--}1.7$ dB. The other eight positions fit nothing better than 2–4 m at amplitude ≤ 0.23 with little improvement. An amplitude of 0.4 after a 1.5 m longer path needs a reflection coefficient near 1: a hard surface, not foam. Fitting one plane to all eleven extra paths fails (residual 0.9 m for any arc radius 0.6–1.5 m).

Fig. 2 · Left: the tone position term at each of the 18 probe frequencies (3 speeds $\times$ 6 harmonics; prop7 and PWM 1200 excluded). Right: the broadband position term, tones and shaft harmonics notched, third-octave, all 55 usable captures at all speeds. Same colour scale. The left panel is the one-pager's problem; the right panel is the room for a broadband source.

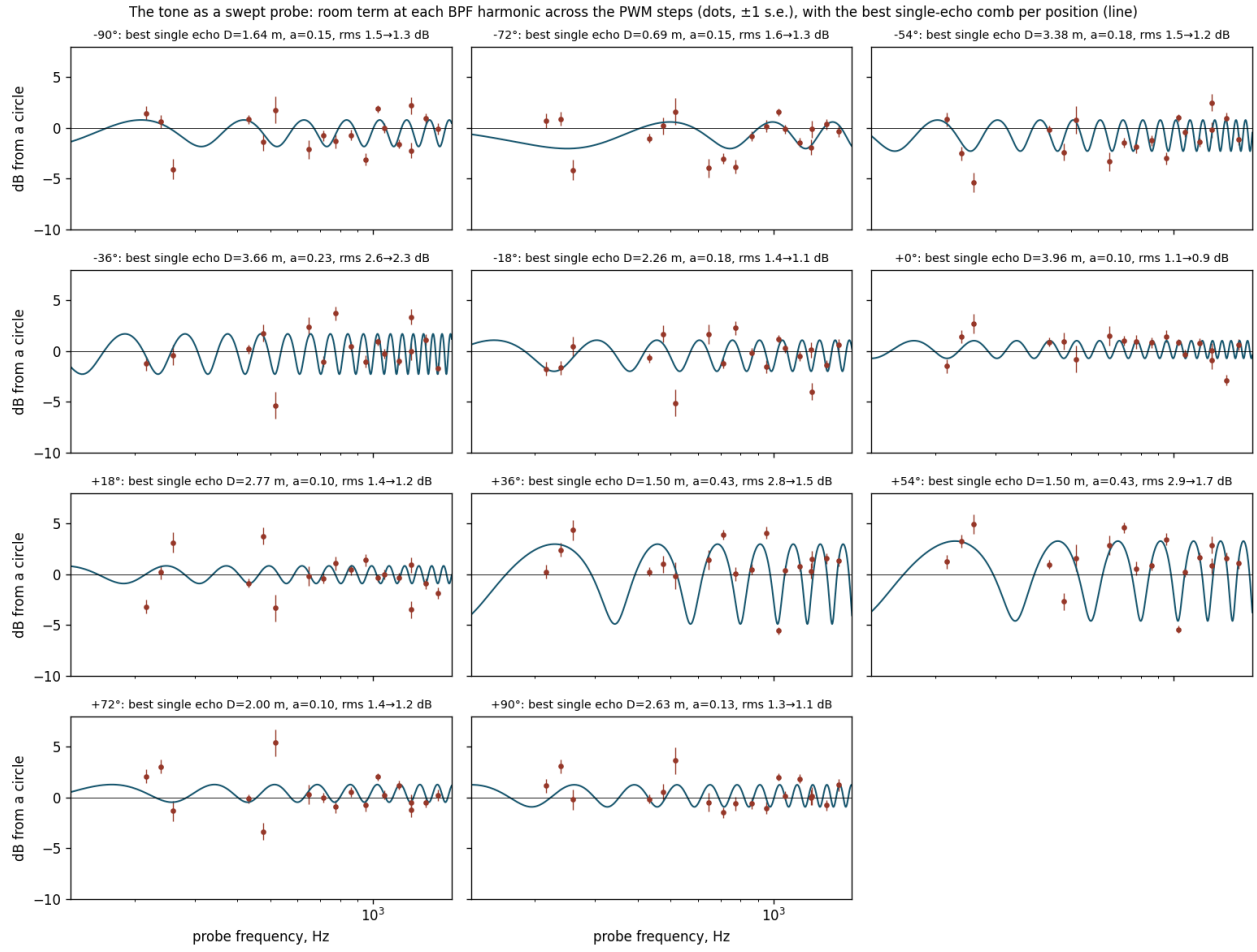
Fig. 3 · The tone as a swept probe: room term against probe frequency at each position (dots, ± 1 s.e.) with the best single-echo comb (line). Only +36°, +54° (extra path 1.5 m) and -72° (0.7 m) are fitted by one echo. Note -36°: -8.3 dB at 238 Hz between -0.6 at 216 and -1.0 at 258, a notch no single echo at this radius can make.
