D	<div>Drafting Notes:</div> <div>1. Green tags on signal flags denote S100 signal.</div> <div>Redraw/modifications (c) Richard A. Cini</div> <div>Lomas Data Productcs</div> <div>Sheet: /</div> <div>File: s100_ColorMagic-1.1-004.kicad_sch</div> <div>Title: Lomas Color Magic Redux</div> <div>Size: USLetter   Date: 2024-08-16</div> <div>KiCad E.D.A. kicad (6.0.11-0)</div> <div>Rev: 1.1-004</div> <div>Id: 1/7</div>					D
	1	2	3	4	5

Sheet: /Clock\_and\_address/

**Title: Lomas Color Magic Redux**

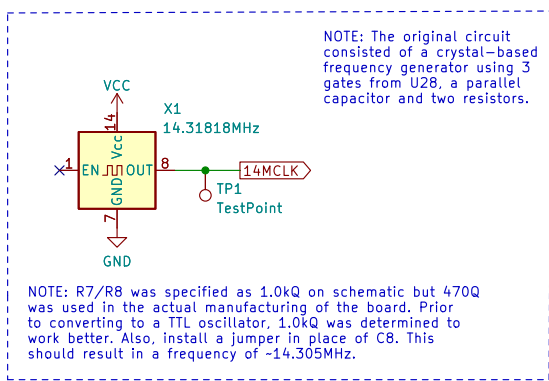
NOTE: R7/R8 was specified as 1.0kQ on schematic but 470Q was used in the actual manufacturing of the board. Prior to converting to a TTL oscillator, 1.0kQ was determined to work better. Also, install a jumper in place of C8. This should result in a frequency of ~14.305MHz.

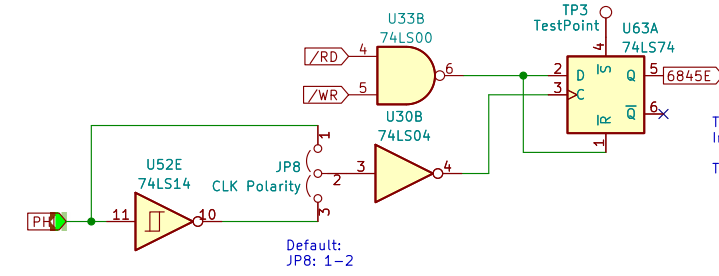
TP3: On the prototype U63.4 is left floating. In the IBM CGA adapter, it's tied to Vcc.  
TIE TO VCC

TP4: On the prototype U65.4 is connected to U64.10. TIE TO VCC.

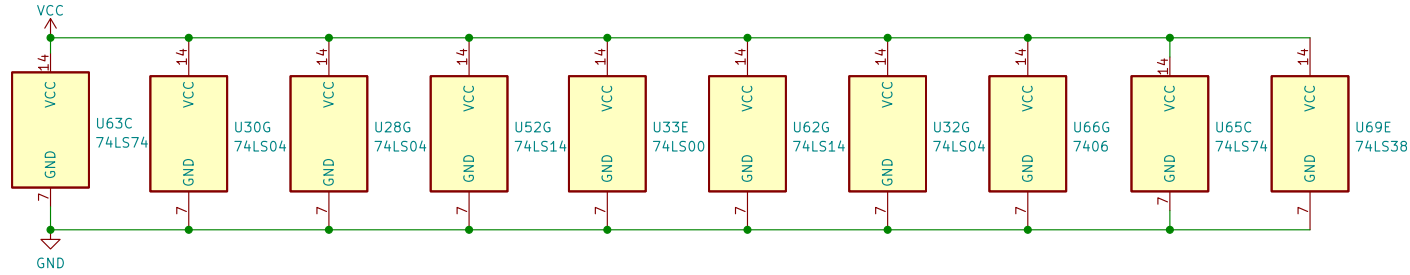
NOTE: Board uses 7406; LS family seems to work fine.
