The arc is fine above 4 kHz. Below 2 kHz the room bends it by up to 8 dB.

Fig. 1 · room error P(position), dB from a circle, mic offsets removed · fit over 12 captures: keys dp1-baseline-horizontal-prop7…prop18, PWM 1900 step (ids in the table below)

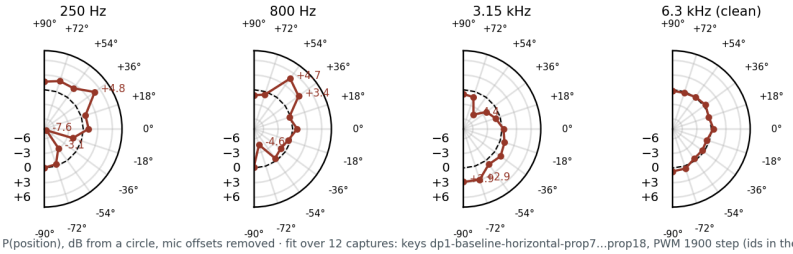
The level at −72° is 2.4 to 5.7 dB too low between 500 and 2000 Hz, in all twelve runs. The dip is deepest at 630 and 800 Hz (−4.5 dB). It stays when a different microphone sits there (811-1896 in eight runs, 810-8901 in the four runs with the arc turned around). This position is the one closest to the chamber corner.

The level at +36° and +54° is 3 to 7 dB too high, at 200–250 Hz and at 630–1000 Hz. Three different microphones sat at +54° over the twelve runs. The bump stayed the same.

Around the blade tone (200–250 Hz) the two halves of the arc disagree: −36° reads −7.6 dB, +36° reads +4.8 dB; −54° reads −3 dB, +54° and +72° read +2 dB. The negative-angle half of the arc (−36°, −54°) is too low, the positive-angle half (+36°, +54°, +72°) is too high. The dip also moves with motor speed (−9 dB at PWM 1900, −2 dB at 2000). A sound wave that bounces off a surface and adds to the direct wave does exactly this: it cancels at some frequencies and adds at others, and the tone slides through those frequencies as the speed changes.

Above 4 kHz the arc reads a circle within ±1 dB at every position. The positions 0°, ±18° and ±90° are within about 1 dB in every band.

1. Take 811-1892 off the arc.
2. Put a small loudspeaker on the stand instead of the propeller. Play short tone bursts at 250 and 800 Hz and record all microphones. The delay of the second arrival at each microphone, times 343 m/s, is the extra path length. Only one surface fits all eleven delays. With no airflow, anything left is the room.
3. Write down the geometry in docs/mic_arc.md: arc radius, propeller height, which wall or corner is at the −90° end, distances from the −72° and +72° microphones to the nearest wall.
4. Cover or move that surface, then run scripts/arc_error_map.py again. Foam only helps at 3 kHz. At 250 Hz the only fix is distance.

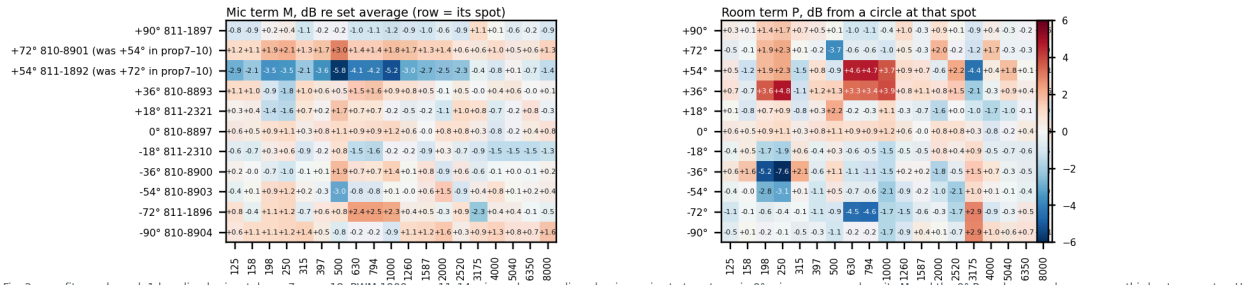
Fig. 2 · Microphone error map (left) and room error map (right), same fit, same scale

Not the microphones, with one exception. Because the microphones at +72° and +54° were swapped after prop10, and the arc was turned around for prop11–14, we can tell apart what belongs to a microphone and what belongs to a position. Ten microphones agree within ±1.8 dB in every band. **Microphone 811-1892 reads 2–6 dB too low from 125 Hz to 2.5 kHz.** Its calibration file does not match the capsule (its sensitivity value, −10.63 dB, is the least negative of the set, while the raw capsule is only about 1 dB low). When it sat at +54° it made the room error look like 7 dB. Take it off the arc or measure it again.

Not one frequency. The error sits in three separate bands, 200–250 Hz, 630–1000 Hz and 3150 Hz, and nowhere else (Fig. 2). Rajmane and Baumann (DAGA 2016) found a steel plate in a chamber only shows up once the wavelength is shorter than the plate (35 cm from 1.25 kHz, 10 cm from 3.15 kHz). So three bands point to three object sizes: about 1.5 m (floor, table or wall), about 0.4 m (stand base or a bar of the arc frame), about 0.1 m (a microphone clamp or mount).

Fig. 2 · one fit over keys dp1-baseline-horizontal-prop7…prop18, PWM 1900, prop11–14 mirrored · rows aligned: mic row i sat at spot row i · 0° mic never moved, so its M and the 0° P are known only as a sum · third-octave centre, Hz
