SoundVisualizer · chamber report, 2026-10-05 · calibrator session 2026-09-16

2 · The chamber, and the main waterfall

2 · Day 3 evaluation by the chamber-qualification method

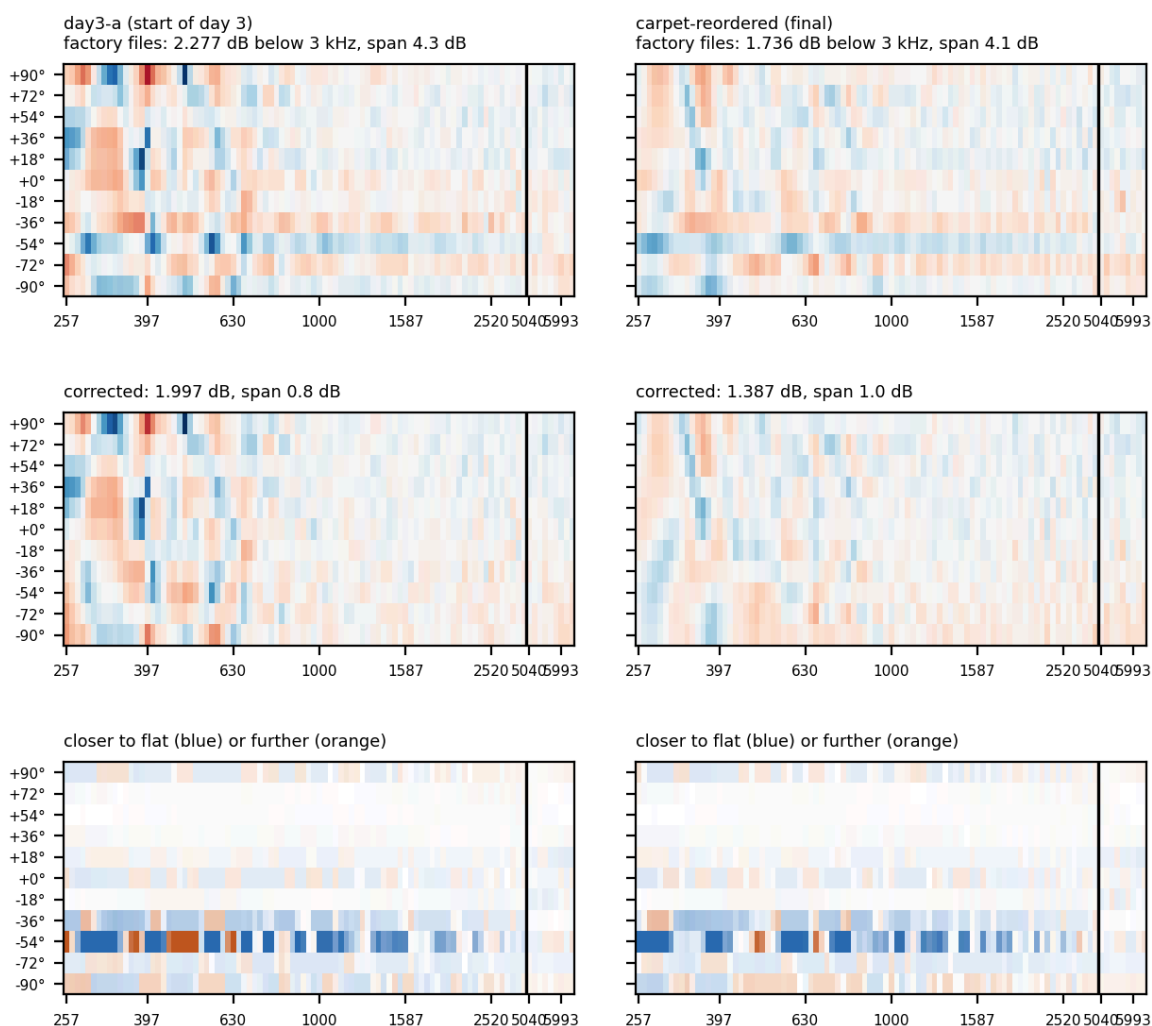
The source: a printed 1 l sphere with an 8 cm driver, at the hub.

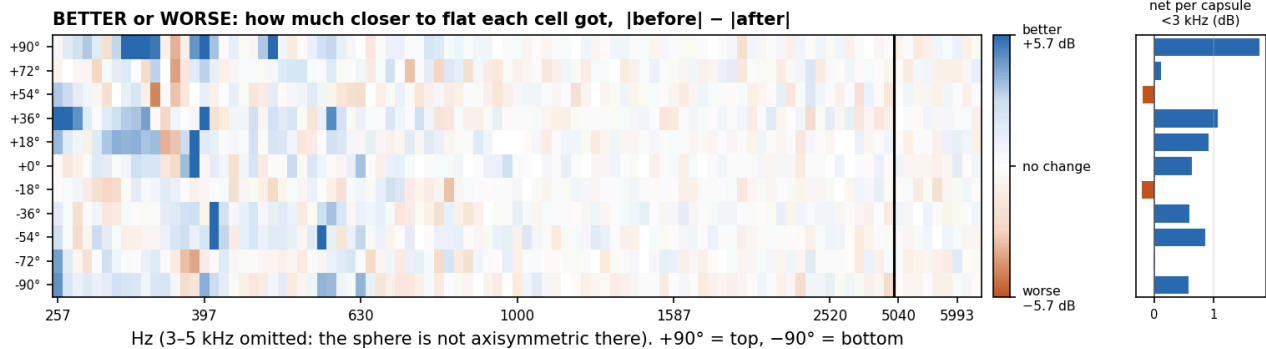
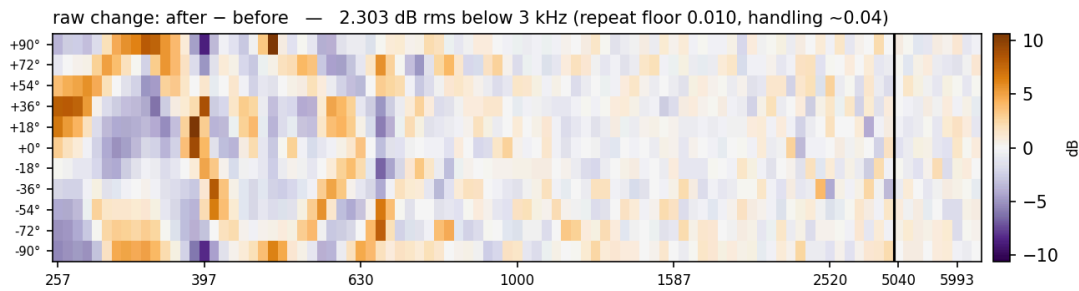
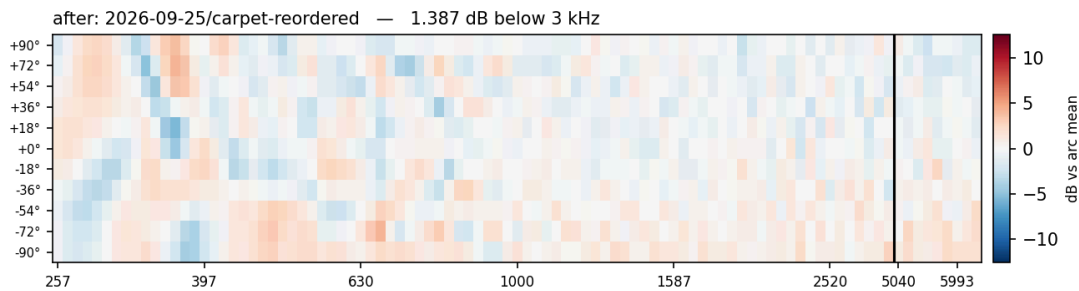
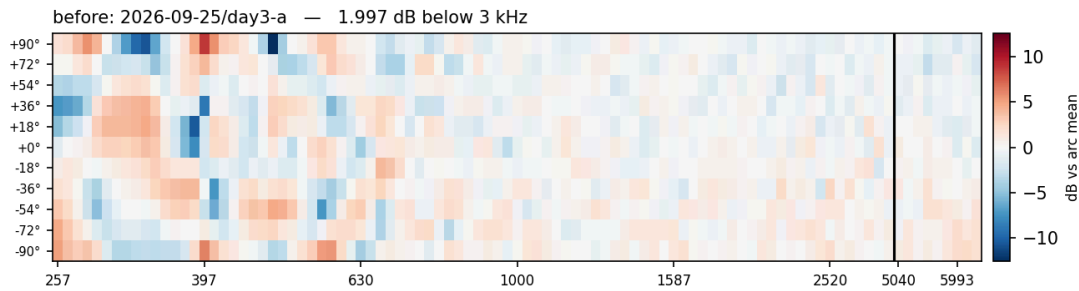
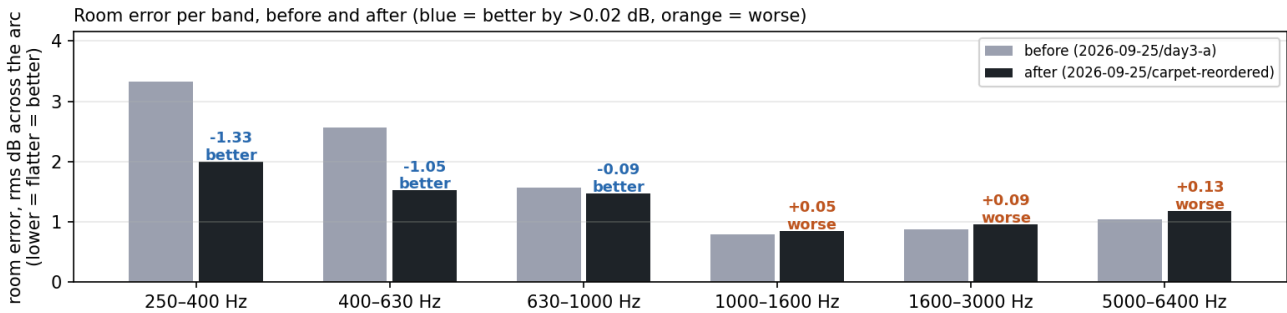
2 · Main waterfall: day 3 start against the final state

Day 3 start (worst) vs final · source moved in between: room error below 3 kHz 1.997 → 1.387 dB (-0.610, better)

2026-09-25/day3-a → 2026-09-25/carpet-reordered · below 3 kHz, 492 of 946 cells moved >0.05 dB toward flat and 415 away from it · 95 tones · 11 calibrated capsules

Blue = inside, yellow = marginal, orange = over. The cut-off is set by the highest failing band, so read it with the lists. **Caveat:** the source was moved between these runs (20 cm closer at 13:44, into the ring plane at 14:03): the map changed by 2.30 dB rms, against 0.14 for a re-arranged carpet and 0.80 for a 5 cm move, so the gain is treatments and source positions together. The one pair with an unmoved source is 24 Sep, empty floor 2.054 → carpet 1.317 (three arrangements 1.317 / 1.318 / 1.324).
